National Civil Rights Museum

Annual Facility Assessment Report

SBC No.: 529/000-01-2020

June 2023

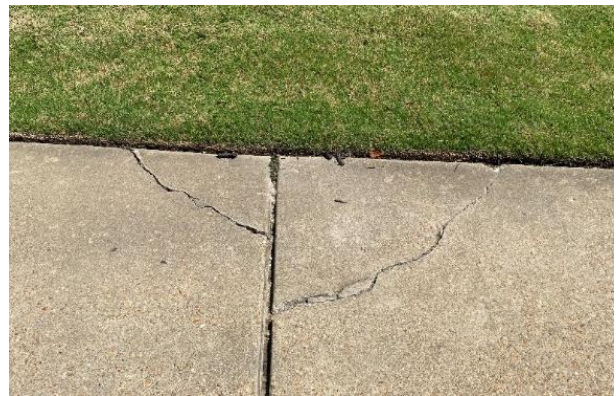
There are areas of cracking along perimeter sidewalks which could present as a tripping hazard. It is recommended to repair pavement at areas where the pavement has settled. Continuous exterior paths from exit stairways to the adjacent sidewalk is also recommended. An accessibility report should be performed for the entire facility to ensure paths that serve as an accessible means of egress meet the accessibility requirements.

Settled sidewalk pavement to be monitored

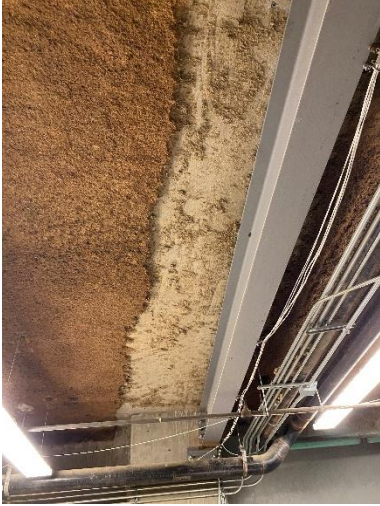
There appears to be no issues with the building foundation. Spray insulation is missing on portions of the basement ceiling. Spray insulation needs to be reinstalled at portions that are missing to keep the thermal performance and any fire code requirements intact.

Spray insulation at basement to be reinstalled

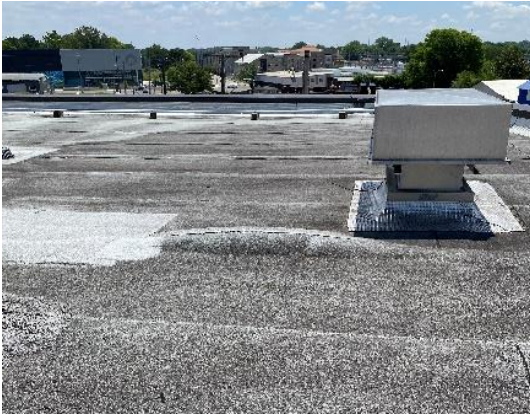
Portions of the largest section of roofing are bubbling and seams were starting to pull apart. The manufacturer holding the roof warranty, if warranty is still active, should be consulted prior to making repairs to maintain the roof warranty. The roof sections that have bubbling and potential for cracking need to be reviewed by a roofer and, at minimum, be repaired. It is recommended that these roof sections to have a full roof replacement. Reference previous roofing report completed by Hefferlin + Kronenberg Architects (Task Authorization #14-008) for additional recommendations for roofing maintenance items. The roof needs to be addressed.

Roofing membrane that is bubbling and cracking

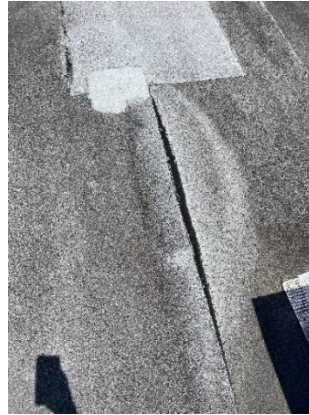
Roof membrane pulling apart at seam

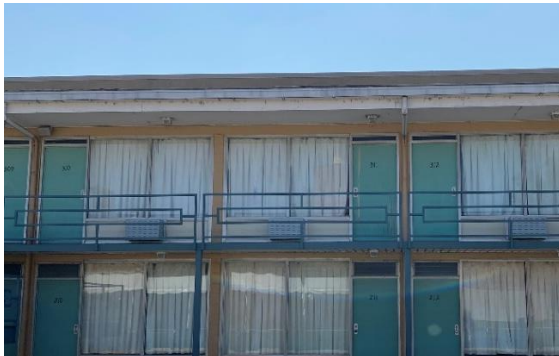
At the Lorraine Motel, a portion of roofing is lifted near the gutter. It does not appear that the flashing or a sheet metal edge were installed at the roof edge to the gutter. There are areas where the gutters and downspouts are damaged. The fascia boards and soffits need to be cleaned. Utilize only cleaning products and methods that will not harm the existing material. Due to the cultural sensitivity of the site, no change should be made to the appearance of any visible portion of the historic facility without review from the Historical Commission.

Roofing edge needs flashing at Lorraine Motel

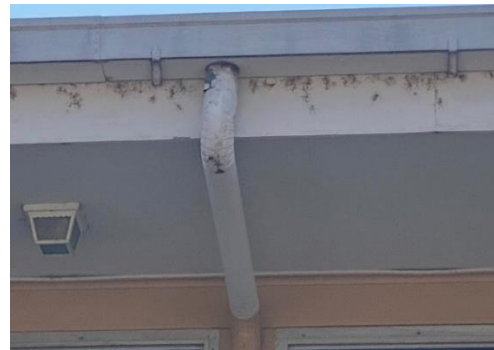
Gutters and downspouts at Lorraine Motel

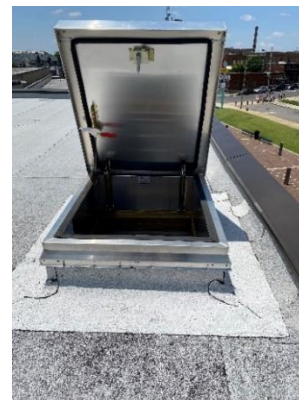
The roof hatch located in the enclosed staircase near the motel has recently been replaced. There is currently free access to the roof hatch. A lock should be installed at the hatch. Also, installing a bar at the bottom of the roof access ladder is recommended for safety. Since the roof hatch is installed within 10 feet of the roof edge, it is recommended that a guard or personal fall arrest anchorage connector be installed. An area of the upper roof was inaccessible at the time of the site visit. A permanent ladder between the lower and upper roof should be installed for maintenance accessibility. Electrical conduit piping for security cameras at the office roof portion are sagging in areas. Provide additional pipe supports at the proper spacing.

New roof hatch needs lock

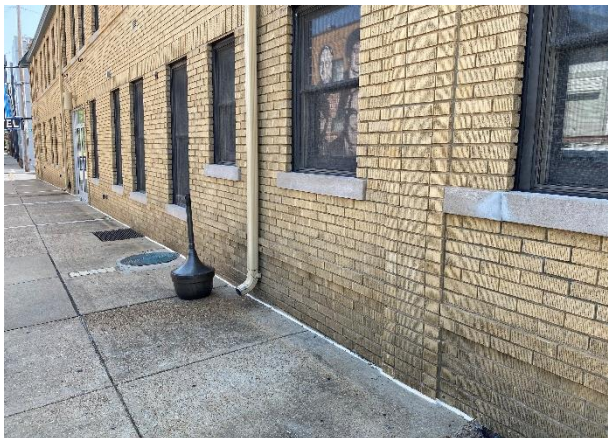
Brick façade around entire perimeter to be cleaned

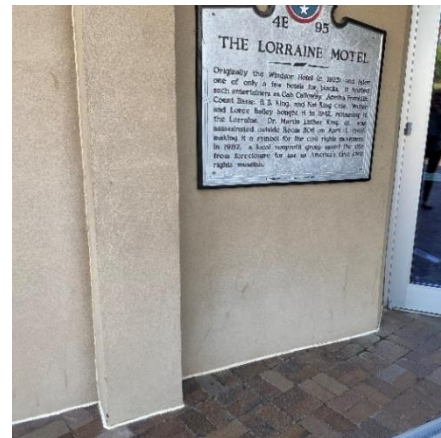
EIFS system to be repaired and repainted

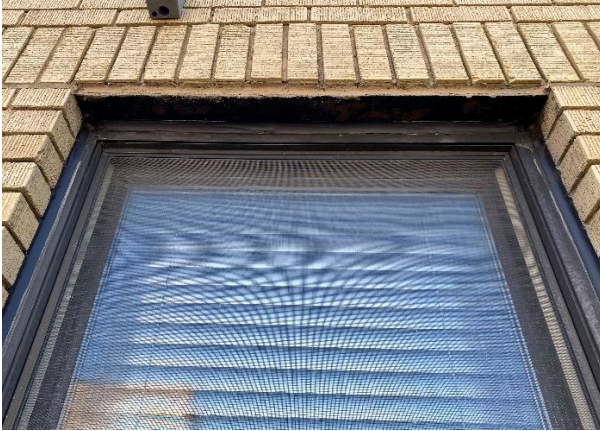
Steel lintels to be repainted

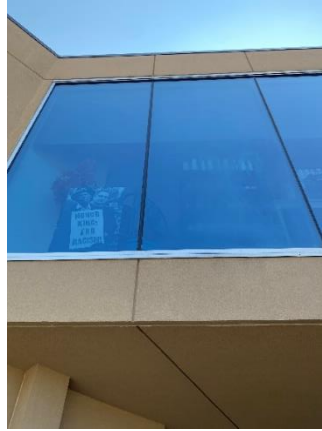
Glazing system needs replacement at gift shop

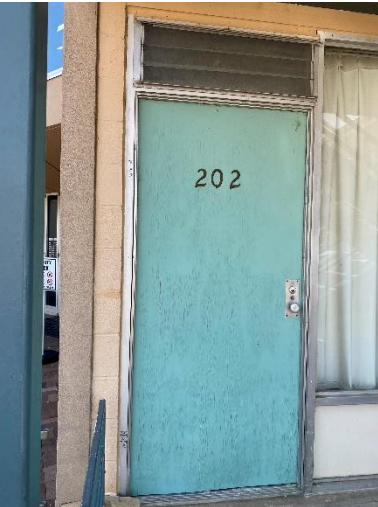
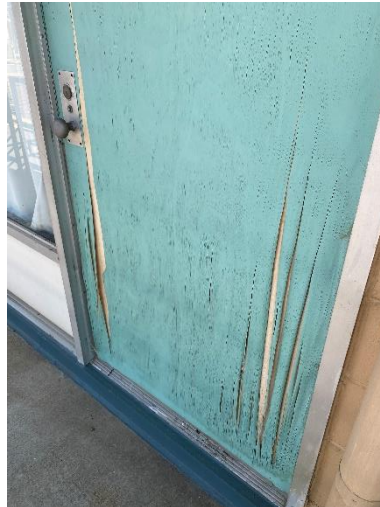
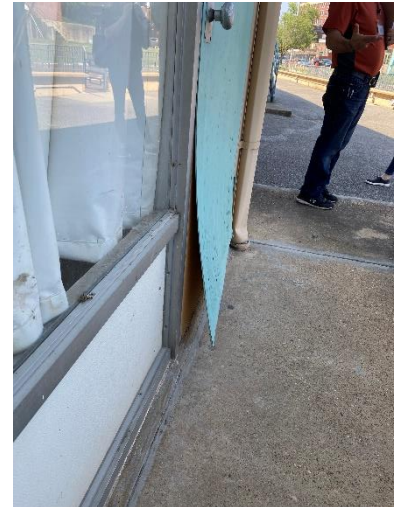
The exterior wood doors at the Lorraine Motel are cracking and the veneer is pulling away from the door core. The doors should be replaced. There is evidence of mildew at the Lorraine Motel's steel framing and glazing systems. This area should be tested prior to cleaning any mildew from steel framing system and adjacent curtains. Remove sealant and provide new exterior grade sealant around the entire perimeter of the frame. Due to the cultural sensitivity of the site, no change should be made to the appearance of any visible portion of the historic facility without review from the Historical Commission.

Wood doors to be replaced at the Lorraine Motel

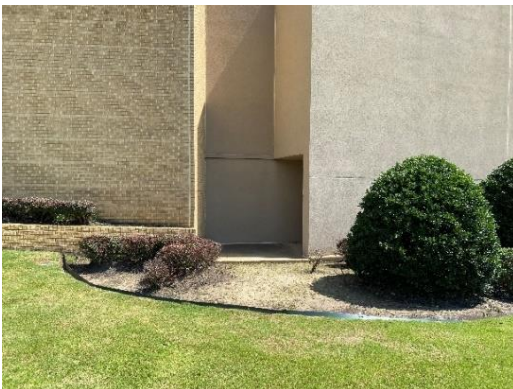
It is recommended an accessibility report be performed for the entire facility to ensure paths that serve as a means of egress are meeting the accessibility and code requirements. Paths should be unobstructed at the exit discharges to the public way. It is recommended that hard surface paths are provided at the west and south exit stairways to the adjacent sidewalks.

Exit discharge at west exit stair

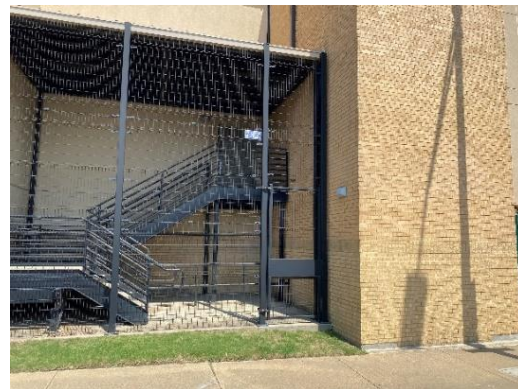
Exit discharge at south exterior stairway

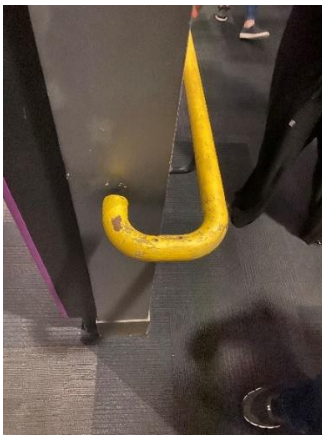
Interior stairs and ramps are in good condition. Continue to maintain the nonslip coating on the stair in the lobby. Another coat may need to be applied to keep the stairs from discoloration. The handrails within the high traffic exhibit spaces are peeling. Portions of the handrails are currently being repaired by refinishing the rails with a high-performance coating. Additionally, there are missing handrails at stairways or ramps. Handrails need to be installed on both sides of the stairs and/or ramps along the path of travel.

Peeling paint on handrail

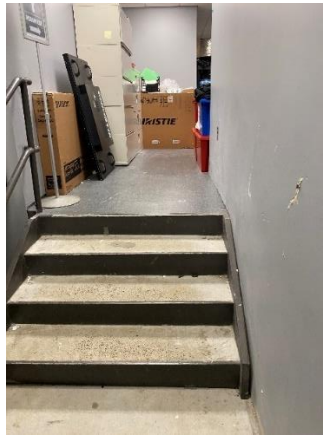
Missing handrail to be installed

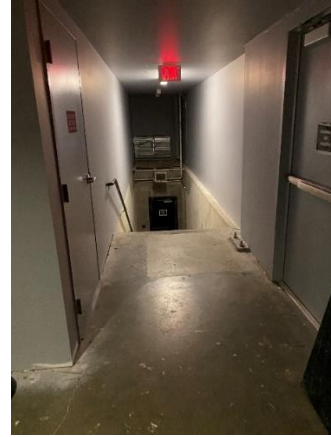
Missing handrail to be installed

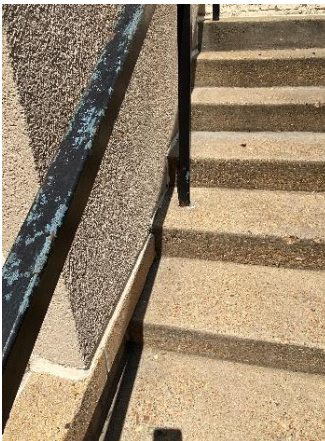
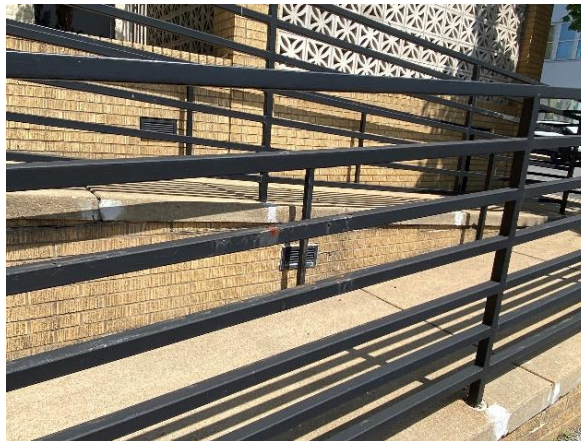
Exterior guardrails and handrails at the east, employee entrance are starting to peel due to weather. The guardrails and handrails need to be repainted. To increase the longevity, it is recommended to use a high-performance coating or replace with stainless steel rails.

Peeling paint at exterior handrails and guardrails that need refinishing

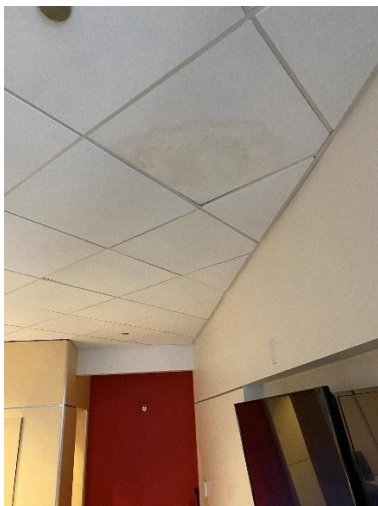
There are a few stained ceiling tiles at the front lobby area along with damaged ceiling grid, which should be replaced as needed. During time of the site visit, the plenum space was not accessible to identify the cause of the staining.

Stained ceiling tile to be replaced in Lobby

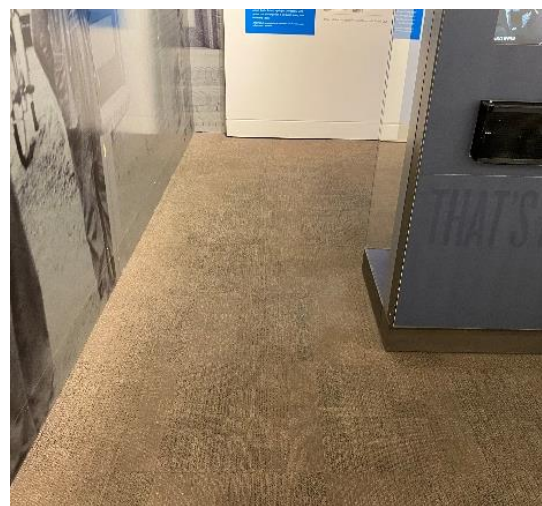
Stained and worn carpet tile to be replaced in exhibit space

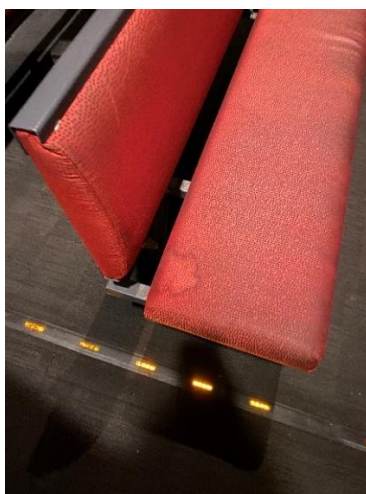
Bench seat upholstery is stained and some fabric is starting to rip. The fabric at all bench cushions and back rests should be replaced. The perimeter trim at the platform seating is starting to pull away. Repair or replace perimeter trim and any carpet that has been damaged.

Stained bench upholstery to be replaced in theater spaces

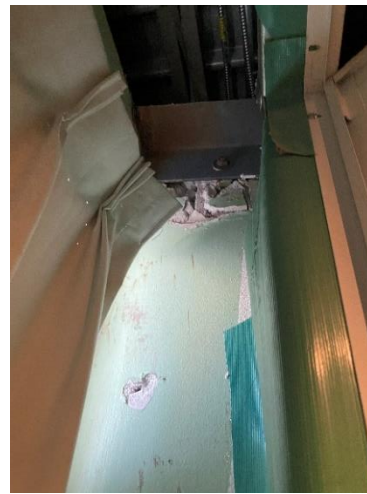
Plaster walls to be repaired at Lorraine Motel

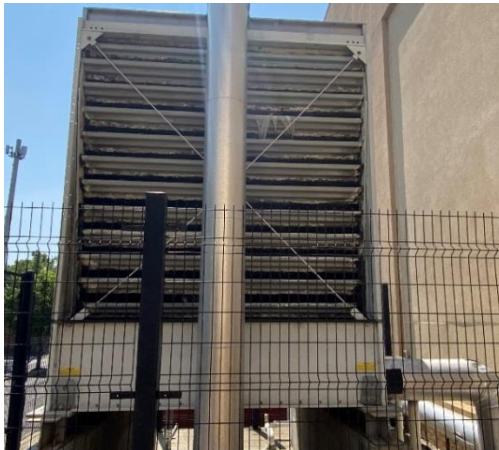
Fins of the cooling tower need to be cleaned

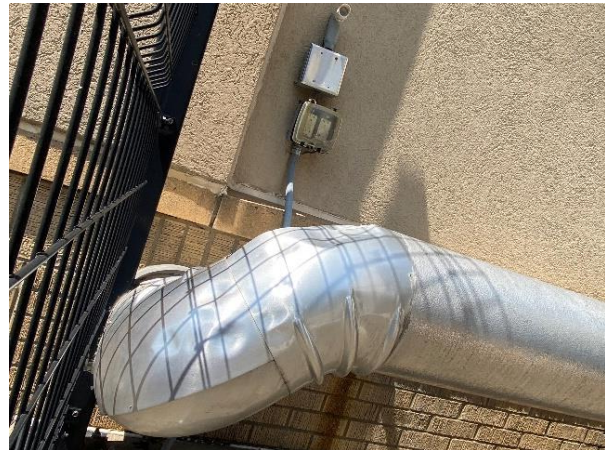
Ductwork to be repaired

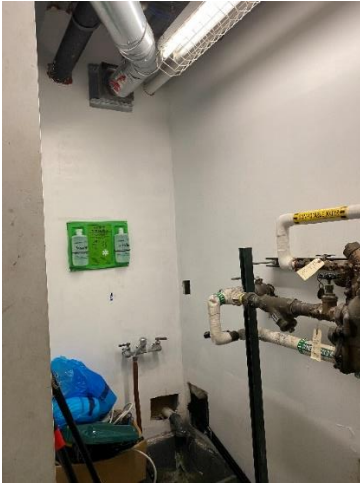
The fire alarm and sprinkler systems were reported to be functioning at time of the site visit. The mechanical room, near the administration offices (in the Lorraine Motel), has holes and penetrations through a fire partition that are not fire rated. All the holes need to be patched with fire rated gypsum board. Any penetrations through these walls need fire rated caulk installed around the perimeter of the penetration. All fire partitions should be reviewed and apply any missing fire rated caulking as required.

Openings need to be patched with fire rated assembly at janitor's closet

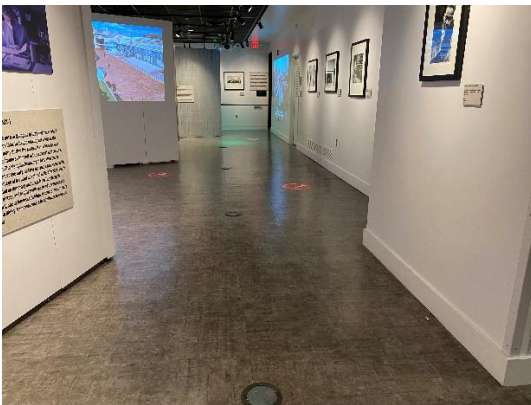
Interior lighting throughout the exhibits and facility are in the process of being replaced with LED light fixtures. The electrical floor boxes located in the rotating exhibit space protrude from the floor and interfere with exhibits and patrons walking paths. It is recommended these get reinstalled so they can be flush with the finish floor surface. The exterior light fixtures at the Lorraine Motel are rusting and need to be repaired or replaced. Due to the cultural sensitivity of the site, no change should be made to the appearance of any visible portion of the historic facility without review from the Historical Commission.

Floor outlets need to be flush with the floor surface

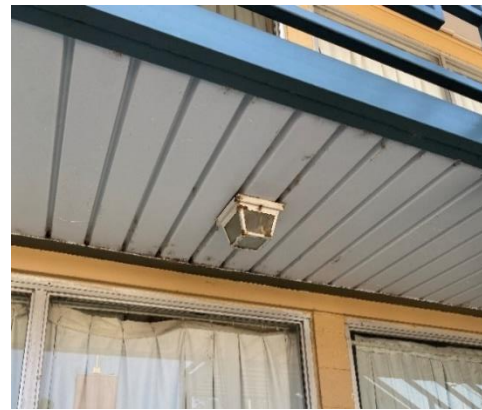
Exterior light fixtures at Lorraine Motel need replacement
