3. Crushed by Trackhoe Bucket

TOSHA Citation(s) as Originally Issued

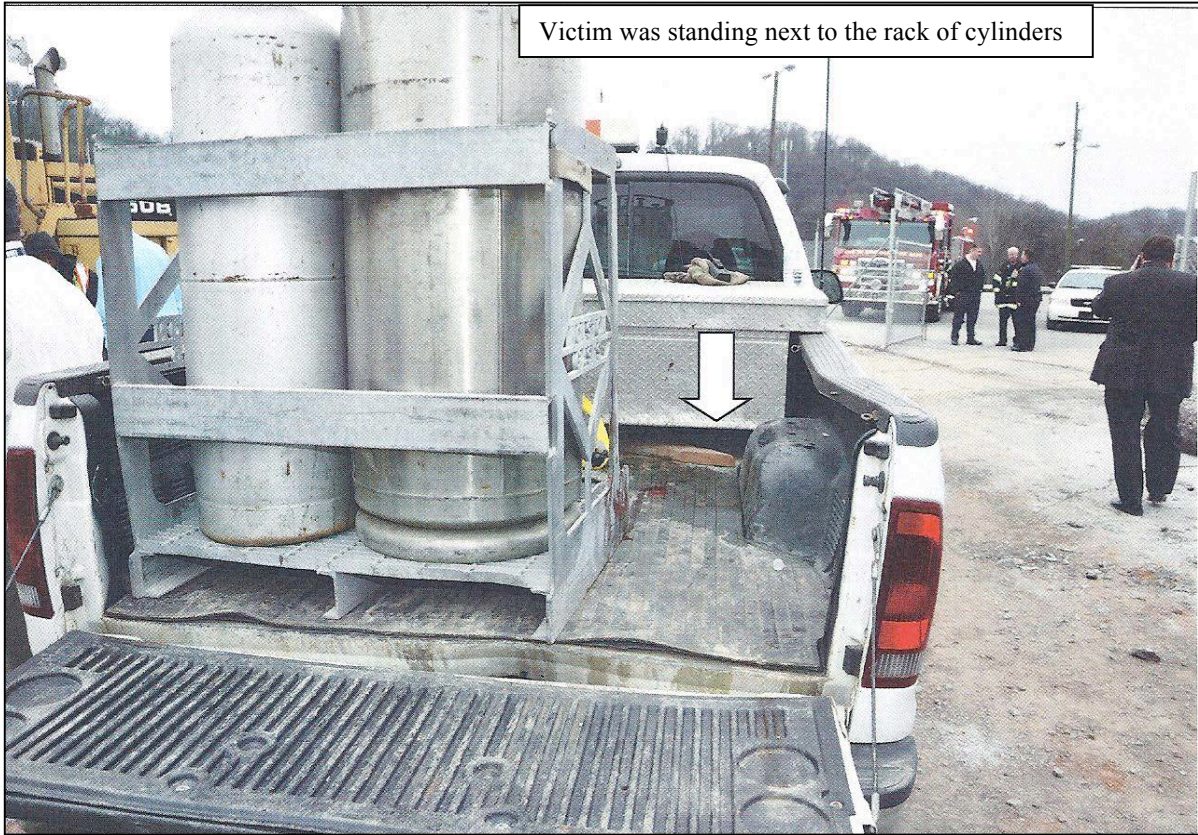
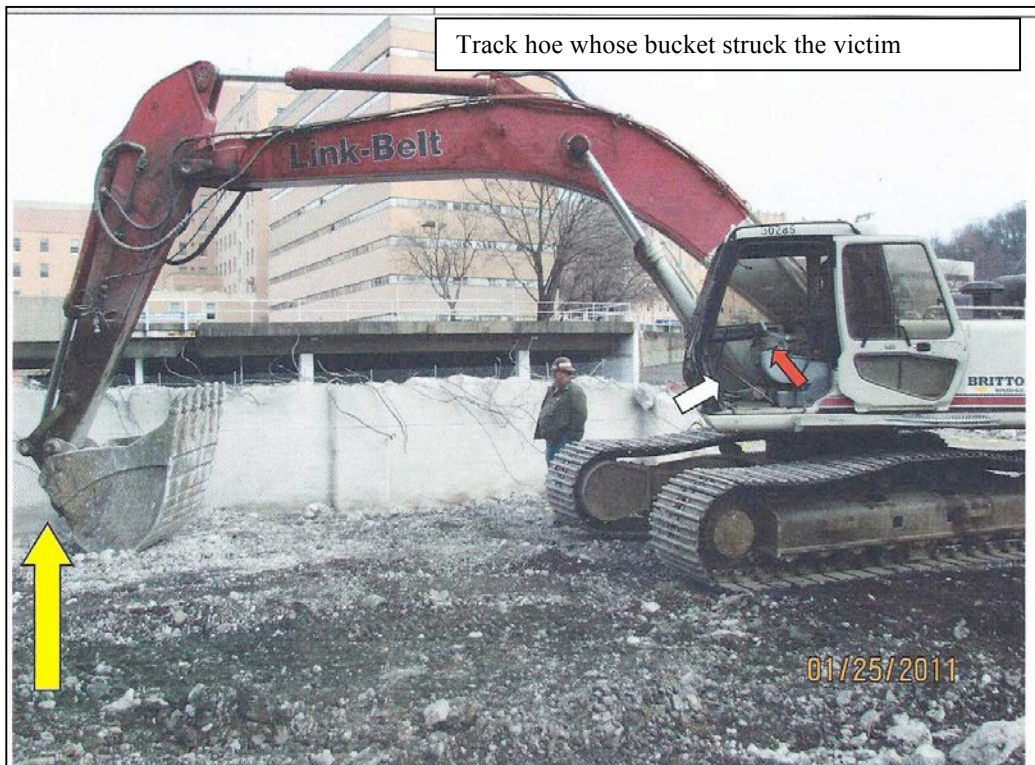
A 28-year-old construction foreman was killed after he was struck by the bucket of a track hoe. The employees were working on a bridge renovation project that was in its beginning stages and would eventually replace the entire top portion of a concrete-and-steel bridge originally built in 1930. On this day, the foreman informed a track-hoe operator and several employees that two racks holding oxygen and propane cylinders were to be moved from the south to the north side of the river. The cylinders were to be used in the torch-cutting process on steel and rebar once they were moved. While the foreman went to the north side, two employees loaded the rack of cylinders into the back of a pick-up truck using a rigging system attached to the rack and to the bucket of the track hoe. The rack was lifted by the bucket and placed in the back of the pick-up. As the cylinders were being unhooked from the slings, the foreman returned and stated he wanted to determine if another rack of cylinders would fit into the back of the truck. The track-hoe operator moved the bucket over to the right of the truck and placed it approximately two-to-three feet above the employees in the truck and just off to the right. The foreman was standing in the truck bed beside the cylinders with his back to the bucket and boom with a tape measure to measure the width of the truck. The track-hoe operator decided to disengage the control joysticks for the boom and bucket, and he reached for the function-control lever which was located low in the cab on his left. Apparently his jacket caught the left joystick, causing it to be pushed down and left. He heard someone yell to move the bucket and looked up to see that the bucket had hit the foreman in the upper back, pinning him to the rack of cylinders in the truck. The injuries to the foreman were fatal.
