24. Equipment overturned

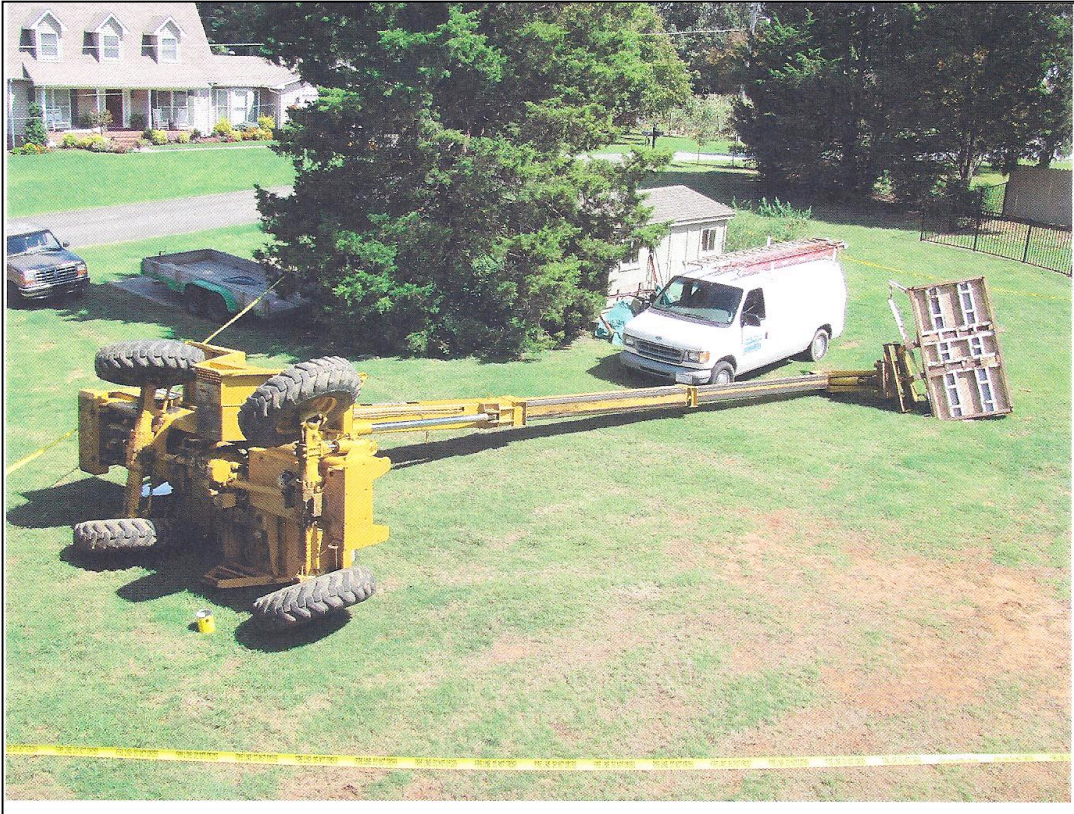
A **37-year-old** construction laborer died after a rough-terrain forklift overturned on a construction project. The company was constructing a garage addition at a residential site. The owner of the business, operating a telescoping forklift lifted the victim approximately 25 feet to a series of windows on the garage addition. The victim was standing on a 4-foot by 8-foot lift platform in place on the forks of the lift with the owner operating the controls. The victim was elevated up to remove plastic sheeting in place over the windows in the garage. Once the plastic sheeting was removed, the victim asked the owner to lift him as far up as possible. (The victim wanted to see how the forklift and platform would perform as a deer stand). Although the owner had refused a similar request earlier in the day, this time he complied. He backed the forklift away from the garage, set the parking brake and lifted the victim up as far as the boom would go and extended it all the way out so that the victim was approximately 35 feet above the ground. After holding that position for a few seconds, the owner began retracting the boom. When he did this, the front right wheel of the forklift began to rise off the ground and the forklift began slowly tilting to the left. The owner tried to tilt the forklift back to the right using the controls available to him, but he could not force the forklift to tilt back. As the forklift fell over, the victim rode the platform down to the ground. First-aid was begun immediately after the victim hit the ground, and emergency services arrived on the scene within minutes. The victim was taken to a local hospital where he was pronounced dead.
