## **27. Fall**

A **45-year-old** and a **21-year-old** Hispanic member of a concrete construction crew fell 85 feet to their deaths when a wall form of a concrete tower under construction fell. Four employees were working on a stairwell tower using a MEVA KLK climbing-scaffold system with a MEVA imperial wall form system that was attached to the decking of the scaffolding system. This is an engineered system designed to build towers. The decking of the scaffold is the work zone for the employees. The system was attached to the tower through a combination of hooks that were anchored to the tower and support struts that were under the system that helped support the system by pushing against the wall of the finished tower below. Once a section of the walls of the tower are poured and the concrete cured and tested the walls of the formwork are separated from each other and the formwork walls are slid back from the cured concrete walls of the tower. A few days before the incident, the concrete for the walls had been poured. Testing of the concrete determined that the concrete was cured and that the wall form system was ready to be pulled back so the system could be moved up to the nex

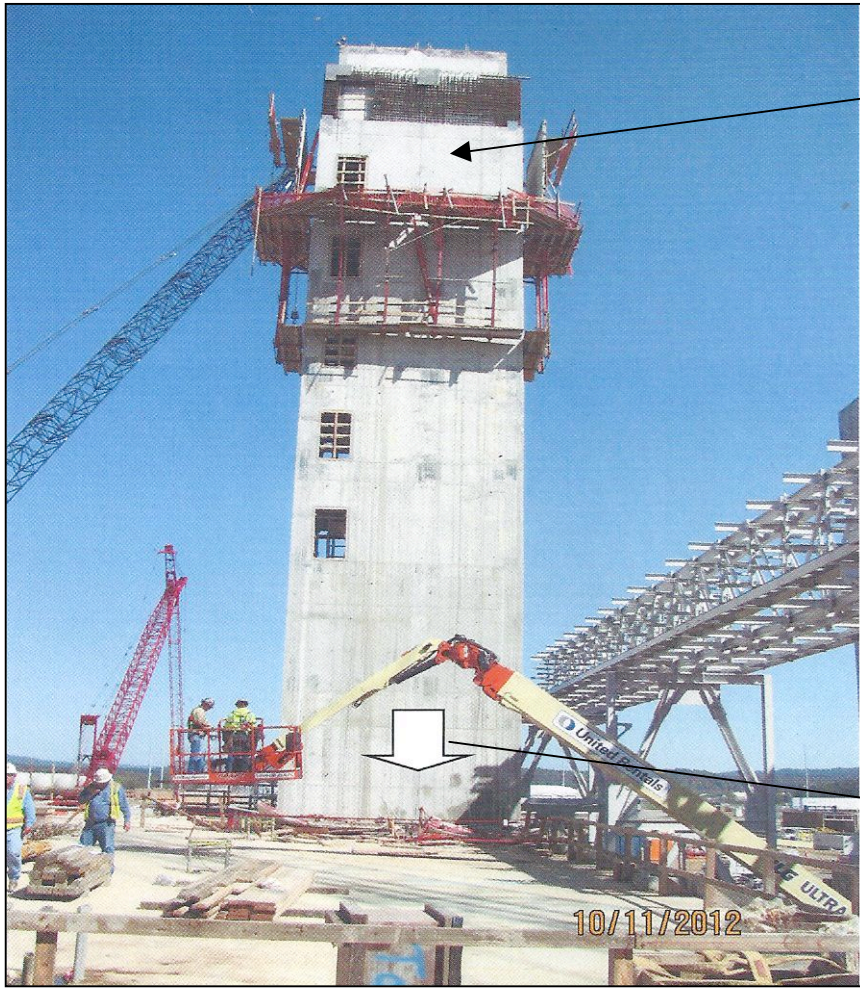
*The south wall form is missing*

*Where the south wall and the victims landed*
