4. Fall through hole in roof

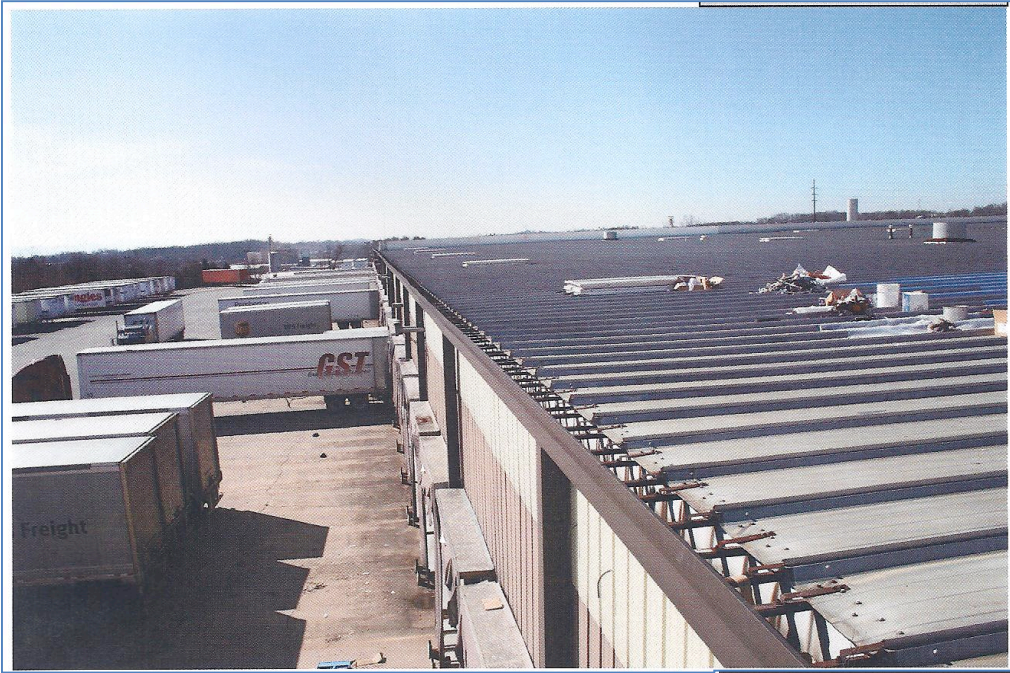
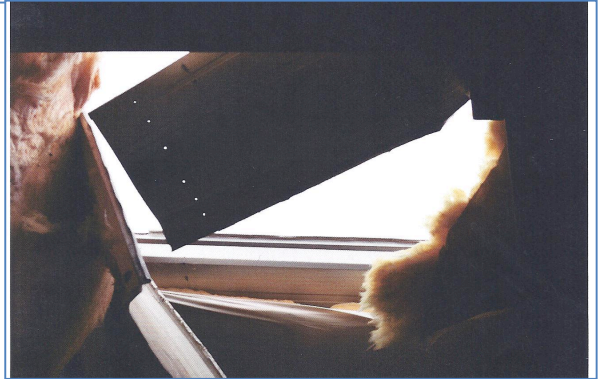
A **70-year-old** foreman of a millwright crew fell to his death through an opening in a roof under repair. The victim's employer was contracted to repair and replace an area of a warehouse building that had undergone structural damage due to a large sink hole that formed under the building's concrete pad. Because the structure of the building had shifted when the sink hole appeared, several roofing panels were damaged and were to be replaced. The victim and three crew members worked replacing panels on the roof. Near the end of the day, the victim noticed that the panels were not in proper alignment and instructed the crew to remove 10 panels. The crew reinstalled four properly aligned panels, but before they could finish their work, the work day ended. This left an opening on the roof approximately 80-feet-by-8 feet in size. The crew covered the opening with loose panels and plastic. The next day the entire crew got into position to remove the loose panels covering the hole. The victim began walking down an existing panel to help. This panel extended into the roof opening and did not have another panel attached to it. One of the crew members yelled to warn the foreman just as he stepped on the last two-and-one-half feet of the panel. The panel bent downward, collapsed under the foreman, and as he reached out to grab onto something stable, he fell through the opening approximately 23 feet to the concrete floor below. Emergency Services were called but they pronounced the victim dead at the scene.
