#8: Fall – Inspection #317747582

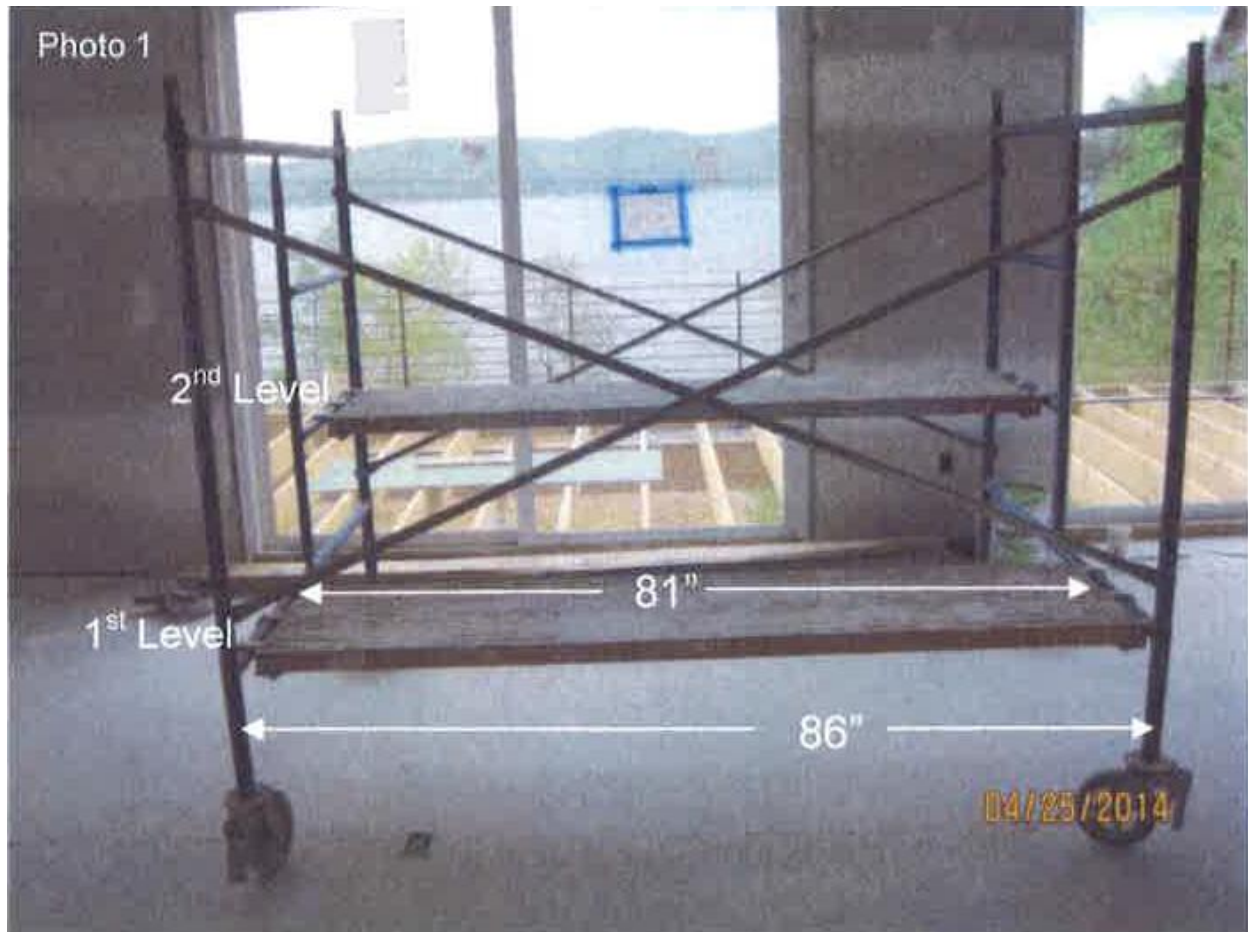
Item 1a 1926.451(b)(1)	Each platform on all working levels of scaffolding were not fully planked or decked in that the Gadsden mobile frame scaffold was not fully decked, exposing two employees to a fall while working from the scaffold to install a reveal molding in the living room.

Photo 1 of 2 – Gadsen mobile frame scaffold.
The victim was working on the 2nd level.

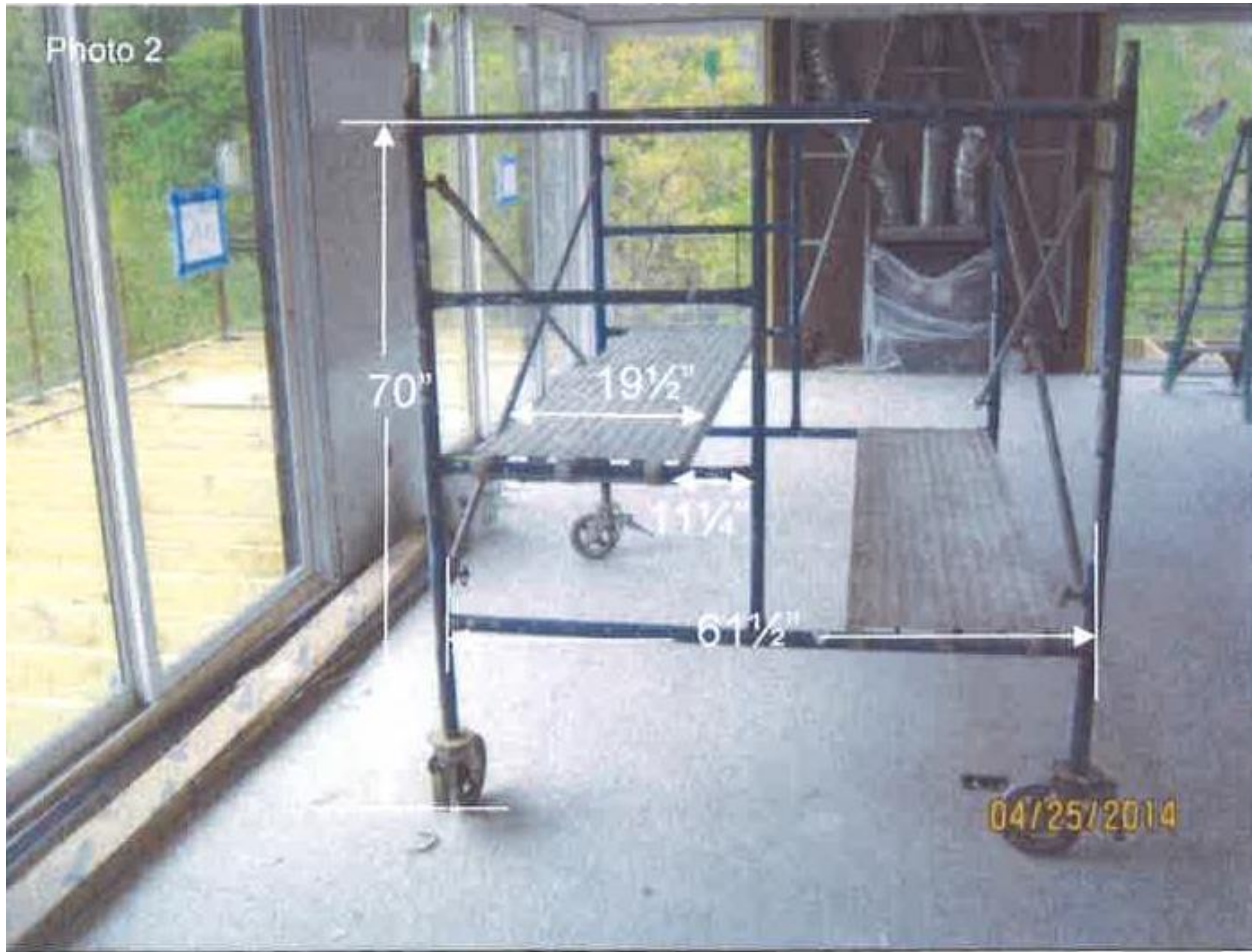
Photo 2 of 2 – Gadsen mobile frame scaffold.
The victim was working on the 2nd level
