### **13 Fall from Roof – Inspection #1234814**

A **24 year old male** employee was fatally injured when he fell twenty eight feet through roofing insulation to the concrete floor below. On the day of the incident, the victim and crew were removing roofing material in preparation for the renovation of the building. After removal of the metal roofing material the insulation beneath remained mostly intact, and a secondary part of the process included the use of aerial lifts to remove the insulation and attachment clips. Once this was done, the roof would be ready for a new roofing system. The job site was “100% tie off” during roof work, and all employees were wearing a full body harness with retractable lanyard. The employer had provided anchor points for lanyard attachment on the roof. The employer also provided a cooler with ice and bottled water on the roof at the beginning of each shift. During the inspection it was determined, that the victim apparently disconnected his lanyard to go get a bottle of water. He stepped back 1 to 2 feet and fell through the insulation. During interviews employees were unsure of when they could disconnect, and were unaware that TOSHA required the

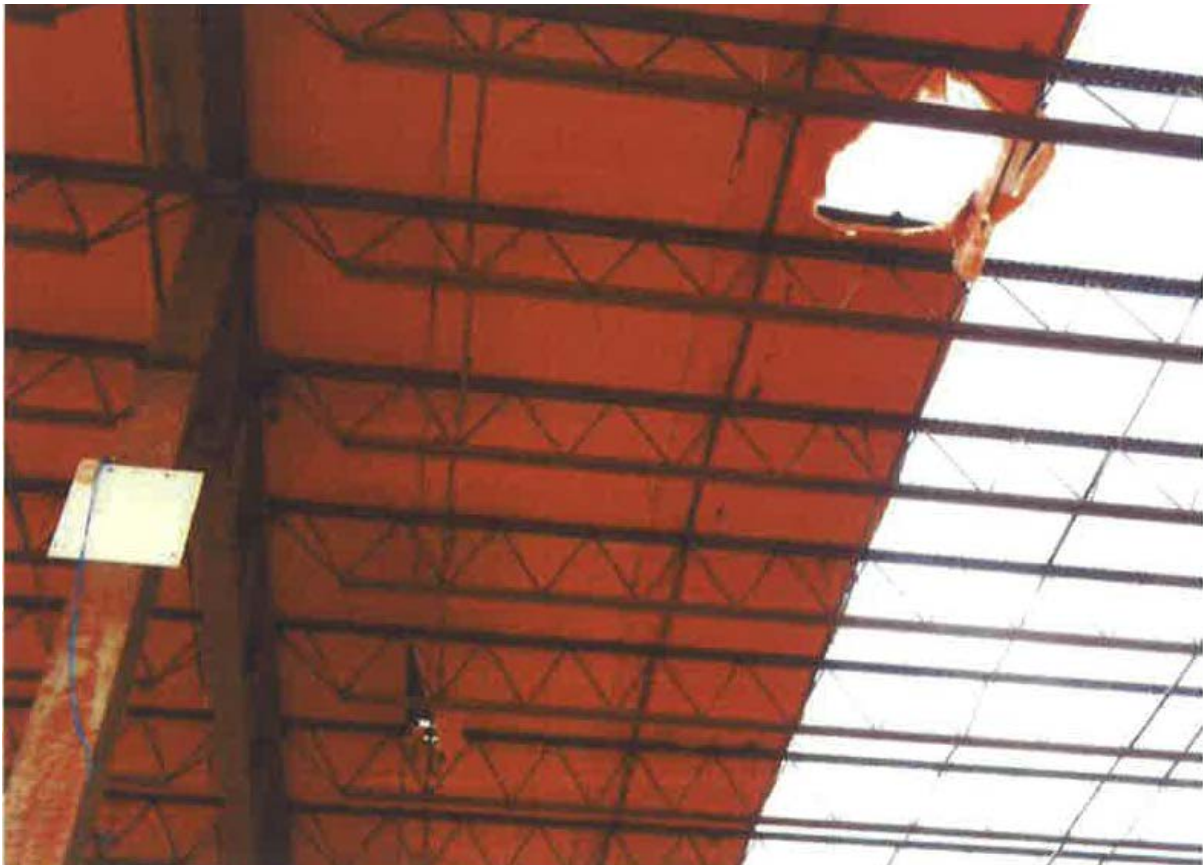
Photo 1 of 1 – Location of where the victim fell through the insulation on the roof.
