## **19 Crushed by winding machine – Inspection # 1242294**

**19 Crushed by winding machine – Inspection # 1242294**

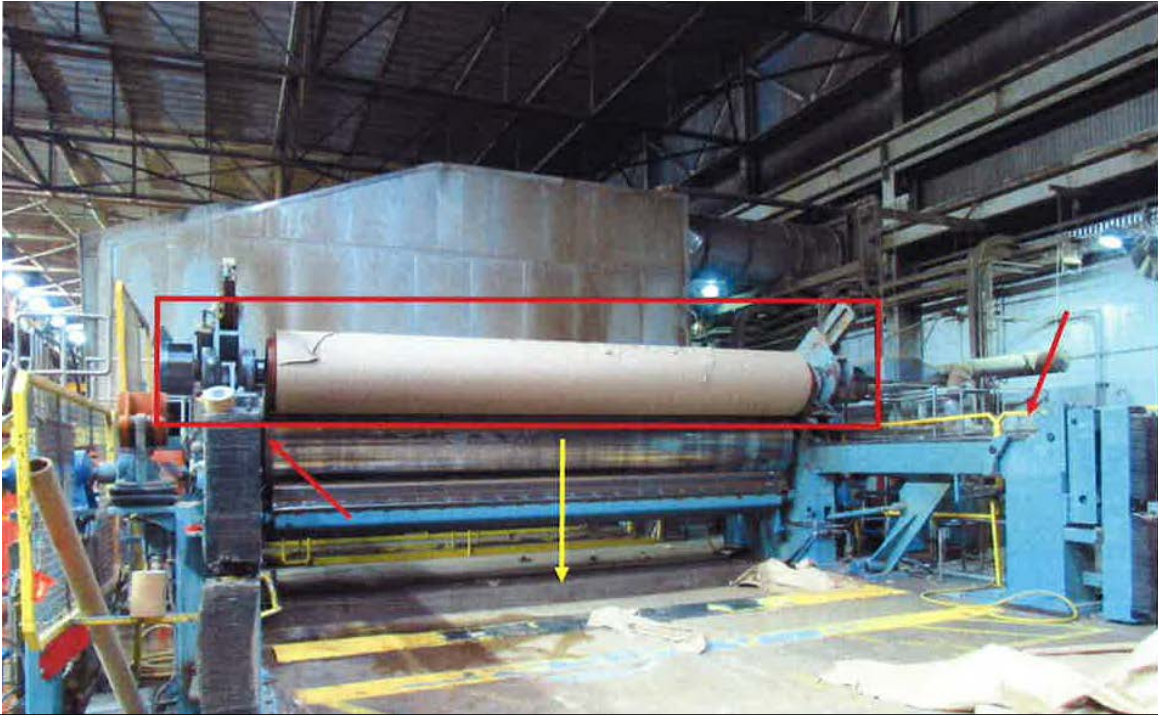
| 29 CFR 1910.261(k)(13)(i) | <p><b>A guardrail that complies with 29 CFR part 1910, subpart D, was not provided at broke holes.</b></p> <p>In that an unguarded broke hole was located underneath the drive roller and air shower of the Tampella winder machine. The hole was approximately 3 ½ feet wide and 23 feet long and the distance to the conveyor below the hole was approximately 10 feet.</p> |

Photo 1 of 2 – The parent reel where the “snap off” occurred is located in the primary arms designated by the red square. The reel that had just finished was sitting on the frame rails designated by the red arrows. The yellow arrow designates a fall hazard where scrap paper would be removed by a moving conveyor located below the machine.

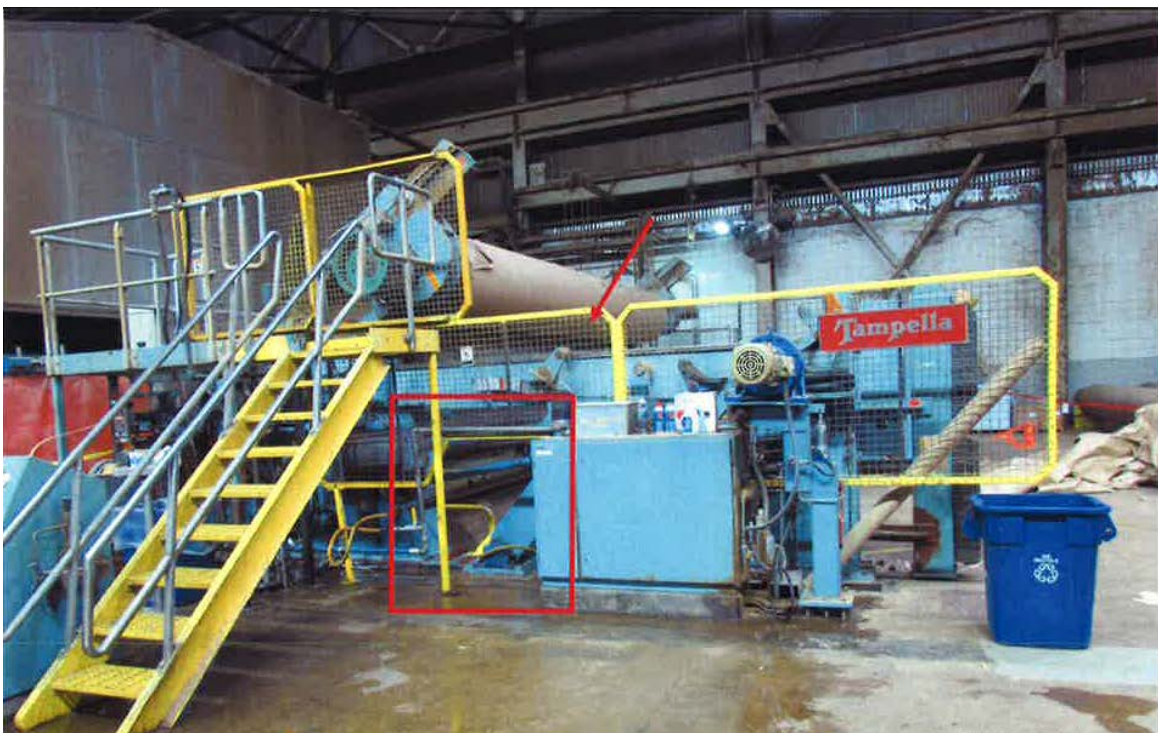
A **53 year old male** employee was fatally injured when he was crushed by a secondary arm and the frame of a Tampella paper winding machine in a paper mill. On the day of the incident, employees working at the Tampella winding machine were in the process of winding up a parent reel with fresh paper coming out of the mill. Once the parent reel is full, the Tampella machine will slit the paper from the mill, and move the parent reel onto a secondary arm, as a new parent reel moves into place to start the winding of paper coming out of the mill. At some point during this process, the paper “snapped off” the second parent reel. The Tampella winding machine uses compressed air as an engineering control to blow the paper back onto the reel, but it did not work. Paper was still coming out of the mill at high speeds and started to build up around the winding machine. The victim and another employee went under the guards between the secondary arm and the machine frame using high pressure air hoses to manually blow the paper back onto the parent reel. As the victim was in this position, the first parent reel was removed off the machine and the secondary arm moved back to position, to accept the second parent reel, crushing the victim. During interviews it was determined that this type of “snap off” rarely occurs, but when it does employees will go underneath or reach through the guards on the sides of the Tampella machine to help blow the paper back over the parent reel. The employer did not have procedures in place for employees to follow when this type of event occurs.

| 29 CFR 1910.212(a)(1) | <p><b>One or more methods of machine guarding was not provided to protect the operator and other employees in the machine area from hazards such as those created by point of operation, ingoing nip points, rotating parts, flying chips and sparks.</b></p> <p>In that there was not adequate guarding to protect employees from leaning or reaching into the Tampella winding machine. An employee was fatally injured after being crushed between the pneumatic secondary arm and the frame of the machine.</p> |

Photo 2 of 2 – The victim went under the guard designated by the red square, and was crushed by the secondary arm and the frame of the Tampella winding machine. There were guards designated by the red arrow in place on each side of the machine, but they did not keep employees from going under them.
