## 7 Caught in pulley – Inspection #1217769

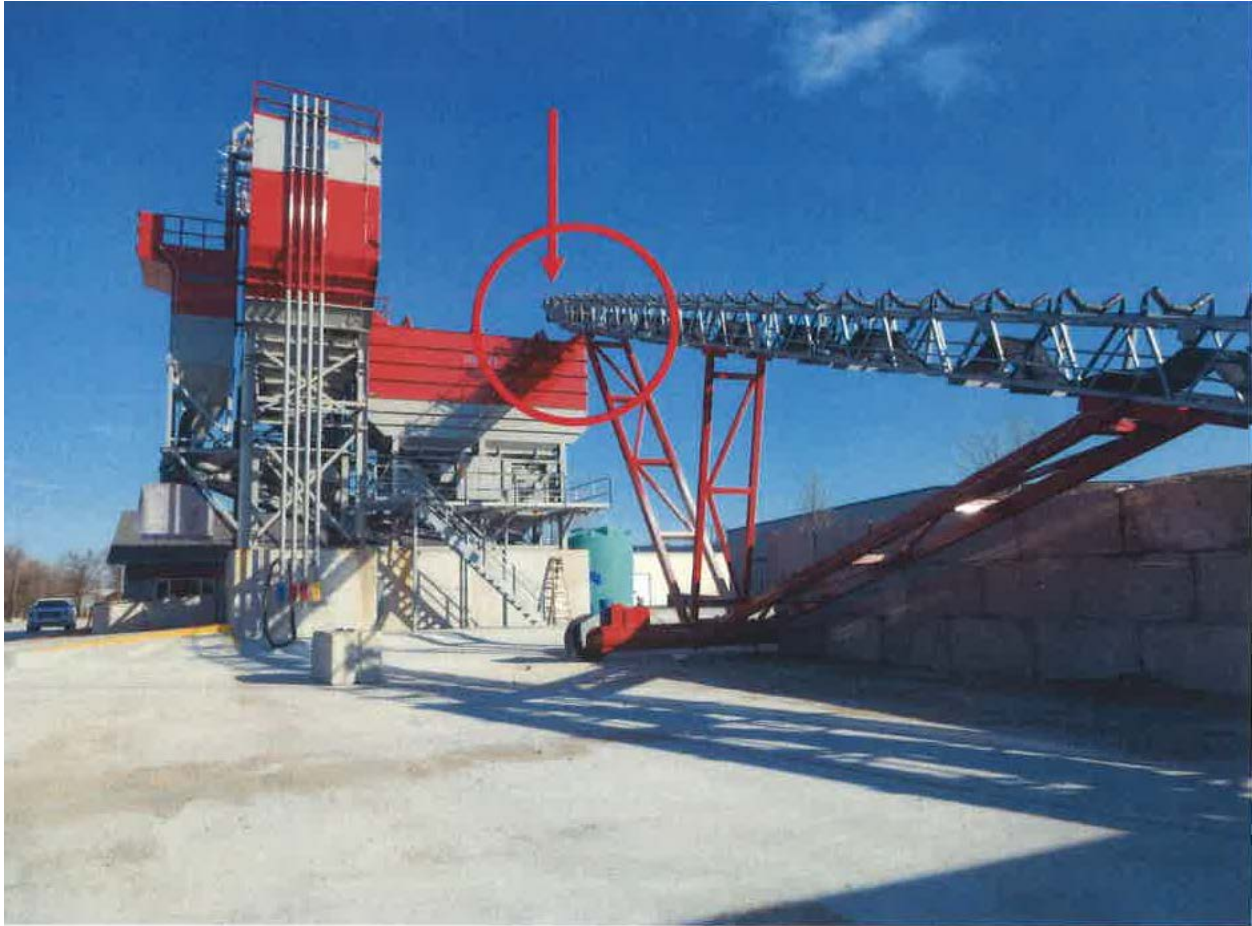
A **51 year old male** employee was fatally injured when he was pulled into a head pulley on a 125' x 10" aggregate conveyor system. On the day of the incident the victim, a Maintenance Supervisor, was attempting to dislodge a patch of ice on the head pulley wheel with a wrench when his shirt sleeve got entangled pulling his arm and body into the pulley system. An employee assisting the victim stopped the conveyor system by tripping a safety wire, but the victim passed away before emergency crews could remove him from the machinery. The company recently opened and had not yet started production. The general lock out tag out program had not been updated to include the site's machine specific procedures.

Photo 1 of 2 – The red arrow and circle indicates where the incident occurred along the 125' x 10" aggregate conveyor located behind the batch plant.

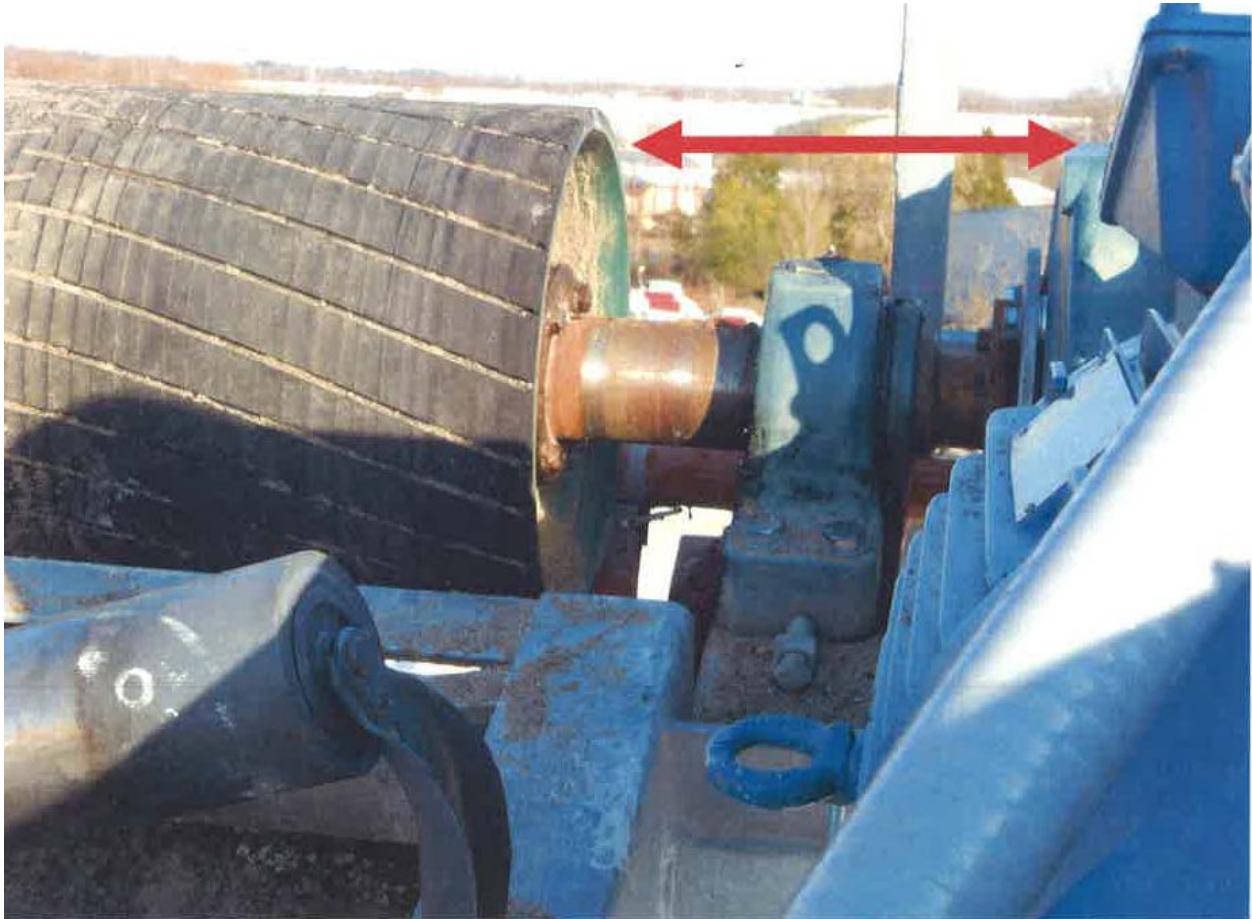
Photo 2 of 2 – The red arrow indicates the area where the victim was pulled into the machine at the head pulley and frame of the 125' x 10" aggregate conveyor.
