**16 Fall ---Inspection #1304211**

A **50 year old male** was fatally injured when he **fell approximately 42'** from a roof while in the process of staging roofing materials. Employees had been working on the roof of this building for four days prior to the incident and 75% of the roof had been completed. This roof is 89 ft. x 67 ft. and has a pitch of 4/12. Fall protection was provided to the employees via full body harness, 6 ft. shock absorbing lanyard, and anchor points mounted to the structure. Attached to the anchor point was a 50 ft. synthetic rope lifeline equipped with a rope grab system and single snap hook that connected to the anchor point. The 50 ft. lifelines and roof anchors are left on the roof until the roofing activities are completed.

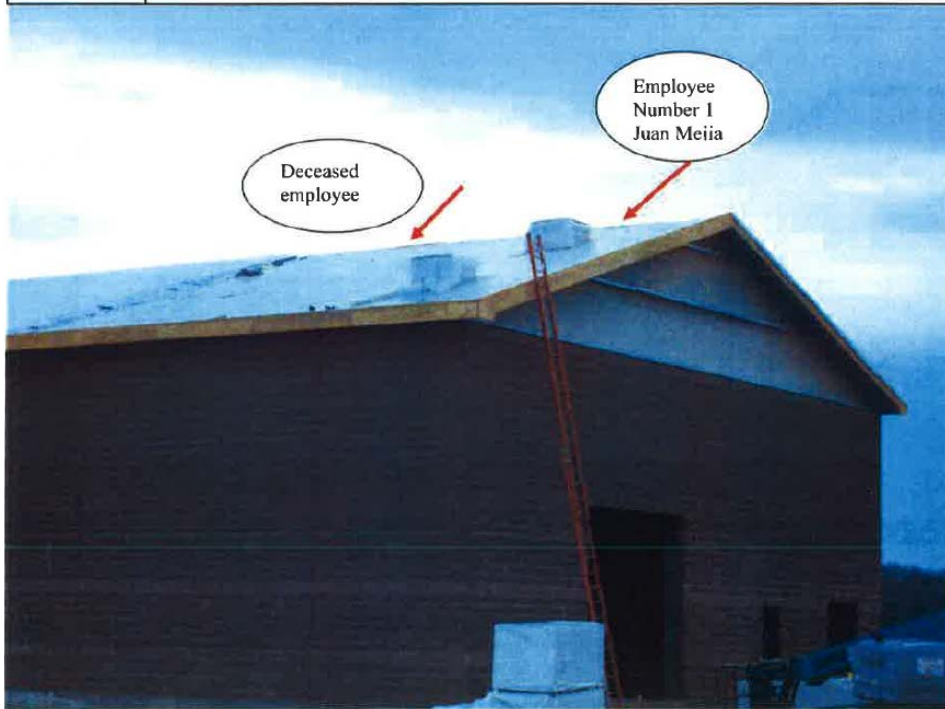
Description:	East elevation of Sludge Dewatering Building, right section of the roof that had not been completed with insulation and water shield material. Arrows indicate the approximate location of the two employees that were on the roof, anchors were installed near the area where the arrows are pointing as described by the employee that was on the roof when the fall occurred
--------------	---------------------------------------------------------------------------------------------------------------------------------------------------------------------------------------------------------------------------------------------------------------------------------------------------------------------------------------------------------------------------------

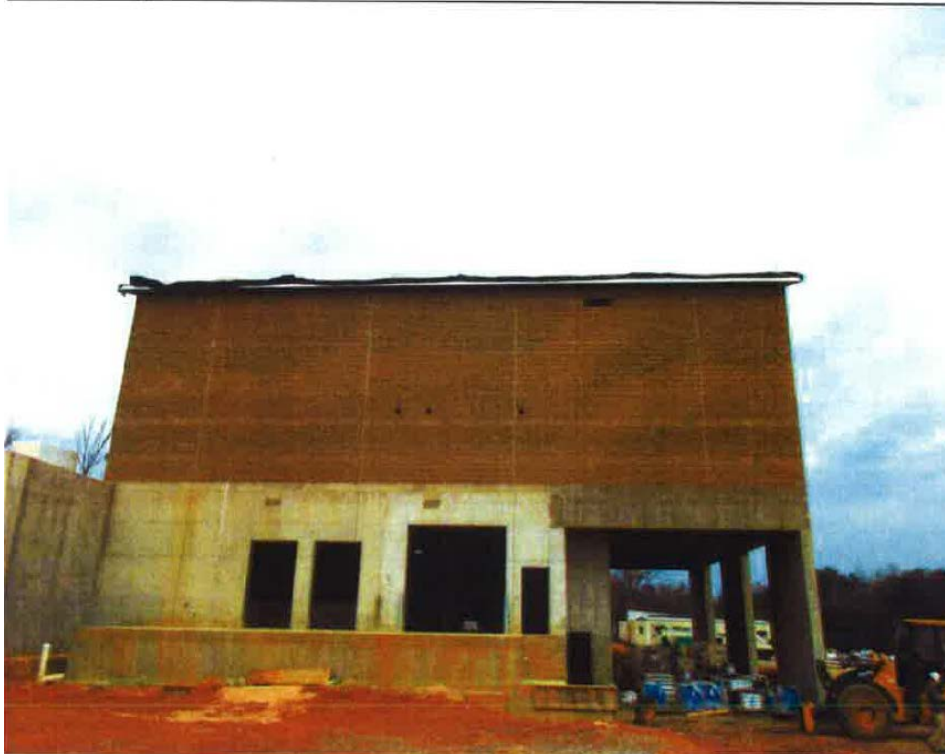
On the day of the incident, the victim exited the aerial lift and traveled to his work area located in the middle section of the roof, within minutes of arriving to his work area, two employees on the roof heard him yell and witnessed him fall from the previously completed west side of the roof. Based on this information, it is believed that the victim was standing approximately 20- 25 feet away from the edge of the roof, near the ridge cap attempting to connect to an anchor point when he unintentionally stepped on the opposite side of the roof where the water shield (slick surface) had been applied the previous days, causing him to slip and fall from the eave on the west side of the roof onto the concrete loading dock and subsequently onto the ground below.

It was determined that the victim did not have his 6 ft. shock absorbing lanyard attached to his harness when he accessed the roof, therefore, was not able to properly connect into any of the lifelines positioned on the roof.

Description:	West elevation of the Sludge Dewatering Building, this is the side of the building where the employee fell from the roof
--------------	--------------------------------------------------------------------------------------------------------------------------
