18 electrocution ---Inspection # 1306972 Red Stag Contractors

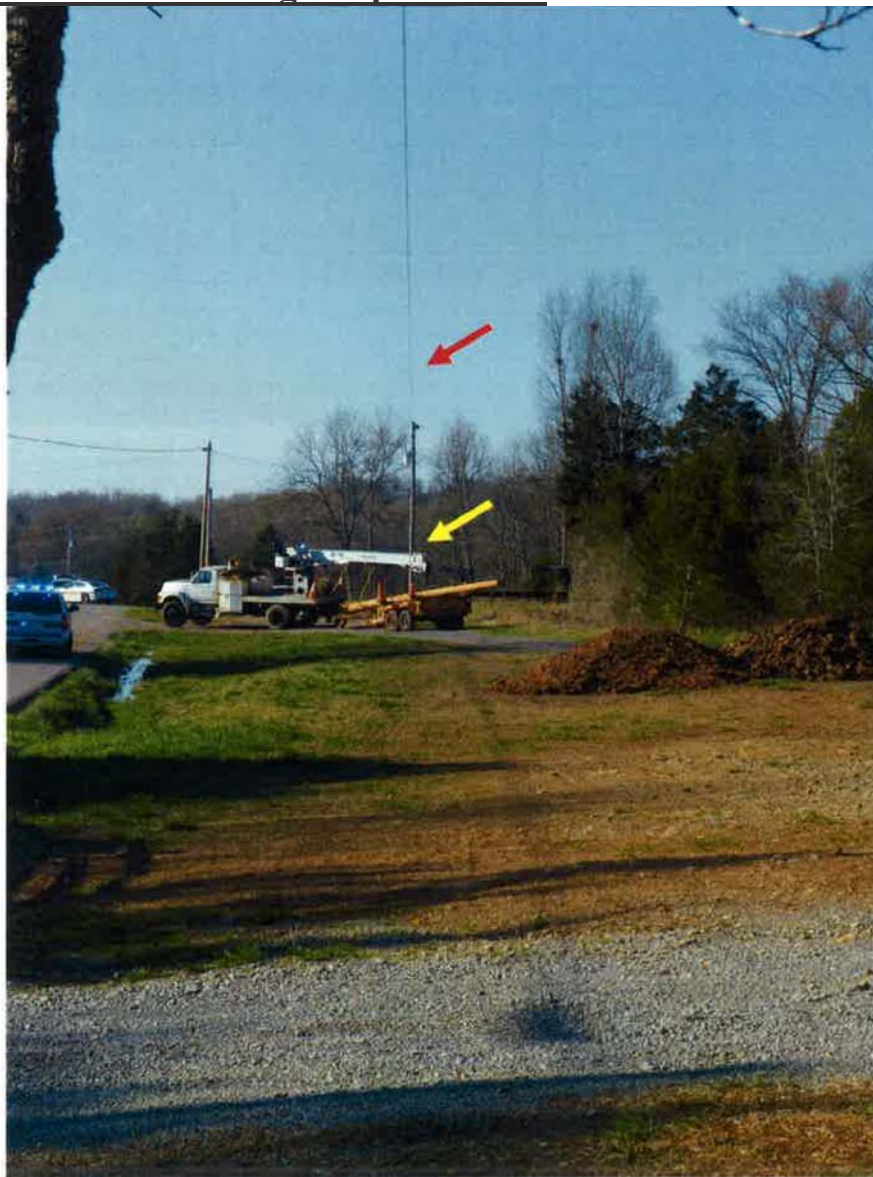
According to witnesses, the victim was standing towards the rear of the truck on the driver's side and was leaning against the truck. It was determined that the boom has a reach of 29.7 feet in the fully upright position when not extended and made contact with the 14.4Kv overhead power line during the process of lifting the tongue of the trailer. None of the employees were spotting the line for the boom operator.

Description : Yellow arrow indicates the boom of the truck. The red arrow indicates the energized power line.

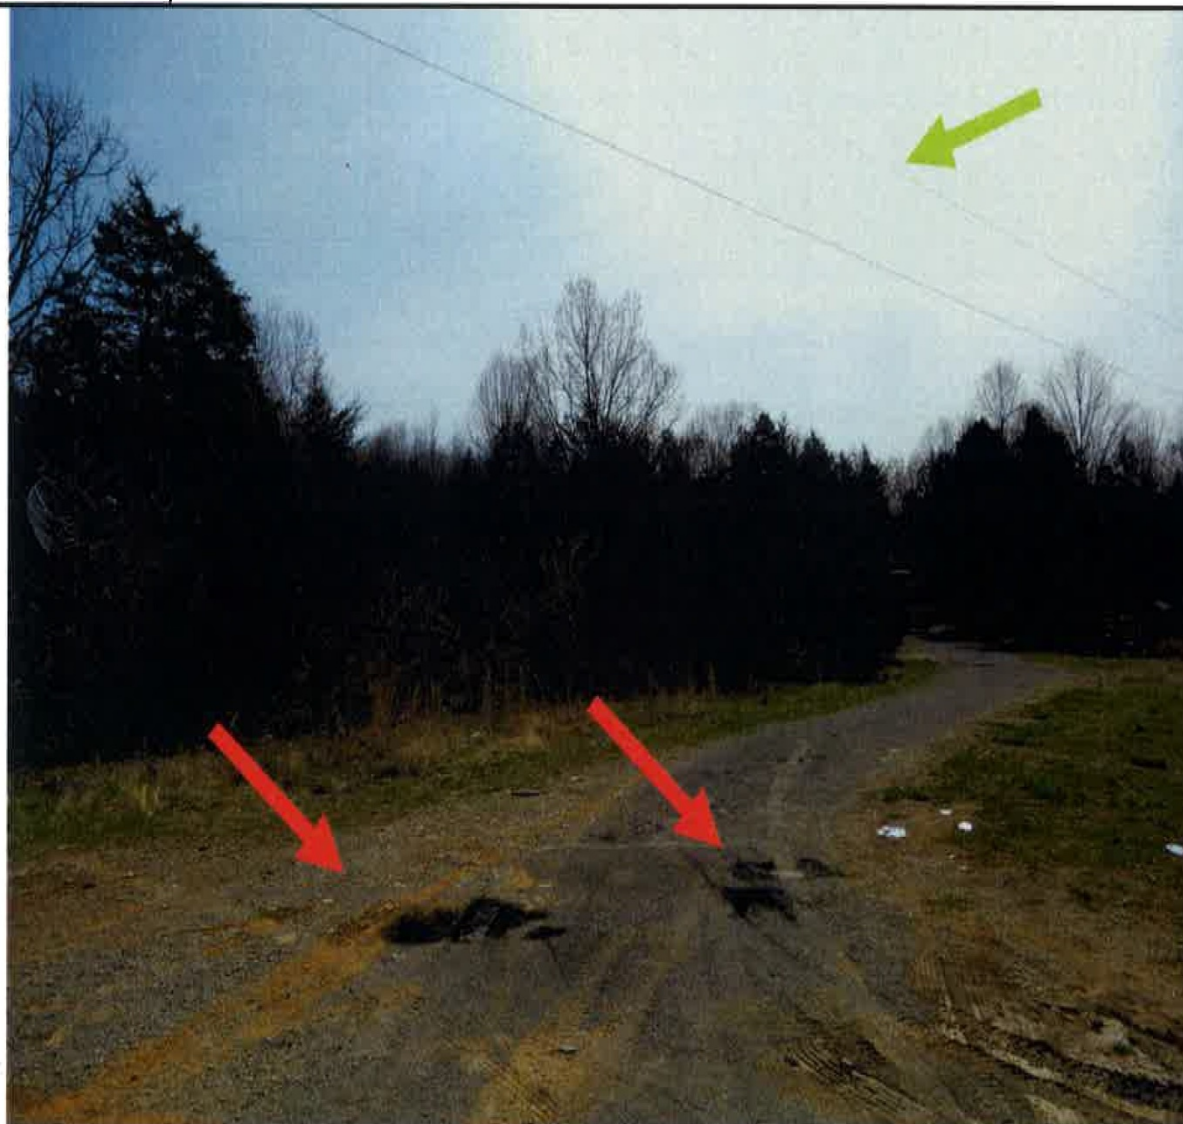
Description	Red arrows indicate the bum marks where the rear tires of the truck were when the boom was energized. The picture was taken so that the viewer would have been looking at the front of the truck had the truck still been in its original location. The green arrow indicates the power line which energized the boom.
--------------------	--
