**19 Fall ---Inspection #1308572 Glen Mullins Trans**

A **31 year old male** was fatally injured when he **fell 14' from a roof** while helping to repair a water leak. On the day of inspection the victim was hired to help fix the northwest corner portion of the dome roof of a building that housed a taxi service. The northwest corner leaked where the dome roof met the vertical face of the building. The victim worked for approximately 3 hours on Tuesday as he assisted the owner of the taxi service in framing and applying plywood to the portion of the roof in need of repair. On Wednesday, at approximately 8:45 a.m., the owner and victim began to work on the roof by moving material into place and measuring tin to cover the framed portion of the repair. At approximately 9:15 a.m., the owner was lying on top of the framed repair. He asked the victim to hand him a piece of tin, which he did while approaching from behind. As the owner was placing the piece of tin on the corner the victim passed by him on the left side subsequently falling off of the roof.

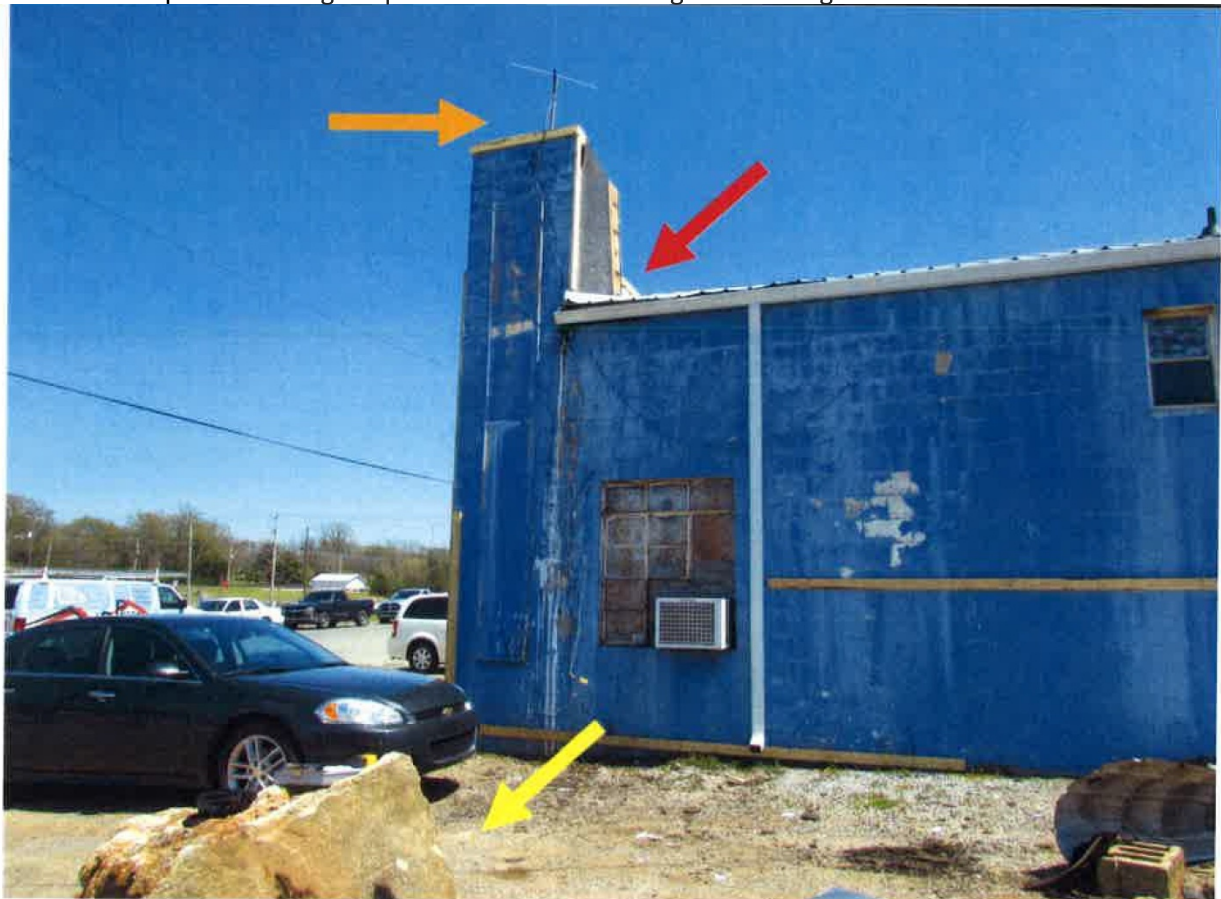
<b>Description</b>	The red arrow indicates where the victim was standing before falling 14 feet to the ground below. The yellow arrow indicates where the victim landed 11 feet 3 inches away from the building. The orange arrow indicates where the eye witness was positioned approximately 21 feet high at the time of the incident. Neither employee was wearing fall protection while working at such heights.
--------------------	---

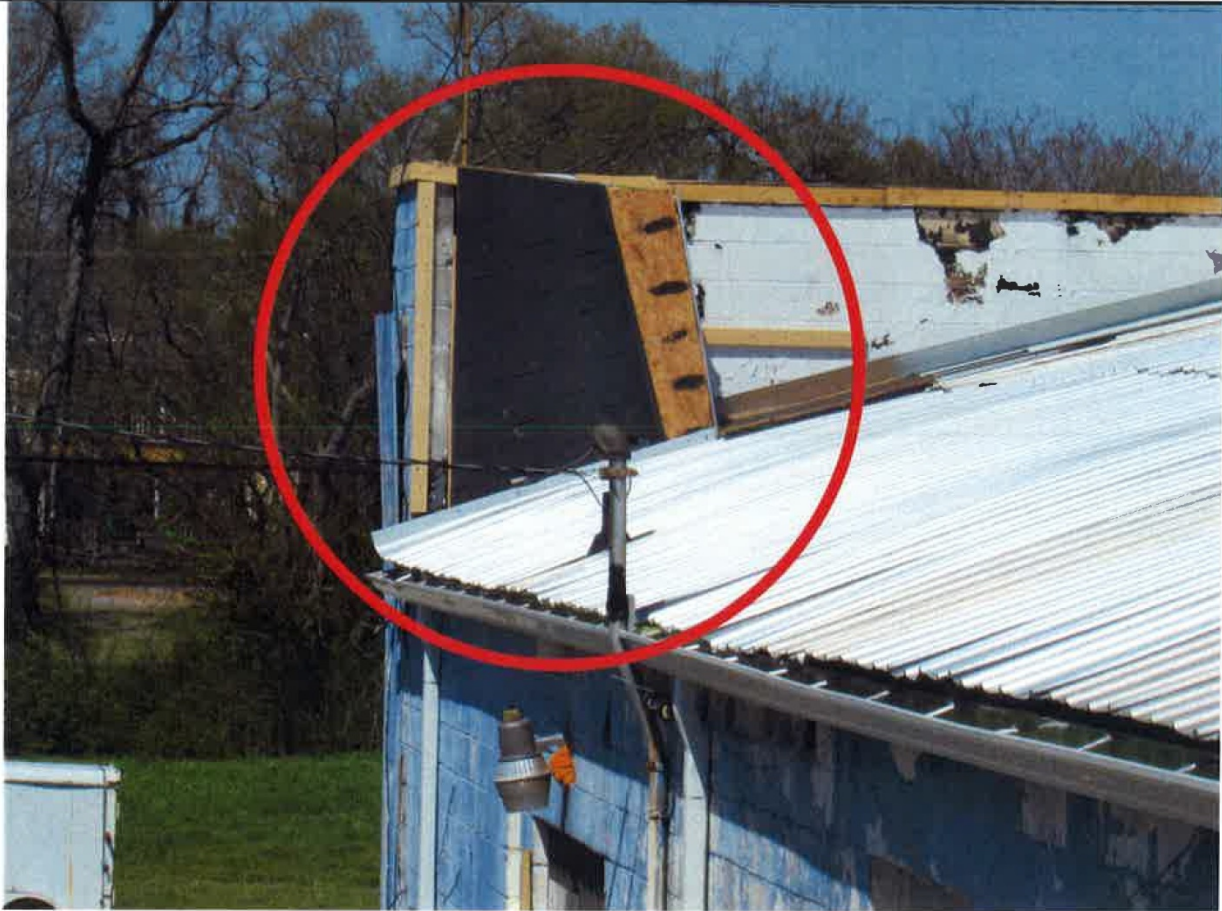
Description This photo shows where the employees were in the process of installing a 37-inch wide x 68-inch long sheet of metal roof tin to a manufactured frame.

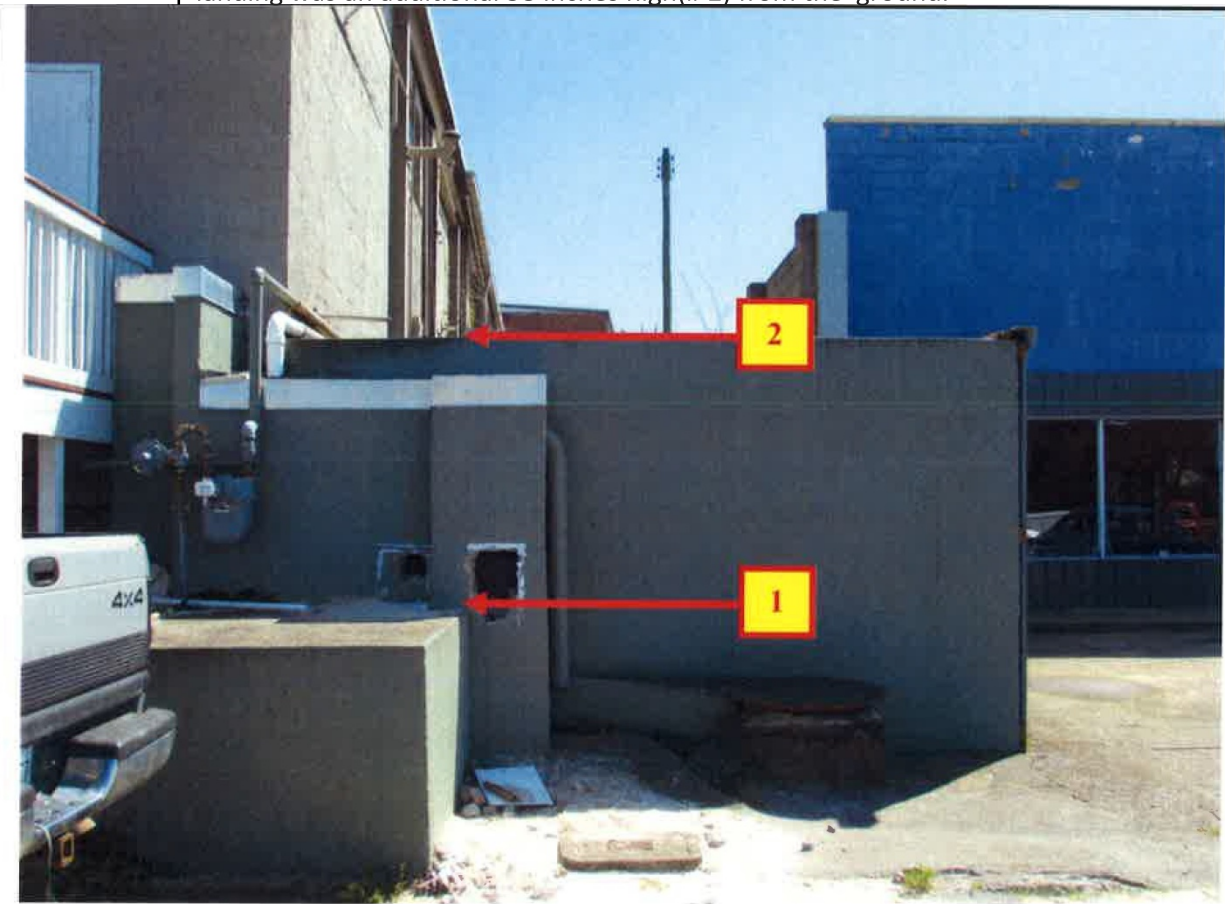
In that employees were documented as having used a 6-foot stepladder, on the east side of the roof, to access a roof that measured 81 inches high from ground to the upper landing surface in which the side rails did not extend at least 3 feet (0.9 m) beyond the upper landing surface. The ladder only extended up to 9 inches below the landing surface.

In that a 6-foot Werner stepladder was not fully extended open, as intended to by design, while being used to access two landing surfaces leading lo the upper landing surface of the roof at the northeast section of the building.

In that two employees had used the top step of the 6-foot Werner stepladder to access the upper landing surface of the roof which was 81 inches high. The top platform of the ladder measuring 9 inches below the roof's edge.

**Description** | This photo shows where the employees used a 6-foot stepladder, in the closed position, to access two landing surfaces before accessing the roof on the northeast section of the building. The first landing was 38 inches high (# 1). From the first to second landing was an additional 58 inches high(# 2) from the ground.
