29 Fall from elevation ---Inspection #1328791 Duck River Electric

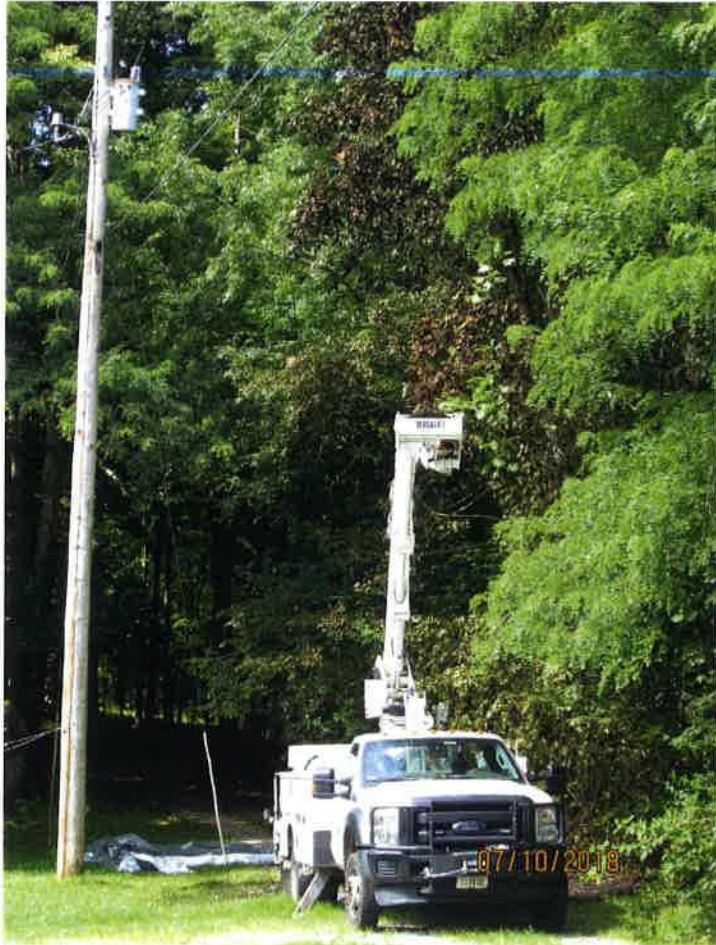
No replacement part had been ordered or installed on truck 23; therefore, it is assumed that the TruGuard control block on Truck 23 had another hydraulic leak which caught fire causing the victim to lower the bucket as far as he could then try to get out and in the process fell to his death.

Victim was in bucket and had the boom raised while working on security light. After bucket caught on fire he lowered boom and moved it away from the power lines. The photo shows the location of the bucket when the employee climbed out and subsequently fell to the ground due to it being on fire.

After the fire damage was discovered and reported on truck 106, Versalift was contacted and a replacement part for the TruGuard system was ordered for truck 106. This replacement part allowed the hydraulic lines to pass straight through the area without threaded fittings. The employer reported that since the new part has been installed the leaks have stopped.
