7 Fall from elevation – Inspection #1295753

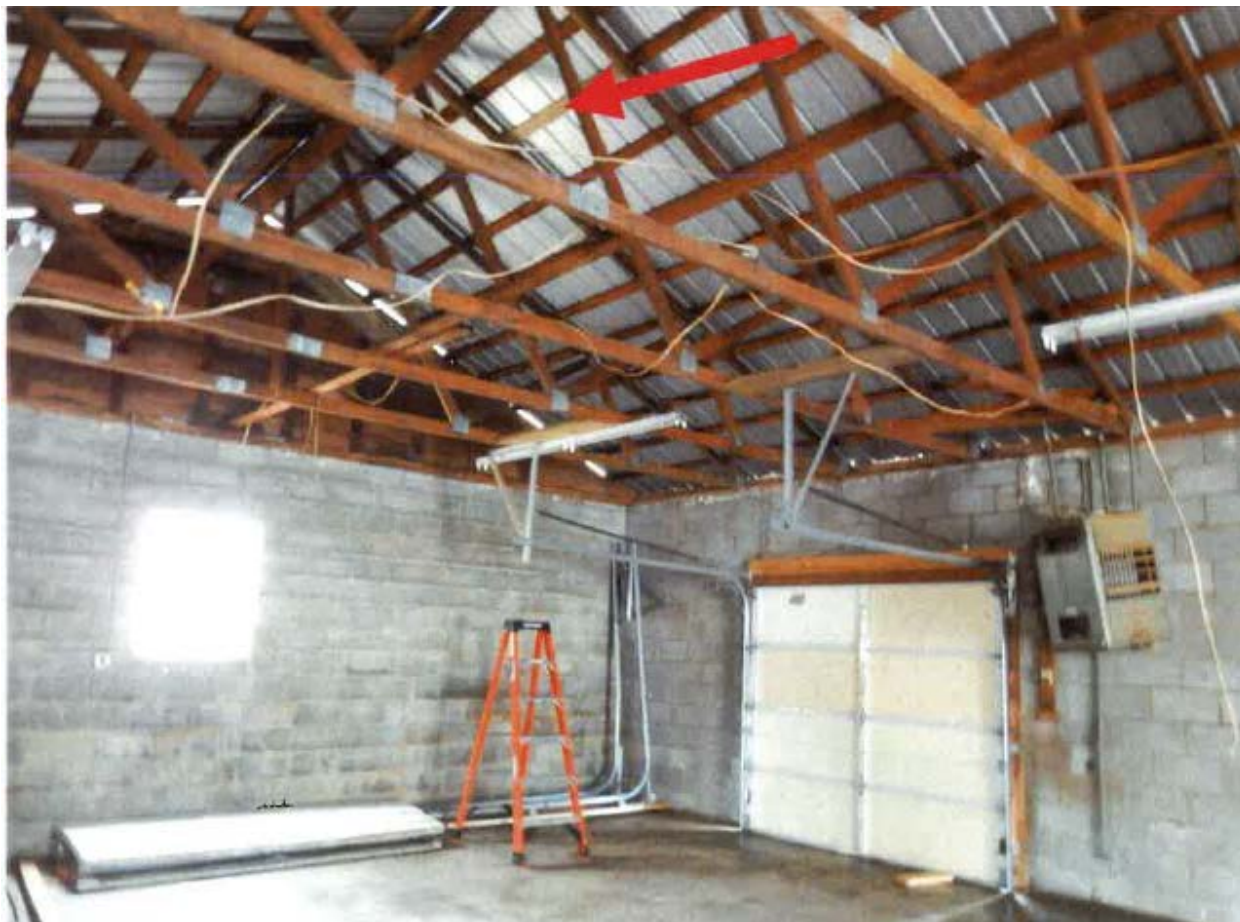
1926.501(a)(2)	<p>Employees were allowed to work on surfaces which did not have the requisite strength and structural integrity.</p> <p>In that employees were allowed to perform work from the lath of the structure. The lath was not structurally sound as it collapsed from the weight of an employee.</p>
----------------	--

Photo 1 of 1 – Shows the area where the victim fell. The red arrow in the photo indicates the piece of lath that the victim was sitting on just before he fell. This piece of lath broke.
