A **22 year old male** employee **fell approximately 42'** from the stair platform of an apartment complex under construction.

39 Fall from elevation—Insp# 1500974 Raul Antonio Herrera Leiva

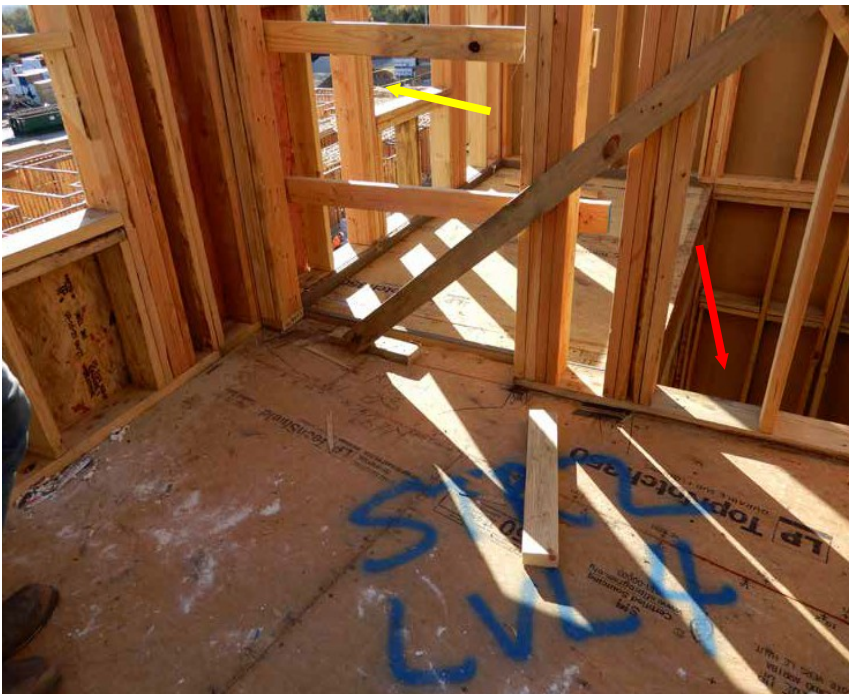
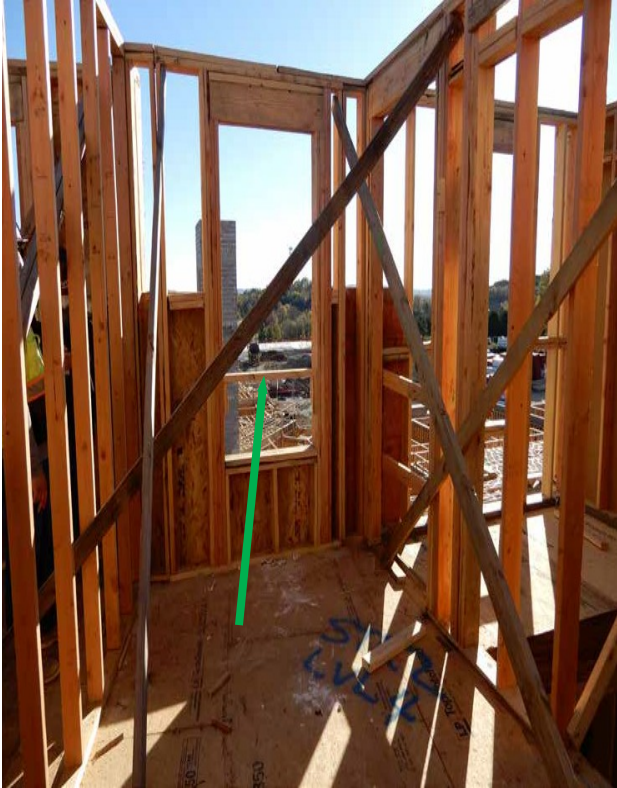
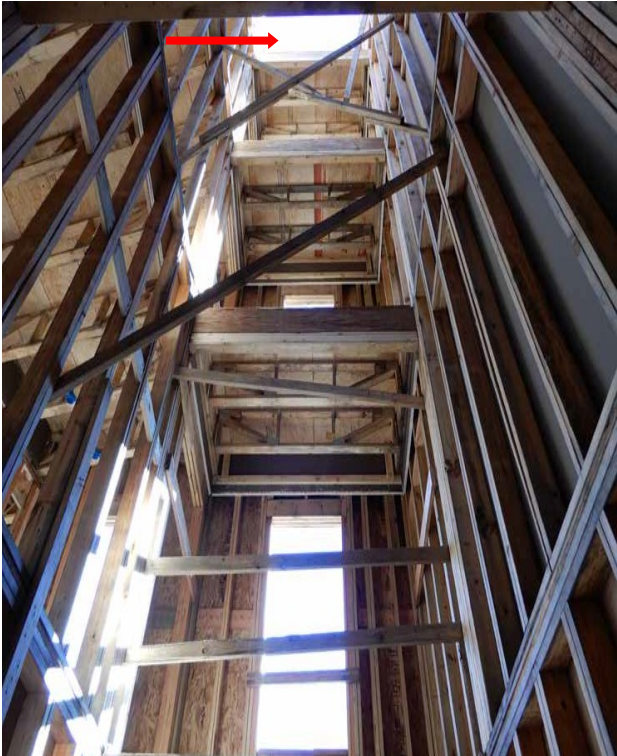
The employees installed the sheathing to the areas outside of the living room, bedroom, and corridor on the 4th level of the building. The nailer was in the aerial lift positioned between the 3rd and 4th floors and in between the protected window opening of the corridor and the unprotected window opening in front of the landing of stairway 2. He indicated that he had just finished nailing the top of the sideways OSB sheet, the 6th one up from the ground, when he looked up and saw the victim had accessed the landing area above him. He stated that guardrails had been in place in the doorway preventing access to the landing area that was 42 feet 7.5 inches above the basement floor and he was surprised to see the victim in this area. He stated he could only see the victim from his chest up. Next, he said the victim bent down to pick up the sheet of OSB he had cut for the area between the windows and fell off the landing. He reported hearing a loud thump and knew the victim had fallen.

In that no fall protection was provided to an employee who was working on a landing with an unprotected side on the 4th level of the building, and who fell approximately 42 feet 7.5 inches to the basement, while assisting with the installation of exterior sheathing.
