8 Crushed by silo—Inspection # 1474222 JDL Construction

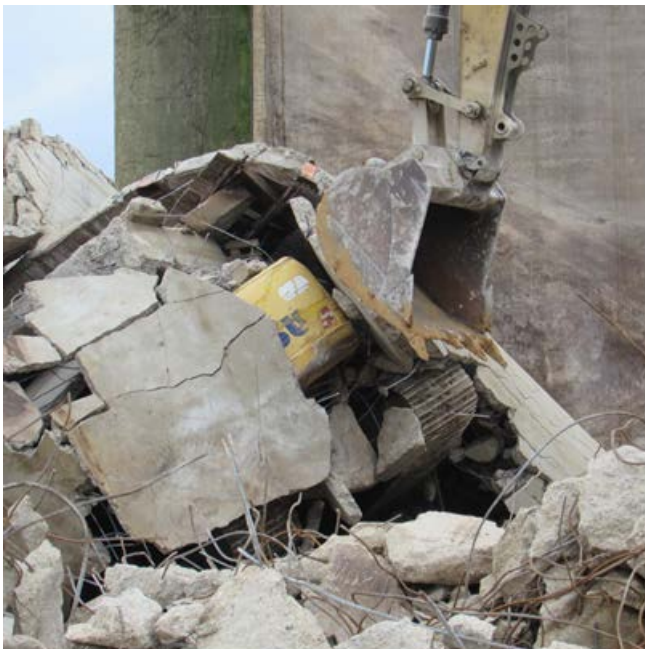
In that a competent person did not inspect the silo involved in the incident that had previously been disturbed four days prior to the incident.

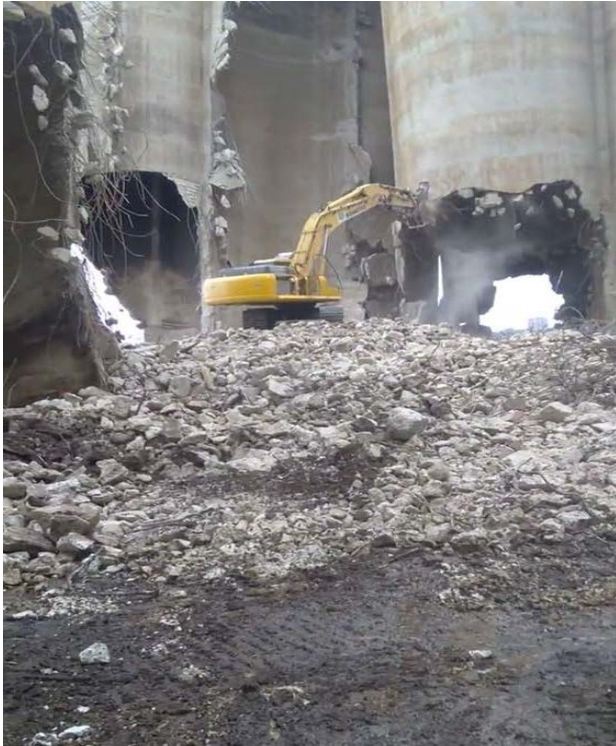
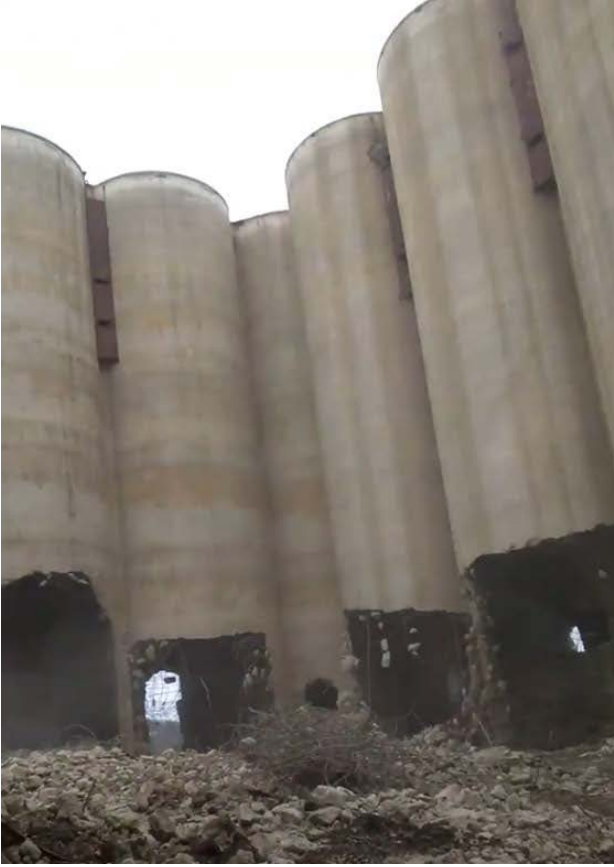
NEXT TWO PHOTOS TAKEN ABOUT ONE MONTH PRIOR TO ACCIDENT  
(employee provided to give an idea of what the silos looked like during demolition)
