A **23 year old male** employee was **electrocuted** while installing a new HVAC unit at a residential home. This incident occurred on Sept 22 but was not reported until Oct 11; therefore, the job was completed at the time of inspection.

Electrocution—Insp # 1557229 Chris Reads dba R&R Heating and Cooling

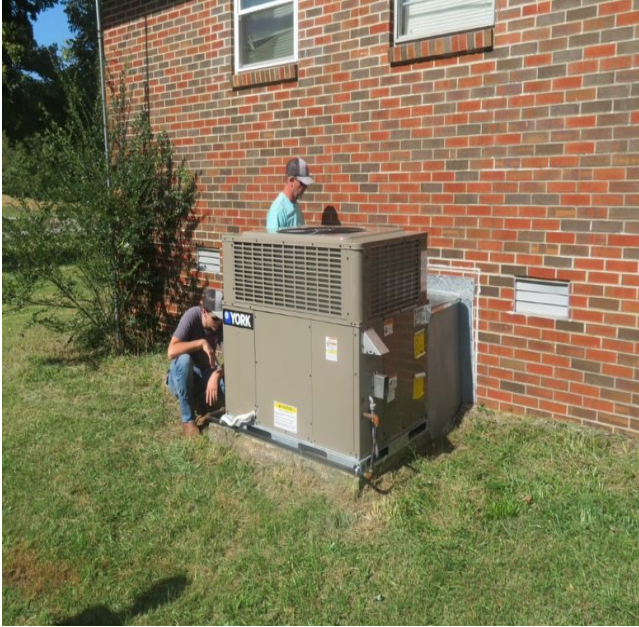
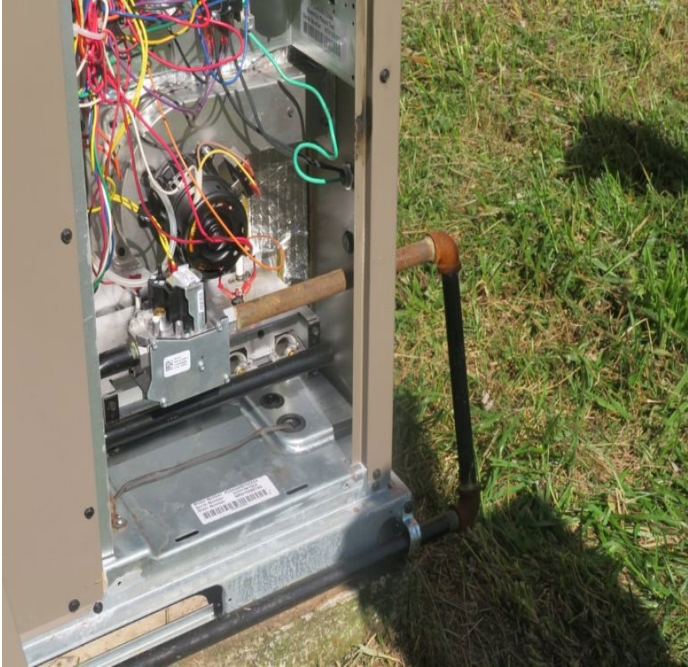
It was explained by the employer that there were two hot wires in the electrical system of the HVAC; one used to power the adapter cord and the other had a wire nut end. Also, the hot wires were tested, and each had 125 volts of electrical energy. It is uncertain which wire the victim contacted; however, the owner stated that he will never use the adapter cord again.

Based on information obtained, the victim was working within proximity to energized electrical wires installing metal gas pipe and was not protected against electrical shock by de-energizing or guarding the circuits.
