In that an **18 year old male** employee **fell 18 feet** through a section of roof insulation after metal roofing had been removed in an airplane hangar during the process of reclaiming the metal.

Fall—Insp #1540822 Sammie Banegas dba Joel's Construction

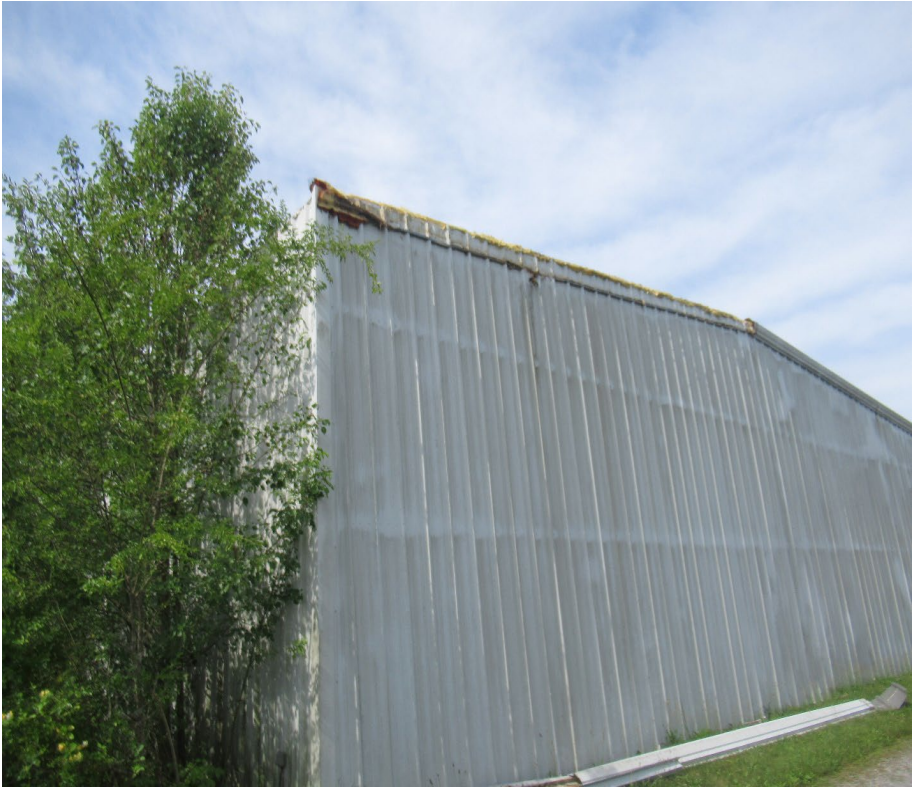
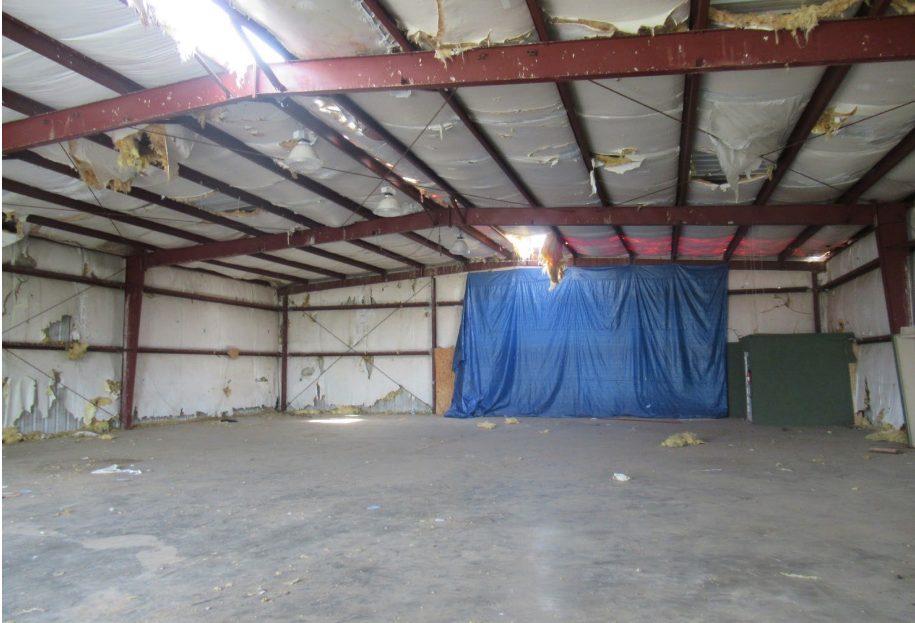
The employees were working to remove metal roof decking from a steel framed airplane hangar on a residential property. The hangar measured approximately 59 feet wide by 74 feet long, for a total area of 4,366 square feet. The roof edge had an approximate height of 16 feet, with the roof peak measuring approximately 18 feet high. The day the incident occurred was the first day employees were on site and had been working for only 2 hours before the incident. Employer and employee interviews revealed that two employees were working from the rooftop to remove the metal decking in order to install fall protection anchor points directly into the roof joist. It was determined that the amount of work that had been performed to remove several decking panels was more than necessary to simply connect anchor points and the employees were working unprotected from fall hazards. The two employees accessed the roof by a 40-foot aluminum extension ladder that was positioned on the southwest side of the hangar. Once on the roof the employees began removing the entire ridge cap along the center of the rooftop and had removed approximately 4 metal roof decking panels on the northeast corner of the roof. Each decking panel measured approximately 30-feet in length and 40 inches wide. Once the panels were removed it created an approximately 390 square foot hole opening, exposing the buildings unsupported fiberglass insulation, creating an unprotected edge

While the supervisor was away it was stated that the victim climbed onto the rooftop by the extension ladder located on the southwest corner of the hangar. At the time, one employee worked from the southern edge of the rooftop while removing the final part of the ridge cap, while the other worked from the northeast corner, continuing to remove the roof decking. Of the two employees on the rooftop only the employee working from the northeast corner observed the new employee on the roof. This employee stated that he instructed the new employee to exit the roof as he was not supposed to be up there. The victim continued to walk over to the northeast corner of the roof where the metal decking had been removed to observe the other employee working. It was at this time that the victim stepped off of the roof decking and on to the exposed, unsupported building insulation. The victim fell through the insulation and roof opening, approximately 18 feet to the concrete floor below.
