A 59 year old male employee was crushed by an elevator mechanism on a machine that moves vinyl fence posts while performing maintenance activities without the machine being locked out.

Crushed by elevator mechanism—Insp # 1657666 Barrette Outdoor Living, Inc.

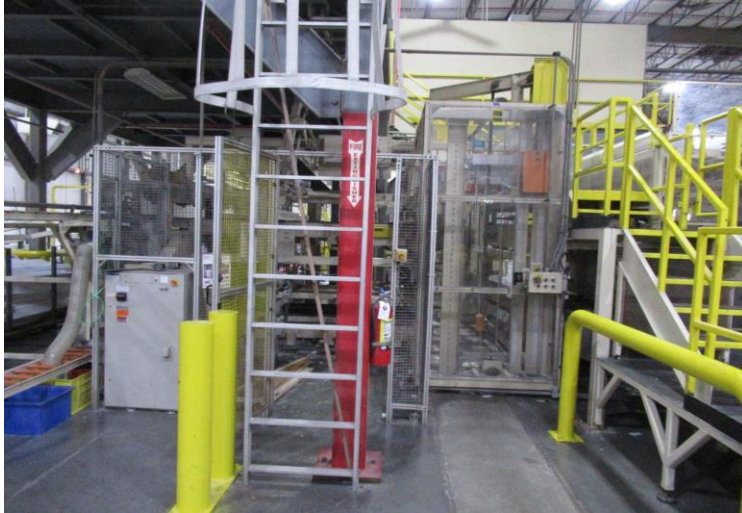
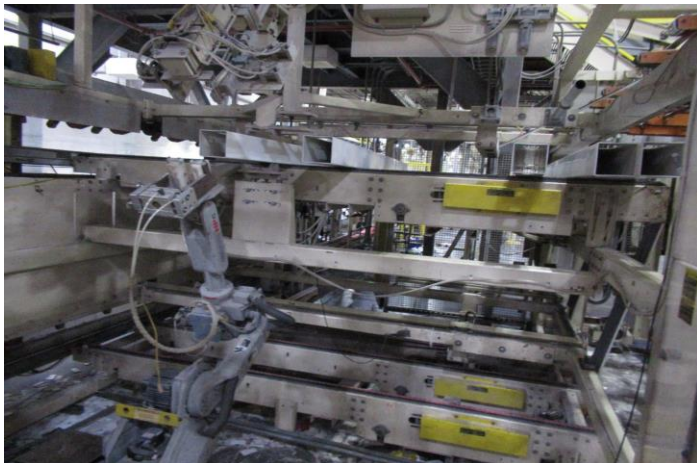
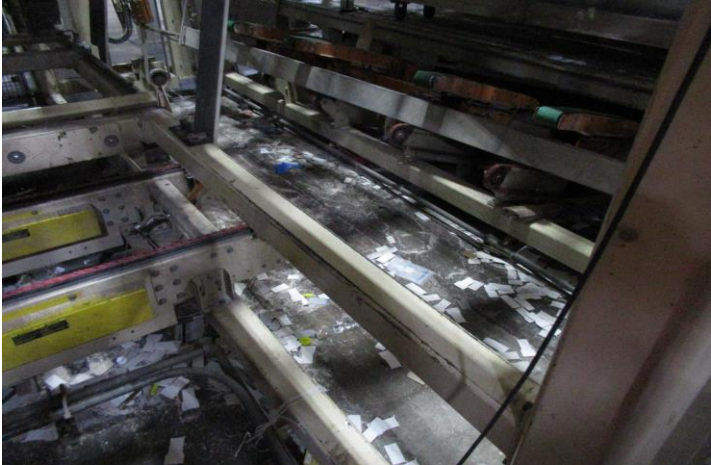
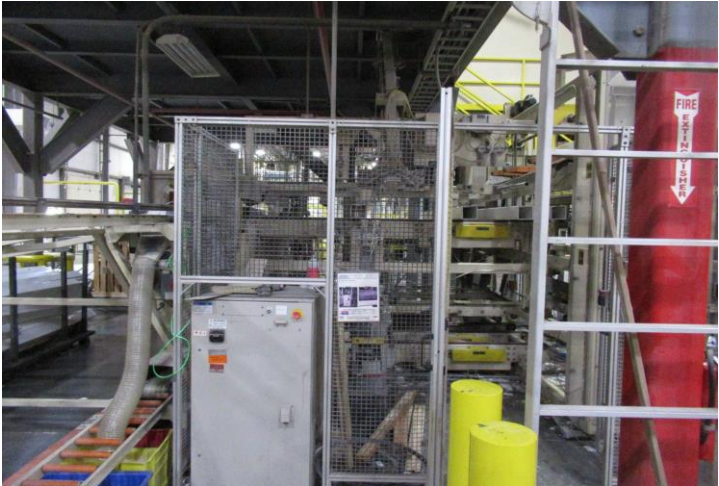
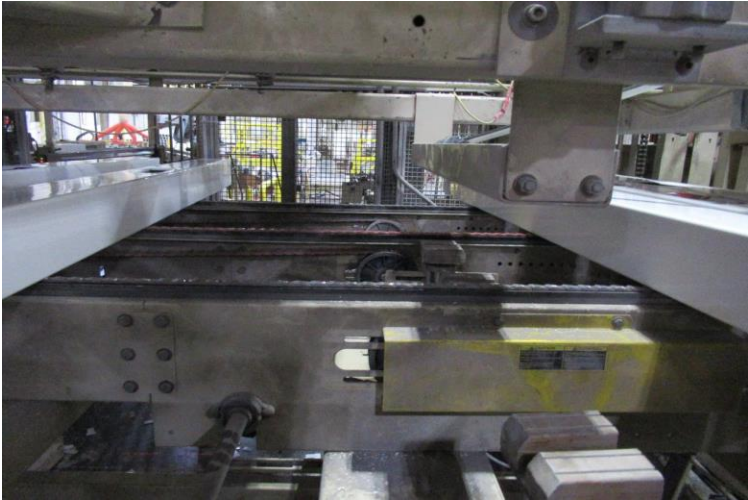
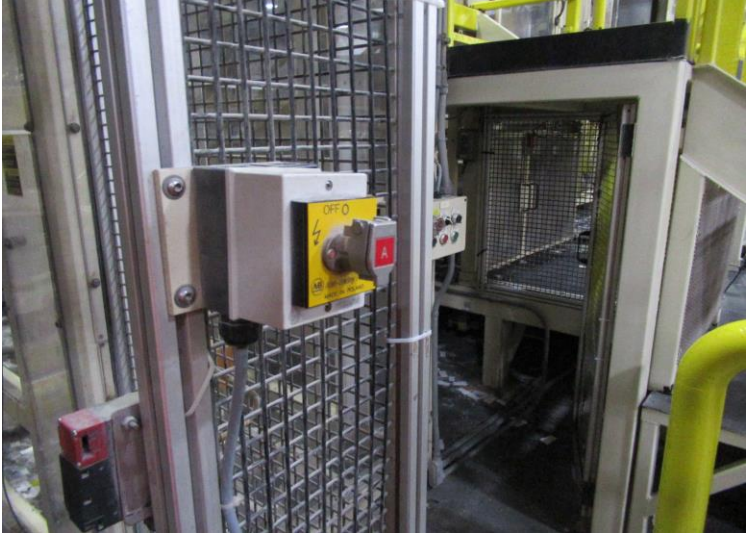
During the investigation, it was determined that the victim was employed as a Maintenance Technician. He was attempting to repair a cylinder in an area referred to as EDL #2. EDL #2 is a pre-package staging area for completed vinyl fence posts, for which the process of conveying, wrapping, and heating is automated. The automated process relies on a series of electronic sensors to govern its programming and actions. The conveyor is a two-tiered system; the posts on top are wrapped and packaged differently than posts that are conveyed along the bottom. The Elevator involved in the incident acts as a type of bridge; if there are posts on the top conveyor, then the Elevator will position itself to convey the posts at the top. If posts are running along the bottom conveyor, the Elevator will lower to the bottom position and convey those posts. The positioning of the Elevator, either up or down, is determined by the presence of posts on the conveyors. Presence or absence of posts on a conveyor is determined by the electronic sensors.

Once conveyed to EDL #2 in preparation for wrapping and heating, the posts are halted by small cylinders that deploy upwards to stop the posts from moving on the conveying rails. If the cylinders do not work properly, the posts will stack up incorrectly and will cause problems as they convey to the next area. The victim was attempting to repair one of the cylinders that had begun to malfunction when the elevator unexpectedly started moving downward, catching him between the elevator and the floor and crushing him. Coworkers were unable to raise the elevator and were unable to remove him from the area; apparently the elevator had to complete a cycle before it would raise. Maintenance staff had to take the machine apart to remove the victim; he died before being transported to the hospital.

At the beginning of the inspection, the employer explained that the EDL #2 area, including the Elevator, had not been locked out prior to beginning maintenance activities. The employer further explained that the caged area surrounding EDL #2 and the Elevator was protected by interlocks and key switches; the victim turned the switch to OFF and removed the key. He then entered the left side (facing) of the caged area; he did not enter the Elevator side, which was guarded by a different set of interlocks and a key switch. He did not switch the Elevator side to OFF, nor did he open the interlocked door to the Elevator.

At some point after entering, the victim moved from the EDL #2 conveyor side of the cage to the Elevator side. The cylinder requiring repair was on the far side of the conveyor and would have been difficult to reach from the side where he entered. Through interviews, TOSHA believes that he moved to the Elevator side of the cage to obtain a better reach to the cylinder. Further, TOSHA and the employer believes that he triggered a sensor on the bottom conveyor, which would have given the Elevator directions to move to the lower position of the conveyor due to its programming. In the lowering of the Elevator, the victim was caught between it and the floor.

In that one employee entered the operational area of the "Elevator," a component piece of machinery of the EDL#2 operation and for which there was no guarding in place to prevent entry, and was crushed between the Elevator and the floor, resulting in his death.
