7. Smoke Inhalation

Catastrophe—No Fatality

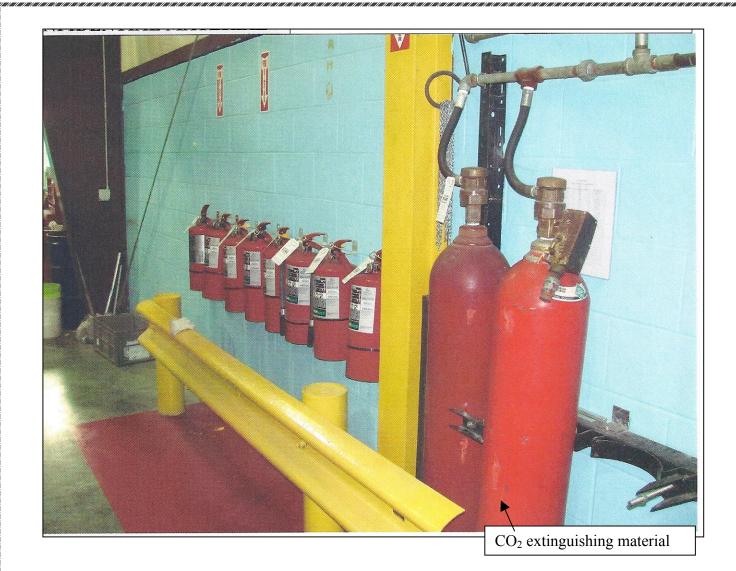
Three employees of a manufacturing facility were admitted to the hospital after fighting a fire at the facility with portable fire extinguishers. The facility manufactures parts and accessories for the automobile industry. The fire occurred in the department where headliners for SUVs are made. A fire began in a headliner press used to mold the headliners from a sheet of polypropylene composites. A four-by-eight-foot sheet in the oven of the press caught fire. A quality assurance tech first observed black smoke rising from the top of the headliner press and activated the built-in carbon dioxide fire-suppression system. The supervisor in the area ran to the press and activated the general alarm. As the headliner department employees were evacuating the plant, maintenance workers began to arrive at the press area as required. Two maintenance workers fought the fire with portable fire extinguishers brought to them by the supervisor. After the two maintenance workers were successful in extinguishing the fire, they and the supervisor exited the plant. Once outside, they were observed by the company nurse to be coughing and she instructed them to go to the local hospital. The three employees admitted to the hospital and treated for smoke inhalation and kept overnight. They were released from the hospital the next day.
