#16: Crushed By – Inspection #317804540

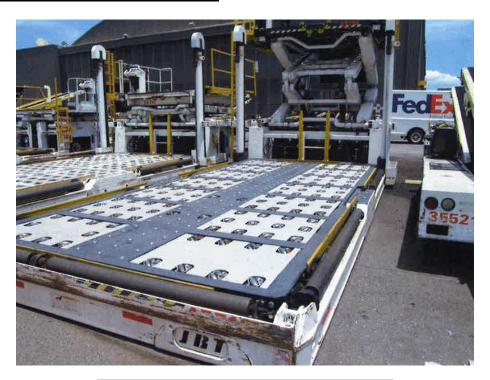
Photo 1 of 2: Cargo Loader

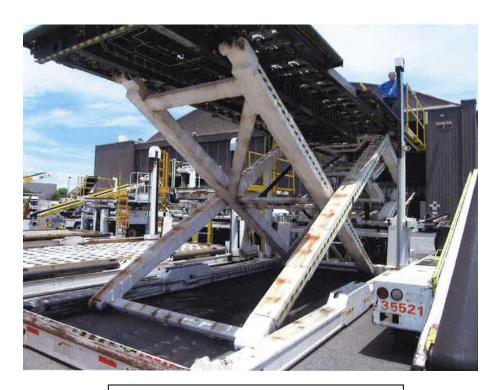
Photo 2 of 2: Cargo Loader raised for loading aircraft
