#20: Crushed By – Inspection #988904

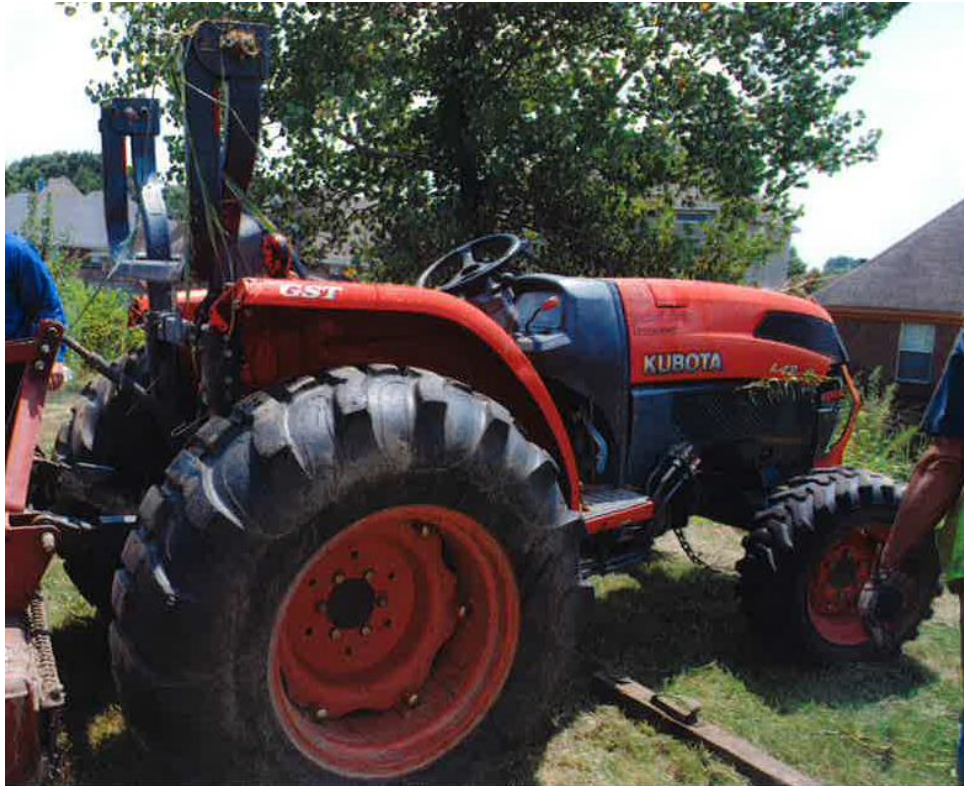
Photo 1 of 2: 2009 Kubota Tractor

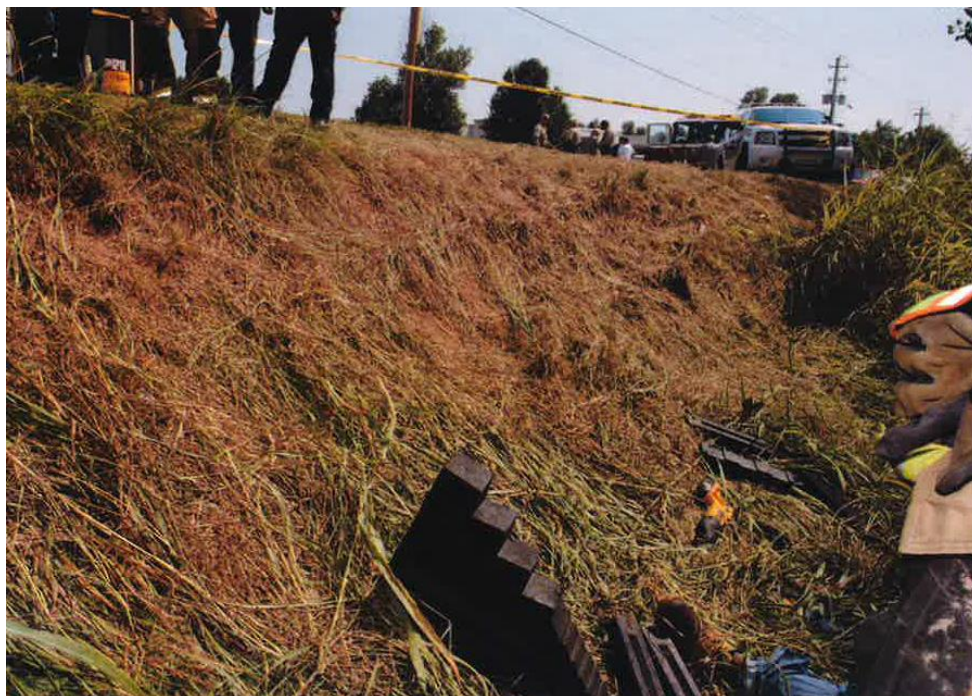
A **29 year old male** employee was fatally crushed by an overturned mower. The victim was injured when the 2009 Kubota tractor Model# L424QGST, while mowing a bank along the road overturned pinning the victim underneath the tractor causing his death. The employee was not wearing a seatbelt at the time of the accident and the roll over bar was down on the tractor.

Photo 2 of 2: Tractor overturned pinning the victim
