## **#22: Crushed By – Inspection #1004075**

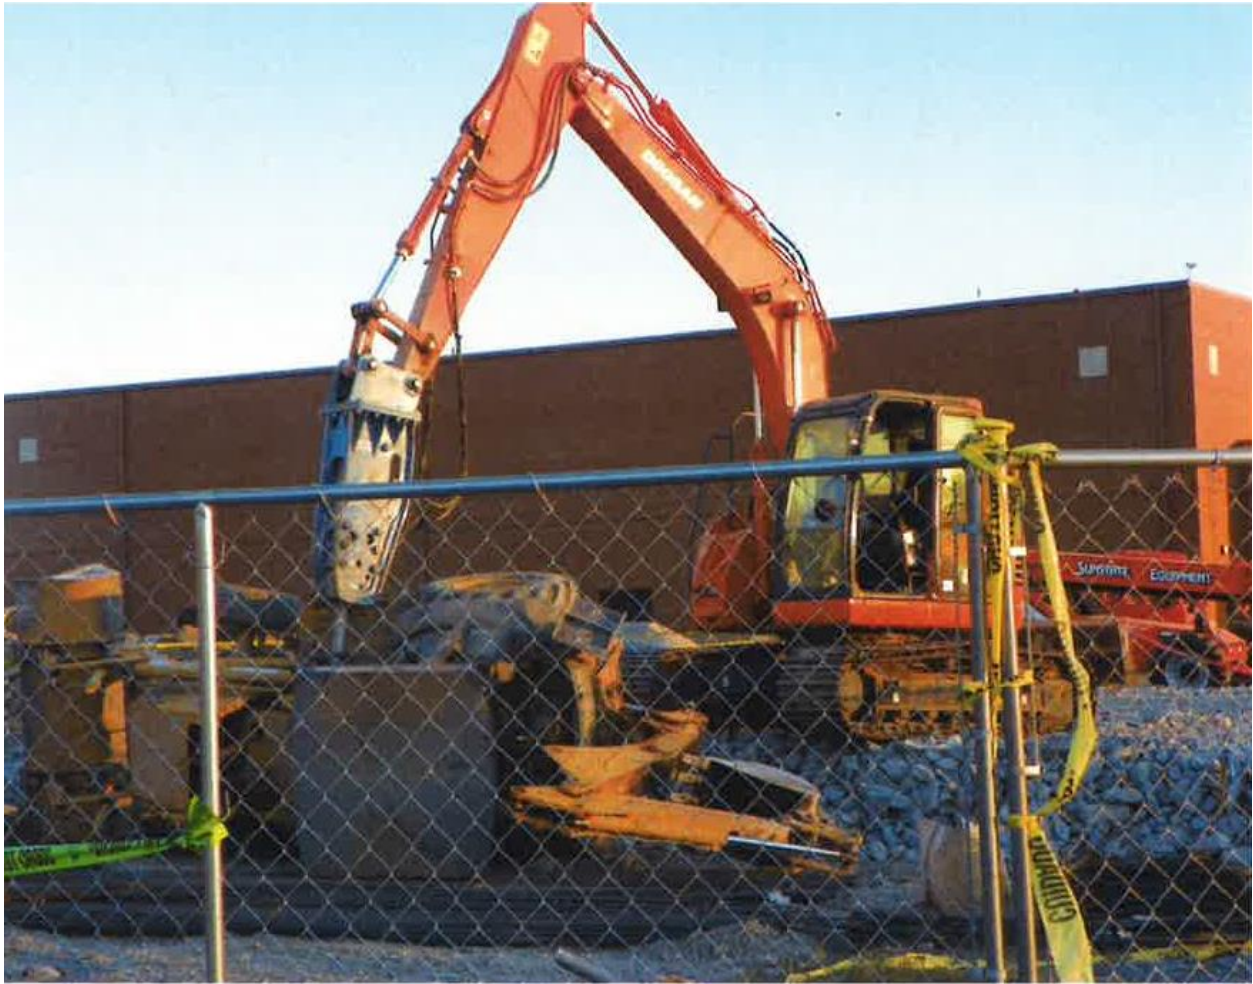
A **58 year old male** employee was crushed by an overturned front-end loader/back-hoe. The victim had been employed for approximately two weeks and had been allowed to operate the back-hoe sporadically. On the day of the incident, the victim was operating the front-end loader/back-hoe. The employee moved the equipment to get crushed rock to put into a trench for leveling. The employee drove the equipment over the side of the elevated pad. The equipment overturned and fatally crushed the operator. The front-end loader/back-hoe was not equipped with a seat belt at the time of the accident.

Photo 1 of 1: Track-hoe was used to move overturned back-hoe
