Crushed by and caught-in between machinery – Inspection #1041324

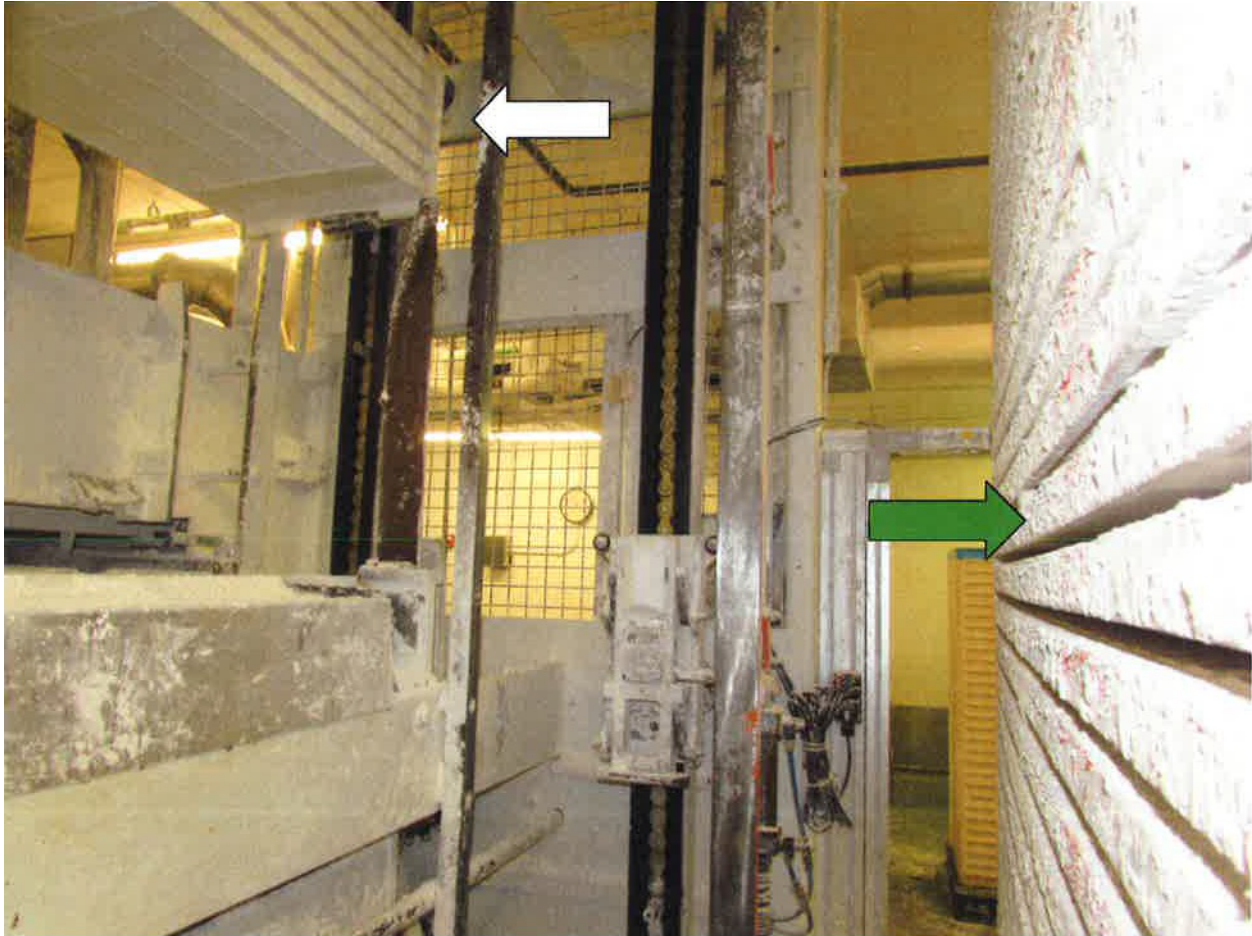
A **54 year old male** employee was fatality injured while cleaning the de-stacker area of the mogul machine in the gummies department when he was crushed between a tray of product, and the frame of the de-stacker mechanism of the mogul machine. The mogul machine would become obstructed during the day with falling and shifting gummy trays, and starch. The track that moved the trays would get covered with these materials and would need to be cleaned with a pneumatic air wand. The victim performed the company lockout/tagout procedure for the mogul machine, and locked out the vertical movement of the de-stacker. As the victim entered the machine for cleaning, he inadvertently struck a positional sensor inside of the track system, and advanced the candy trays into the machine. The victim was standing directly adjacent to the metal frame of the de-stacker mechanism when a stack of trays began to advance into the machine, crushing him between a tray of product and the frame of the de-stacker. The first responders and company mechanics attended to the victim while working to reverse the tray track mechanisms to free him from the machine. During the investigation, it was determined that the company program addressed how to lockout the electrical energy source for both the vertical movement of the de-stacker section of the mogul, and the lateral movement of the track system that fed the de-stacker section of the mogul, but did not specify that both must be done to safely remove all hazardous energy sources before maintaining or servicing that area of the machine. The supervisors that were responsible for monitoring the lockout/tagout procedures did not understand the necessity to isolate the energy sources for both sections of the machine. The training for the service and maintenance of the mogul machine was from operator to operator, with no follow up or discovery by the employer to verify the effectiveness of the training. The lockout/tagout point for the lateral control was located on the opposite side of the room, on the other side of the machine, approximately 80 feet away. The victim died from blunt force injuries due to compression by machinery such as multiple fractures, a rupture of pleura, hemathorax, contusions of the intestines, and abrasions on the face.

Photo 1 of 1 – Photograph showing the mogul machine destacker area.
