## **Electrocution – Inspection #1117027**

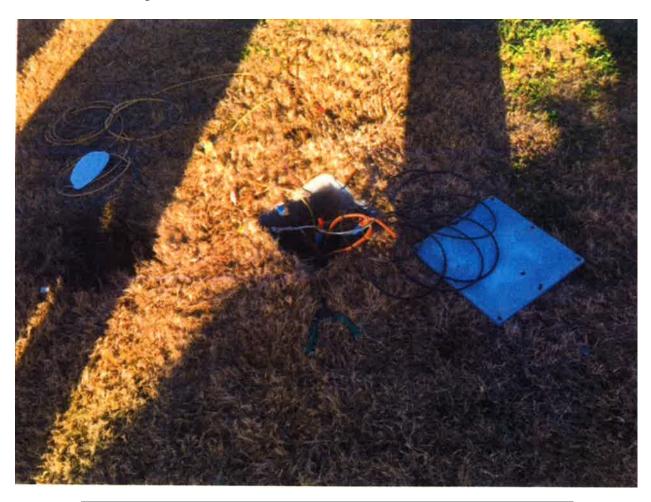
A 42 year old male employee was fatally injured when he was electrocuted while installing underground electrical service to a parking lot light pole. The electrical contractor was hired to install emergency generations for a warehouse. During the construction of the concrete pads for the generators, a conduit supplying power to one of the parking lot lighting fixtures was damaged. The victim and two co-workers were in the process of running the new conductors from the light fixture pole to a 277 volt junction box approximately 75 feet away. At some point during the day, one of the co-workers found the victim lying over the junction box in contact with an energized wire. The victim never regained consciousness, and passed away two days later from his injuries. The county medical examiner's report confirmed the cause of death was low voltage electrocution. During the investigation, it was determined the junction box originated in a breaker panel, then went through a photo cell that turned on the lights at dark, and off during daylight hours. The photo cell on this circuit controlled many light fixtures in the parking lot besides the one the victim and crew were working on. After the incident a witness stated that the parking lot lights were on. The company had a "No Hot Policy" therefore, the crew should have disconnected the line to the junction box at the breaker panel, and the photo cell should not have been relied upon for keeping the line de-energized.

29 CFR 1926.416(a)(1)	An employee was permitted to work in such proximity to any
	part of an electric power circuit that the employee could
	contact the electric power circuit in the course of work, while
	the employee was not protected against electric shock by de-
	energizing the circuit and grounding it or by guarding it
	effectively by insulation or other means. In that employees
	worked in a junction box for the parking lot lighting system
	without assuring that the 277 volt circuit had been de-
	energized and locked out at its source.

Photo 1 of 1 – Photo of junction box where victim was found.
