## **Overtured forklift – Inspection #1016891**

A **31 year old male** temporary employee was operating a forklift truck carrying a cardboard box of tobacco waste to a dumpster. He emptied the waste in the first dumpster, and then traveled with the mast up toward the second dumpster to dispose of the box when the truck tipped over crushing him between the ground, and the truck. The victim was operating a counterbalance Linde H25CT LP-gas forklift. The forklift had an 895 lb. Cascade 25D-MC-66Q carton hydraulic pressure clamp attachment which picks up boxes, and bales of tobacco that can't be picked up with forks. The victim had taken a cardboard box full of tobacco stems to a dumpster located outside on the south side of the building. According to a coworker, the victim had pulled up to the dumpster, raised his box up over the top edge of the dumpster, and cut two straps to allow the waste to fall into the dumpster. During this operation, the forklift operator releases just enough pressure off of the box to allow the waste to fall out of the bottom, but still hold on to the box itself. After the waste was dumped, he backed up, and started driving forward towards the second dumpste

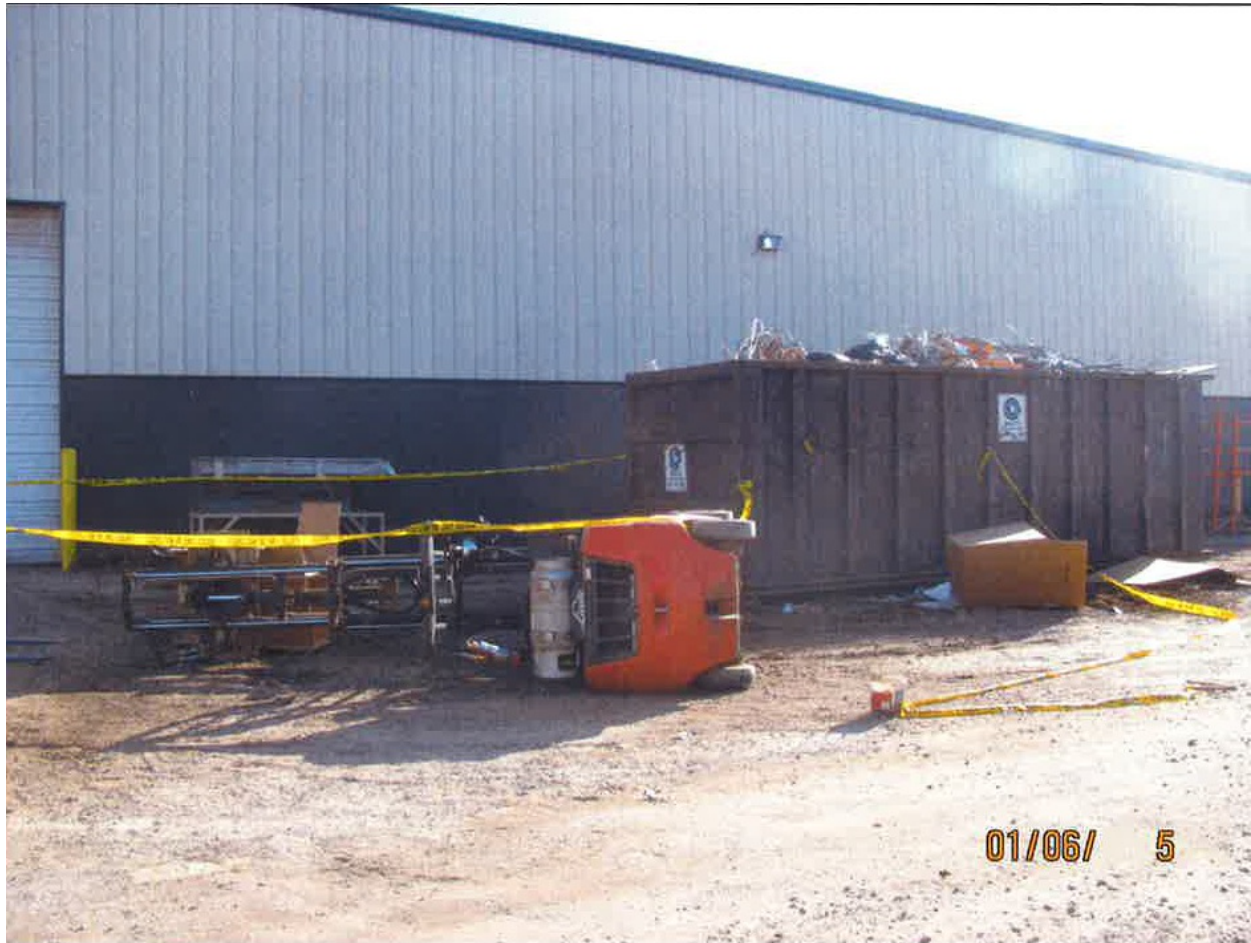
29 CFR 1910.178(n)(7)(iii)	On all grades the load and load engaging means were not tilted back if applicable, and raised only as far as necessary to clear the road surface. In that the employer did not ensure that an employee operating a Linde H25CT LP-gas forklift traveled with the load down as far as possible and raised only enough to clear the ground. The load consisted of an 895 lb. Cascade 25D-MC-66Q carton clamp attachment and a cardboard box. The employee traveled 78 feet between two dumpsters with the top of the mast and clamp approximately 15 feet high.
----------------------------	---

Photo 1 of 2 – Forklift on its side with the attachment in the raised position

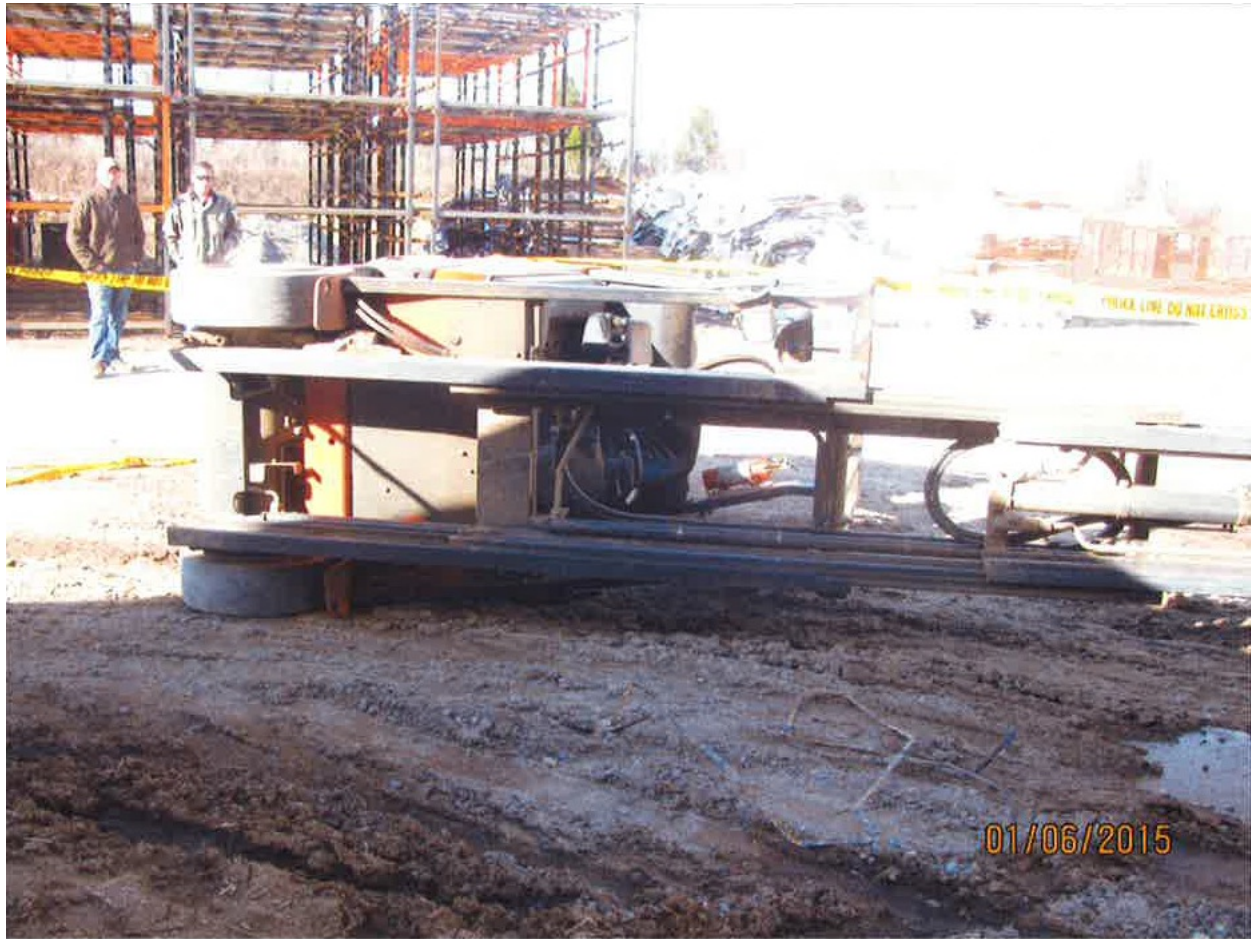
Photo 2 of 2 – Forklift on its side with the attachment in the raised position
