16 Struck by truck & trailer – Inspection #1164092

A **54 year old male** employee was fatally injured when he was struck by a work truck and flatbed trailer containing flint rock. On the day of the incident, a bridge construction crew traveled to the work site with various pieces of equipment that would be used during the day's construction. The work truck involved in the accident was towing a flatbed trailer carrying two large bags of flint rock. Once the work crew arrived on site, employees started staging the equipment and supplies for work to begin. The victim drove the work truck and flatbed to the desired location where one bag of flint rock was removed from the flatbed with a skid steer, and the second bag was cut and emptied onto the flatbed trailer for dispersal with a skid steer. Employees stated that the work truck had a faulty shifter cable connection to the transmission and that it had been reported to management on a previous job. The faulty transmission cable had not been repaired before the truck was used to travel to this work site. It was determined during the investigation that the victim may have been attempting to manually shift the transmission by holding hi

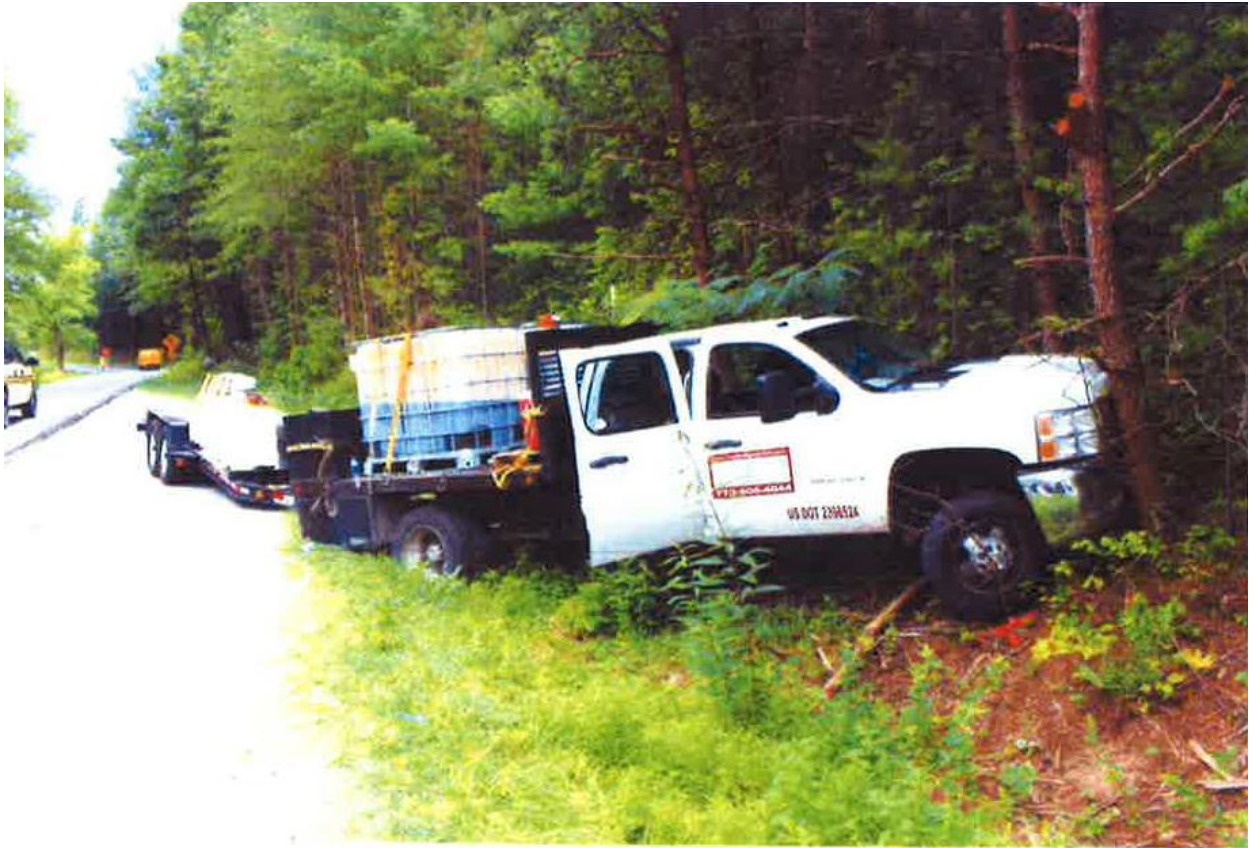
TCA 50-3-105(1)	The employer did not furnish employment and a place of employment which were free from recognized hazards that were causing or likely to cause death or serious physical harm to employees in that employees were exposed to: In that the 2009 Chevy 3500 work truck had a broken shifting cable that required employees to crawl under the truck to manually engage transmission into park which may have contributed to an employee's death after being ran over by the truck and the attached dual axle trailer. Among other methods, feasible and acceptable means of abatement would be to: Repairing or replace shifter cable assembly and/or remove truck from operation
-----------------	---

Photo 1 of 1 – The work truck and flatbed trailer containing flint rock and the location it came to rest after striking the victim.
