1 Struck by work platform – Inspection #1200845

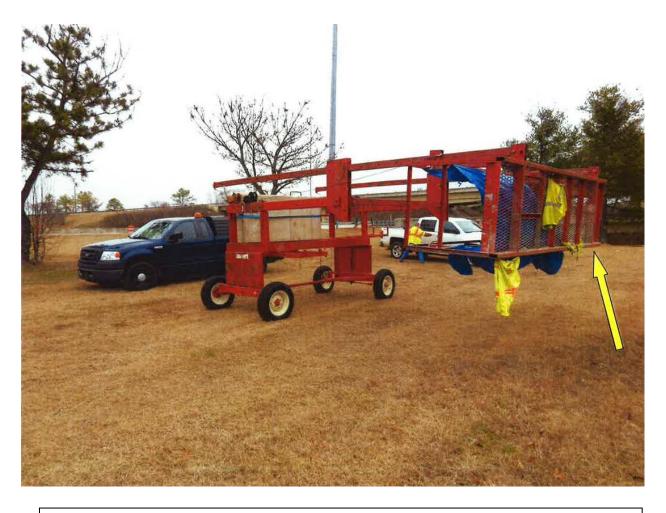
Photo 1 of 1 –The yellow arrow indicates the right-rear side of overhang buggy basket that struck the victim.
