32 Crushed by machine – Inspection #1276842

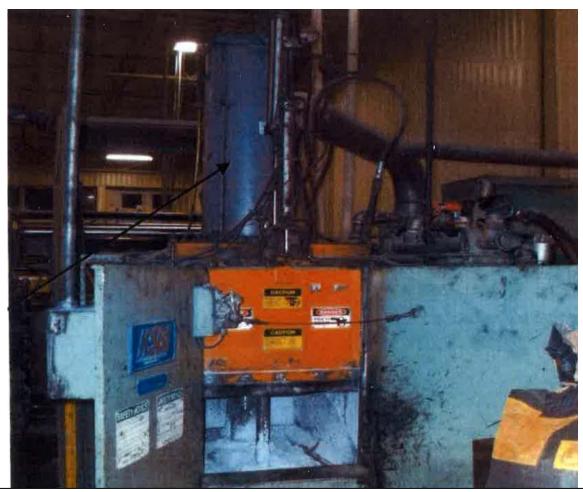
A **46 year old male** employee was fatally injured when he was crushed by the upper ram of a rubber mixer. At the time of the incident the victim was working with a Lab Technician to ensure the proper ingredients were in place for the batch of a specific type of rubber. Once the ingredients are placed on the feed conveyor; the conveyor was moved into position at the front of the mixer door. The conveyor fed the ingredients into the mixer and two rotors at the bottom of the mixer combined the ingredients. This batch was believed to be ruined due to overheating therefore the hopper had to be cleaned out by hand. Once the hopper returned back inside the mixer, the victim placed his head and both arms inside the front door of the mixer and the ram began to move downward. The downward motion of the ram pinned the victim inside the mixer door, crushing him. The TOSHA investigation revealed the victim did not lock-out the mixer prior to entering for cleaning purposes, the pin used to keep the ram from falling was not inserted in the designated area under ram prior to entering, and the ram switch at main control panel was defective.

29 CFR 1910.147(c)(4)(i)	Procedures were not developed, documented and utilized for the control of hazardous energy when employees were engaged in activities such as cleaning up at the machine.
	In that employees were not utilizing lockout tag-out when cleaning built up rubber from the rotors inside the mixer hopper. An employee entering the mixer hopper to remove built up rubber was crushed when the ram moved downward pinning him between the ram and the mixer frame.

Photo 1 of 1 – Photo shows the orange mixer door and this is where the victim entered for cleaning purposes. In the photo the ram is lowered down inside the mixer hopper.
