Two male employees (ages 22 & 30) were fatally injured when they were struck by an Over-The-Road (OTR) tractor/trailer while working in a six man crew during the installation of snow plowable raised pavement markers (SPRPM) along the broken white line that separated the two west bound lanes of traffic on I-40 in the vicinity of mile marker 26.2 near Arlington.

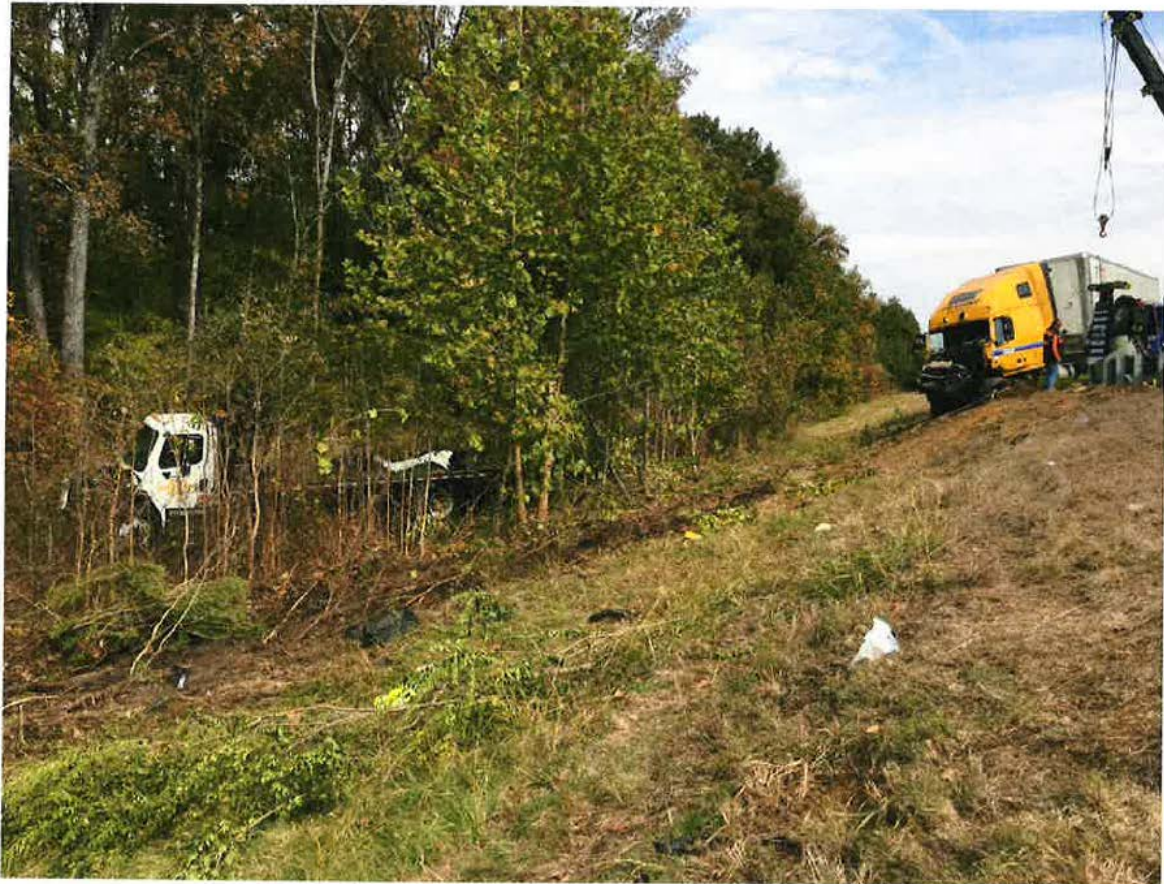
An OTR tractor/trailer was travelling in the right lane when it struck rear of the TMA #147 (Shadow Vehicle 1) and initiated the chain reaction collision with the vehicles in the MOMR. The first victim (Glue Truck laborer) was apparently standing in the westbound emergency lane (outside shoulder) near the right front of Vehicle 4 (Glue Truck) and was struck by the OTR tractor/trailer. The second victim (Glue Truck operator) was separated from the glue truck and struck as well.

Description:	View of the Truck Mounted Attenuator #SS147 at the bottom of the embankment along the north side of I-40 and of the OTR tractor/trailer as it was being recovered.
--------------	--
