2 Struck By 4800# panel—Insp # 1648501 Lucio Lucas OBA L&L

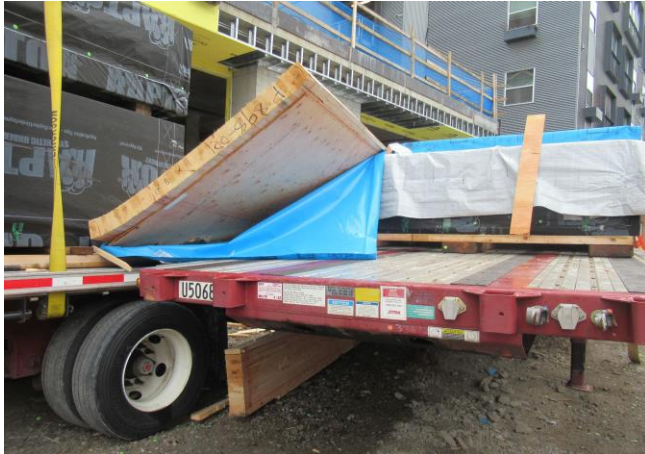
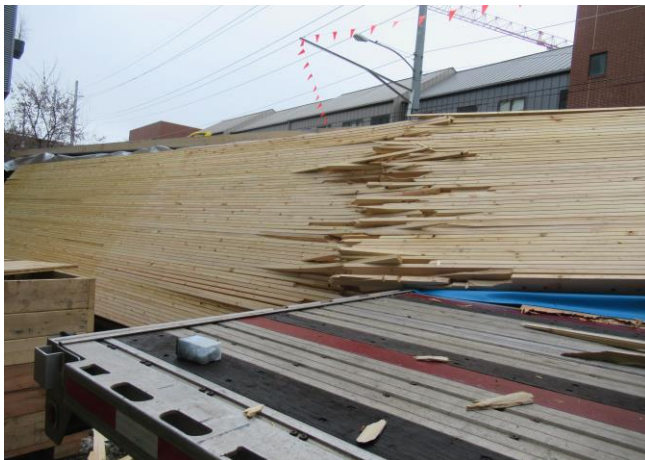
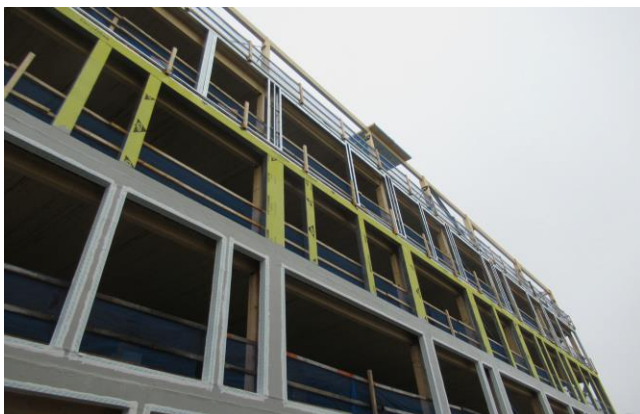
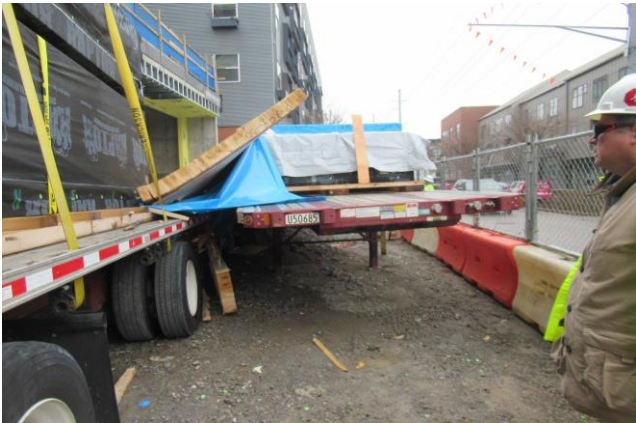
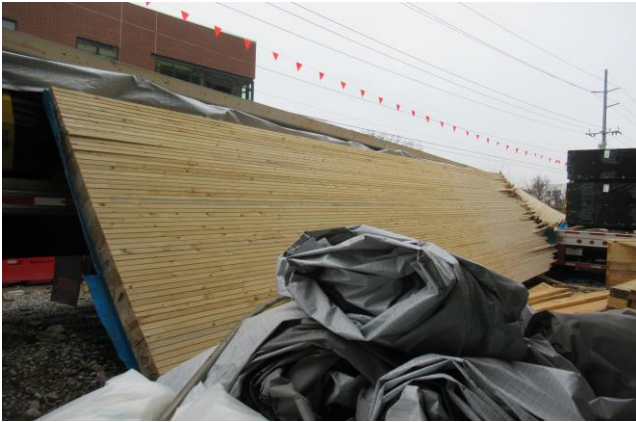
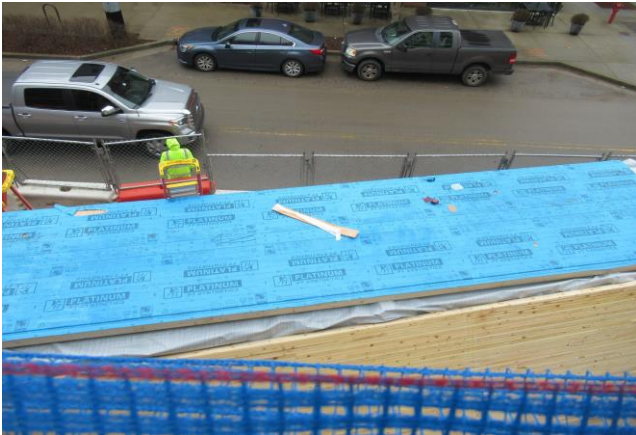
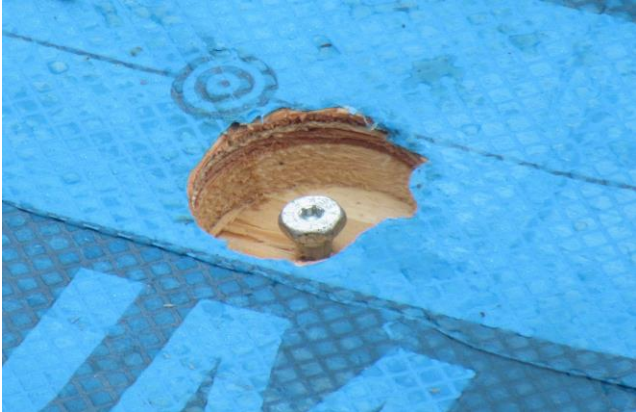
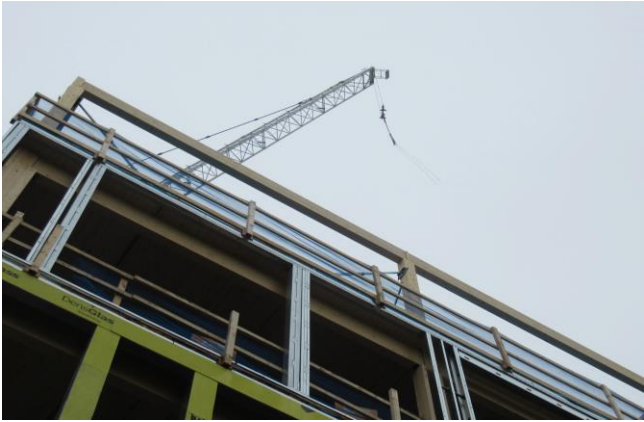
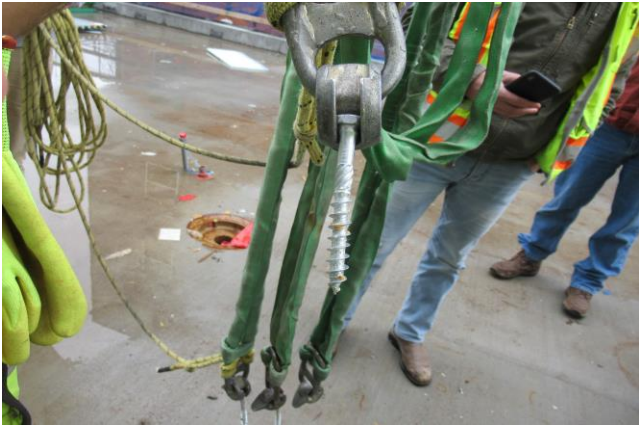
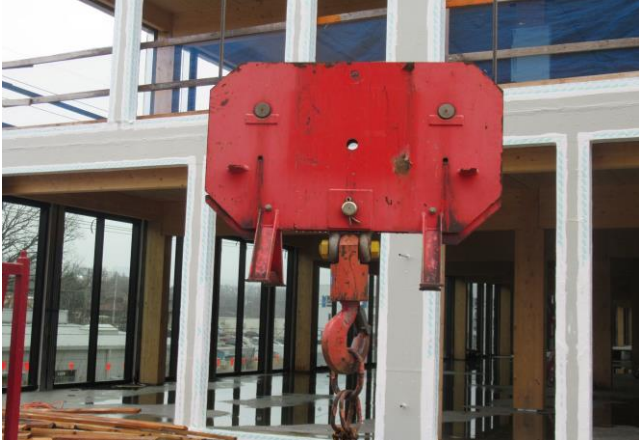
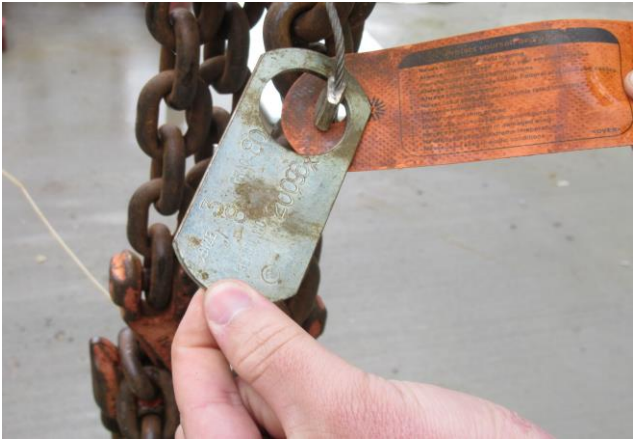
A 35 year old male employee was struck by a 4800 pound panel that was being lifted with a crane from a trailer on the ground to approximately the 5th story of the building under construction.

The victim was working as part of a 2-man rigging team. The team was connecting the rigging on the crane to wooden panels that measured 40'X8' and weighed 4800 pounds. Once the load was connected, a tower crane would lift the panel into place. Anchors are installed by the manufacturer to the wooden panels which are then used with appropriate rigging to lift the panel into place. One of the four anchor points on the panel failed during the lift. When the panel shifted, the remaining three anchor points gave way causing the panel to fall onto the victim, crushing him. According to a witness that was working with the victim at the time of the incident, he had released the 32' long tagline and it was approximately 10' above his raised hand when the load fell. The victim was standing on a flatbed semi-trailer 8 feet above the ground. As such, the panel fell from between 70-80' above the ground according to the crane operator.

The General Contractor located one of the 4 anchor bolts in the street. It was stated that this that was the first anchor point to fail. The other 3 anchor bolts were still attached to the crane rigging at the time of the inspection. An inspection of the location on the panels where the anchor points were installed was not observed by inspectors due to the location of the panel after it fell and the fact that it was not stable. From the condition of the 4 anchor bolts, it was apparent that the anchor bolts did not snap but pulled out of the panel. The three anchor bolts that were still attached to the rigging were bent, likely from the excessive force applied to them when the first bolt failed.

It was determined through interviews with the victim's co-worker, who was working directly with him at the time of the incident, the employees worked under the suspended load. The employee stated that after the taglines were released, they stayed in the area to get ready for the next pick. The victim was standing on the next panel that was to be lifted. The employee also stated that getting to a safe location where they were not working under the suspended load would involve climbing down from the trailer and going inside the building and it was easier to stay out on the trailer. The area where the employees were working was extremely tight. The semi-trailer was situated between the building and a temporary barrier to the street and there was very little room to move around the trailer.
