Struck By Garbage truck—Insp # 1660587 BFI Waste Systems of North America, LLC

A 52 year old female employee was struck by a garbage truck while working as a spotter at the working face of a landfill.

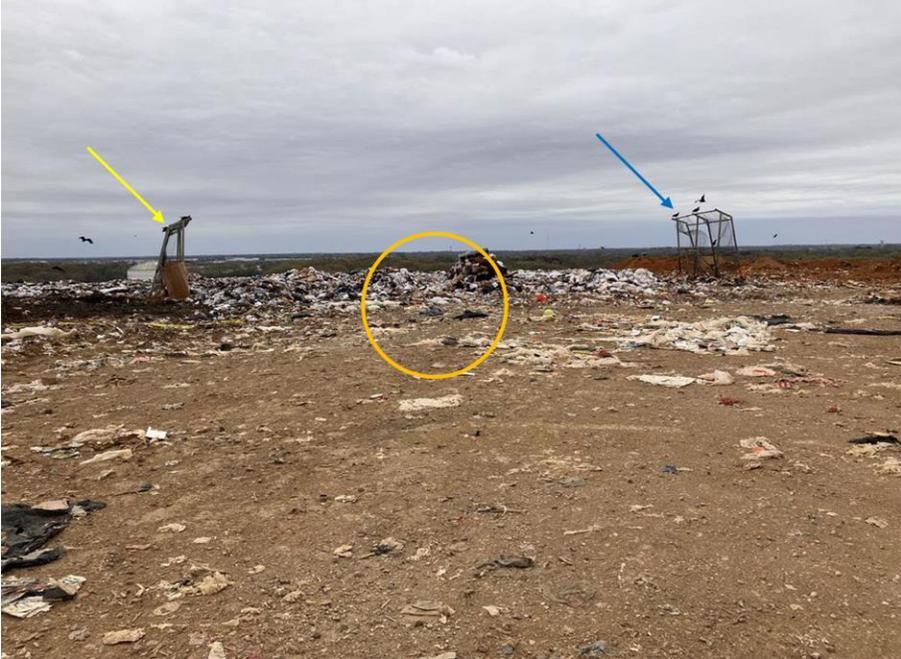
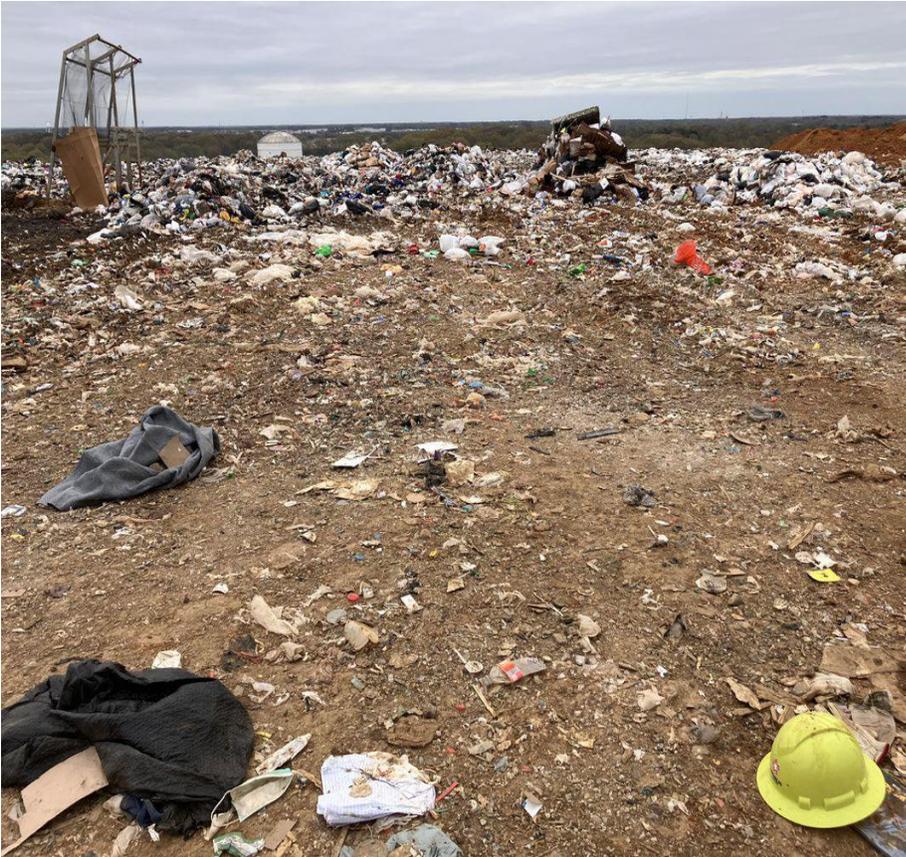
The turnaround area of the landfill was approximately 75 feet wide by approximately 100 feet deep. The service road leading to and from the turnaround area ran roughly parallel to the 75-foot-wide section along the west end of the turnaround area. The working face was along the east end of the turnaround area, opposite the service road. There were two working face screens or fences at the working face. The screens or fences help to minimize loose trash from being blown about by the wind while the garbage trucks are dumping their loads at the working face. The landfill did not have a "spotter zone" that was clearly visible, protected and designated.

The victim was wearing her required PPE (e.g.: high-visibility vest, hard hat, etc.); however, the landfill did not have a “spotter zone” that was clearly visible, protected and designated.

In that employees are exposed to struck-by and run-over hazards when standing out in the open directing garbage truck traffic at the working face of the landfill.

Among other methods, feasible and acceptable means of abatement would be to provide a clearly visible, protected and designated "Spotter Zone" for the spotter, and to enforce rules requiring spotters to stay in the "Spotter Zone" at the turnaround area of the landfill.
