A 55-year-old male, laborer, was fatality injured when he fell through a fiberglass skylight in the roof and landed on the concrete floor, approximately 26 feet below. GDL Metal Buildings, LLC, is based in Memphis, TN, and primarily erects and dismantles metal buildings. The existing building was under renovation. GDL Metal Buildings, LLC, was contracted to remove and replace wall panels, skylights, and the metal roof.

Fall though skylight—Insp # 1668035 GDL Metal Buildings, LLC

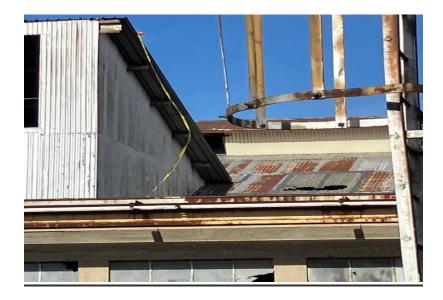
The skylight was the southernmost skylight on the east side of the original, center section of the building. It was the closest skylight to the sawtooth roof of the south addition. The victim had transitioned to the roof of the original, center section of the building for an unknown reason, they had no work to complete in that section. The first person to respond the incident was an employee of another contractor and it was stated that the victim was not wearing a full body harness. He added that he thought there was a harness laying by the victim's right side.

In conclusion, it is believed that the victim stepped from the sawtooth roof of the south addition to the peaked roof of the original, center section, and from there stepped onto, and fell through, a fiberglass skylight panel, falling approximately 26 feet to the concrete floor below.
