A 22 year old male employee was crushed inside a concrete manhole which collapsed the cone section of the manhole when it was struck by a front-end loader.

Crushed inside a concrete manhole—Insp # 1671601 Woods Construction Services, LLC

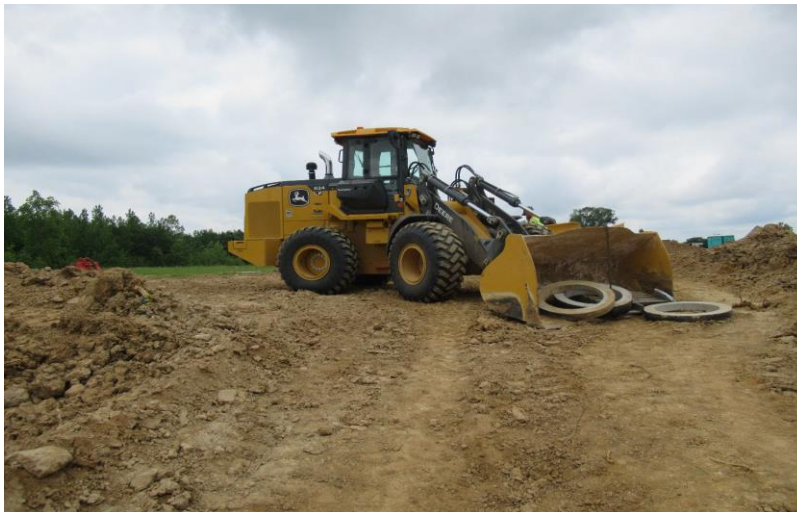
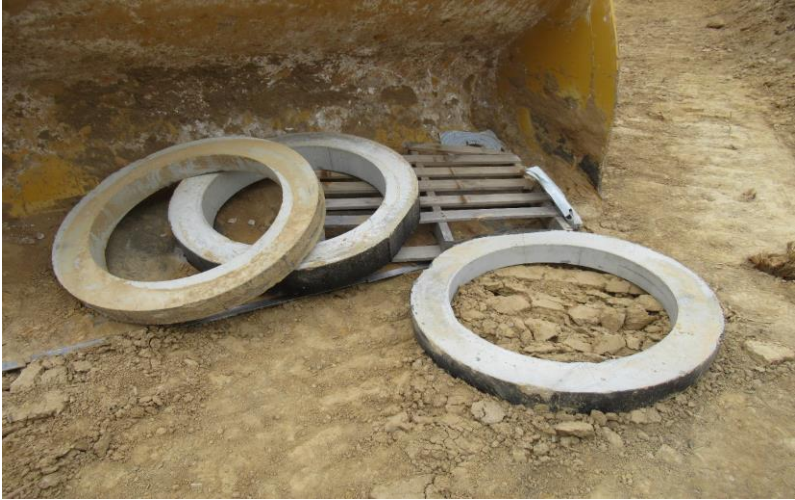
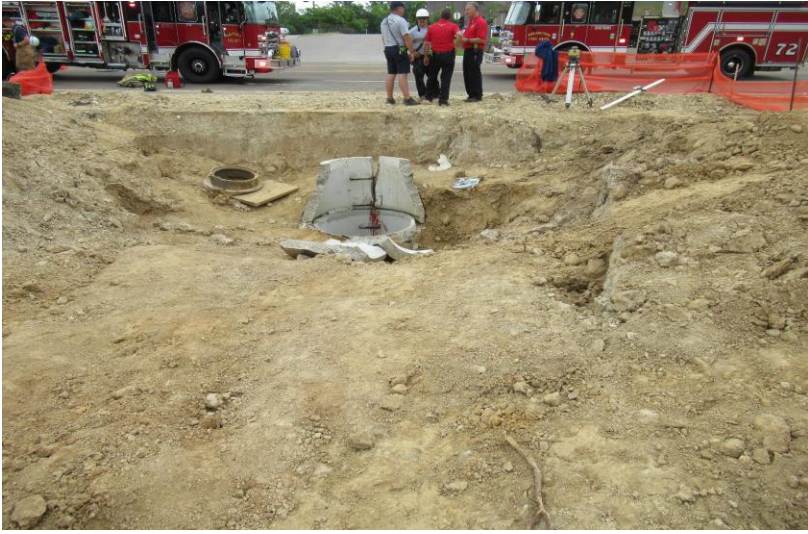
According to photographs taken by the Arlington Fire Department, the blade of the bucket struck the concrete cone section of the manhole; strike marks were gouged into the outer surface of the concrete. The strike marks in the cone section were approximately 18 inches to 24 inches above the surface of the ground, and approximately parallel to the surface of the ground. The photographs also show no marks in the ground (e.g.: gouges in the dirt from the blade of the bucket; a smooth pathway in the dirt from the body of the bucket) leading towards the manhole that would indicate the bucket was not on the ground when it was parked.

The company has a rule that the bucket is on the ground when equipment is shut down. However, based on the information obtained during the inspection, it is believed that the bucket of the front-end loader was not placed on the ground when parked on the incline near the manhole allowing it to roll into and striking the manhole.
