A 55 year old male, forklift operator, was crushed between two Yale forklifts. The accident was first reported to TOSHA as an in-patient hospitalization, but the victim later succumbed to his injuries.

## Struck By forklift—Insp # 1684364 Yates Services LLC

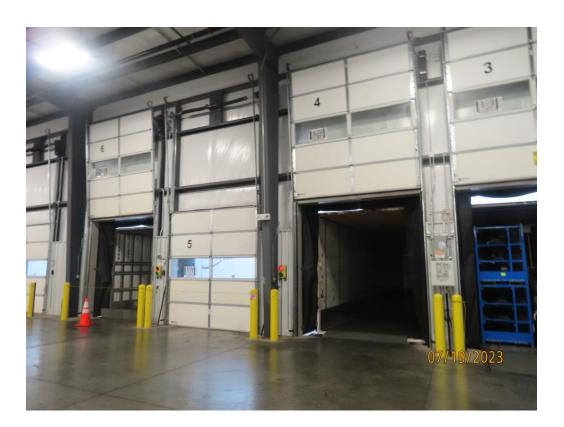
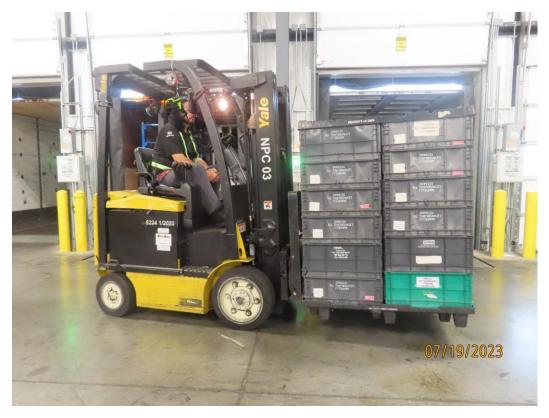
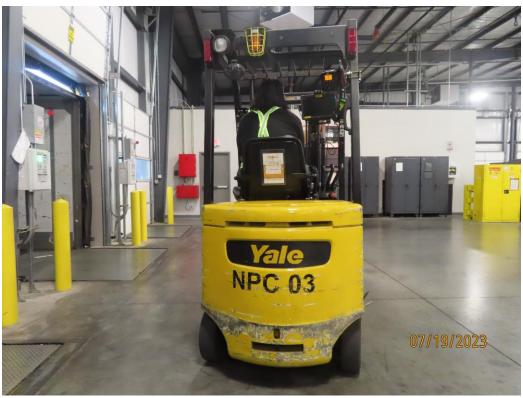
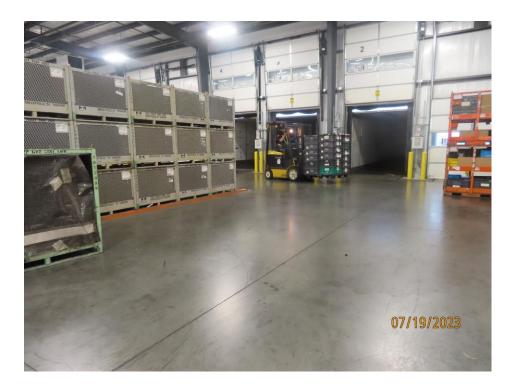
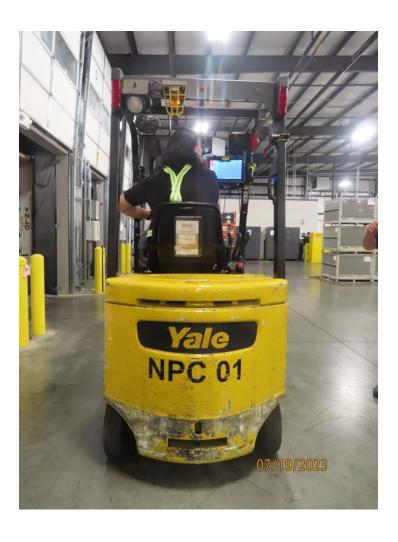
The victim was injured when a forklift operator struck him and pinned him between Yale forklift #3 and Yale forklift #1. The victim had gotten off his forklift and walked over to the table in between bay door #5 and bay door #4 to use the work tablet sitting on the table. Through interviews with management, the victim was using a tablet to make a call for one of the trailers to be brought in. An interview with the employee that was operating forklift #3 that struck the victim, revealed she was operating in reverse, going around a metal stack of boxes containing parts. The employee stopped once she was around the boxes and looked to her right. The employee did not see anyone to her right and continued backing up. The forklift operator then turned to her left looking for bay door #4 to drop off the empty boxes. The employee did not see anyone and continued backing up. As the operator traveled along the bay doors looking for #4 bay door, she crashed into forklift #1 where the victim was standing crushing him between Yale forklifts #1 and #3.

The forklift operator stated she could not turn around to see what was behind her because her foot would let off the brake. Through an interview with the operator, she stated she was approximately 4' tall which was not tall enough to reach the brake and turn around at the same time. It appears that she was unable to maintain a field of vision in the direction of travel when traveling in reverse plus there were no mirrors on the lift at the time of the accident. The employee was not able to turn around when traveling in reverse and keep her foot on the pedals at the same time, therefore she was looking in the direction of travel. As a result, the employee struck the victim pinning him between the forklift she was operating and the stationary forklift.

On the day of the inspection, mirrors were observed on both forklifts the employees were operating; however, the Safety Manager stated the mirrors were installed after the accident. Through employee and employer interviews and demonstration, the brakes, horn, and back up alarms were working properly on both forklifts. The two forklifts were also equipped with a blue light that tells pedestrians the direction the forklift is traveling.

In that a forklift operator was not fully competent to operate a powered industrial truck as she was not able to maintain a field of vision in the direction of travel when operating in reverse and reach the pedals at the same time. This deficiency resulted in an employee being crushed between Yale forklifts #1 and #3.

In that when operating the Yale forklift #3 (Model # ERC050VGN36TE085/ Serial # A968N20672T) in reverse, the operator does not look in the direction of travel. On 07/17/2023 an accident occurred while the operator was traveling in reverse and not looking in the direction of travel.
