A 36 year old male employee was ejected from his seat operating a CAT CP-433E Padfoot Compactor at a new sub-division construction site when the compactor overturned. The employee's head hit the canopy's upper left side main beam and his left arm was pinned under the canopy.

Vehicle Rollover—Insp # 1701031 Hunley Construction LLC

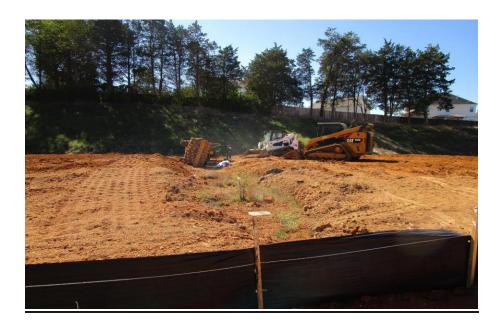
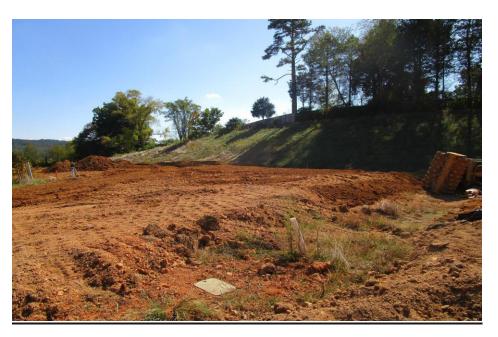
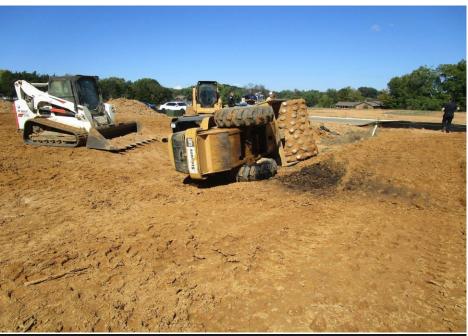
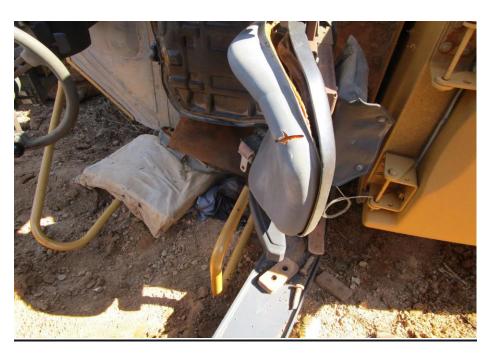
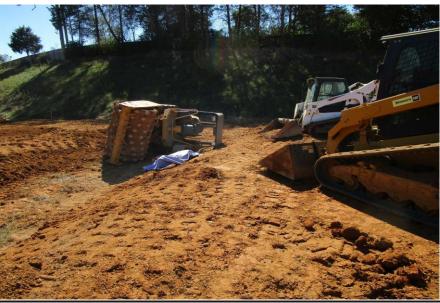
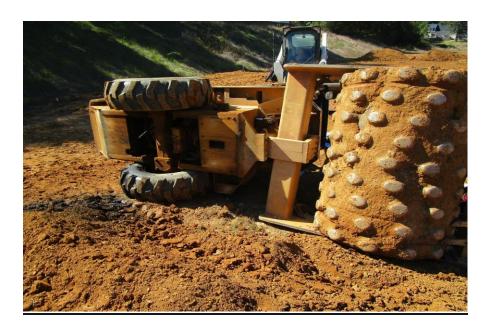
During the inspection, the area in which the incident occurred was observed. The Padfoot Compactor was situated near the back right corner on its side in between two lots. The lot that the compactor was operating on measured approximately 55' wide and 150 long. Each lot was raised with new dirt with a buffer in between each lot that sloped down. The angle from the buffer to the raised section of the lot was approximately 21.4 degrees, a raise of approximately 1 \frac{1}{2} - 2 \text{ feet.}

There were noticeable fresh tracks in the dirt that showed the compactor operating along the northwest edge at the top of the downward slope of the lot. The compactor was working in a direction from northeast to southwest along the raised edge of the lot. The fresh tracks in the dirt show the compactor rear tires sliding down the slope at the edge, pulling the weight of the front drum with it down the slope. There was an impression in the dirt where the side of the front drum dug into the ground and flipped over onto its side. The weight of the front drum is approximately 8,200 pounds by itself.

The employee was not wearing the manufacturer provided seat belt while operating the compactor which resulted in him being ejected from the cab during the roll over.
