# ***TECHNICAL REPORT***

***STATE ROUTE 8 (US-127)  
FROM STATE ROUTE 27 TO PALISADES DR  
HAMILTON COUNTY  
PIN 115819.00***

***PREPARED BY  
ARCADIS  
For the  
TENNESSEE DEPARTMENT OF TRANSPORTATION  
PROJECT PLANNING DIVISION***

***FINAL REPORT  
December 23, 2011***

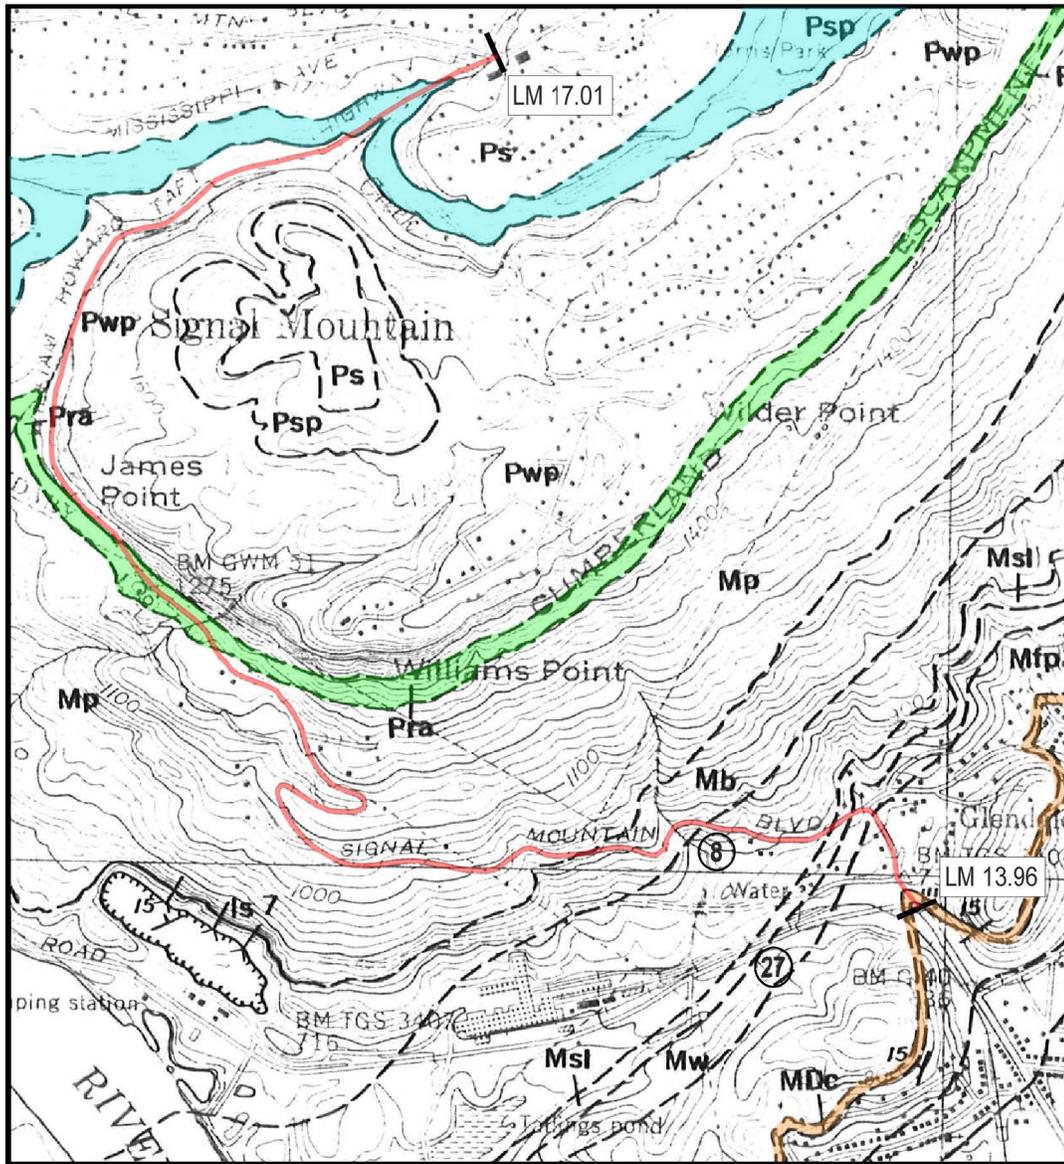
More specifically, the rocks contained in the project site, range in ages from Devonian to Pennsylvanian. These rocks form a syncline that is Walden Ridge. The rock strikes generally northeast-southwest with gentle dips of two (2) to fifteen (15) degrees in toward the axis of the syncline. A significant fault is noted at the base of Walden Ridge called the Cranmore Cove Fault. A geologic map of the area is shown on Figure 3.

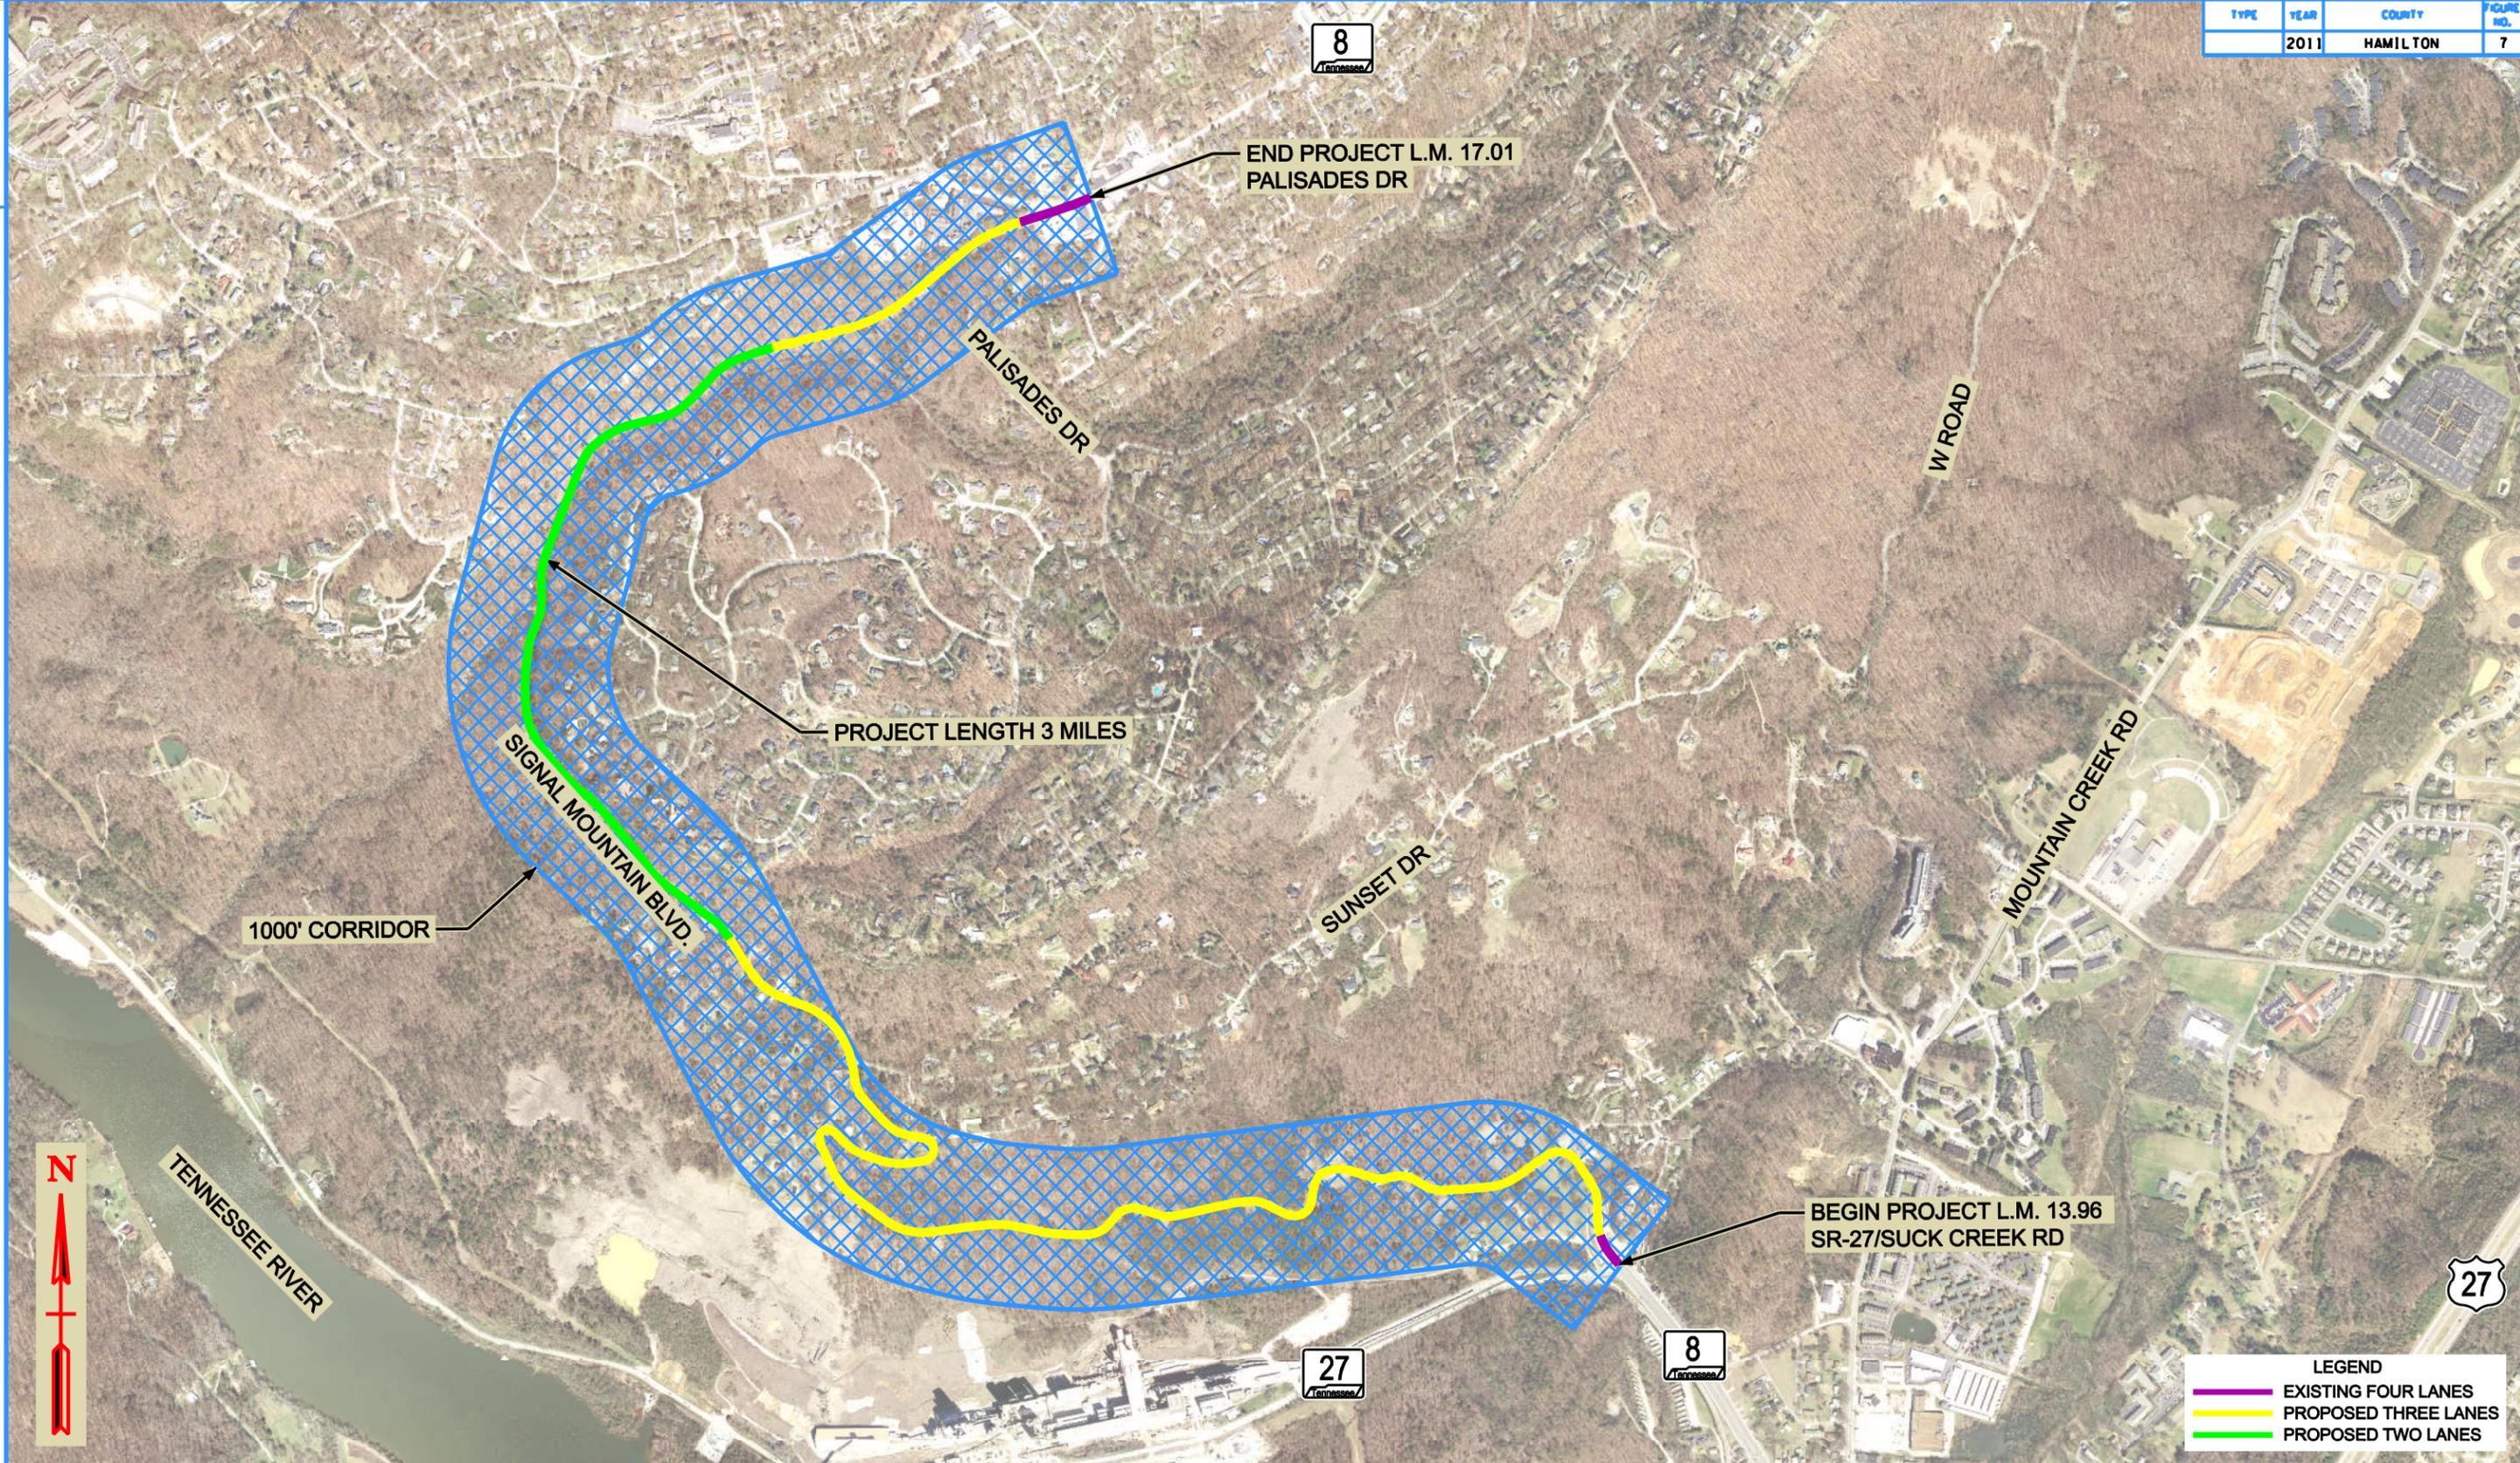
FIGURE 7  
RECONSTRUCTION  
SR-8/SIGNAL MTN BLVD

EXISTING FOUR LANES
	PROPOSED THREE LANES
	PROPOSED TWO LANES

Option 2 would follow the existing alignment of SR-8 (US-127), providing a 45 miles per hour minimum design speed, with two (2) lanes and an additional truck climbing lane from LM 14.00 to LM 15.65 and from LM 16.59 to LM 16.92. The estimated cost of Option 2 is \$75 million. Large cut and fill slopes will cause considerable impacts to adjacent property owners and significant visual impacts to the route. This Option would meet the stated purpose and need by creating a safer, more efficient and reliable route between Signal Mountain and Chattanooga.

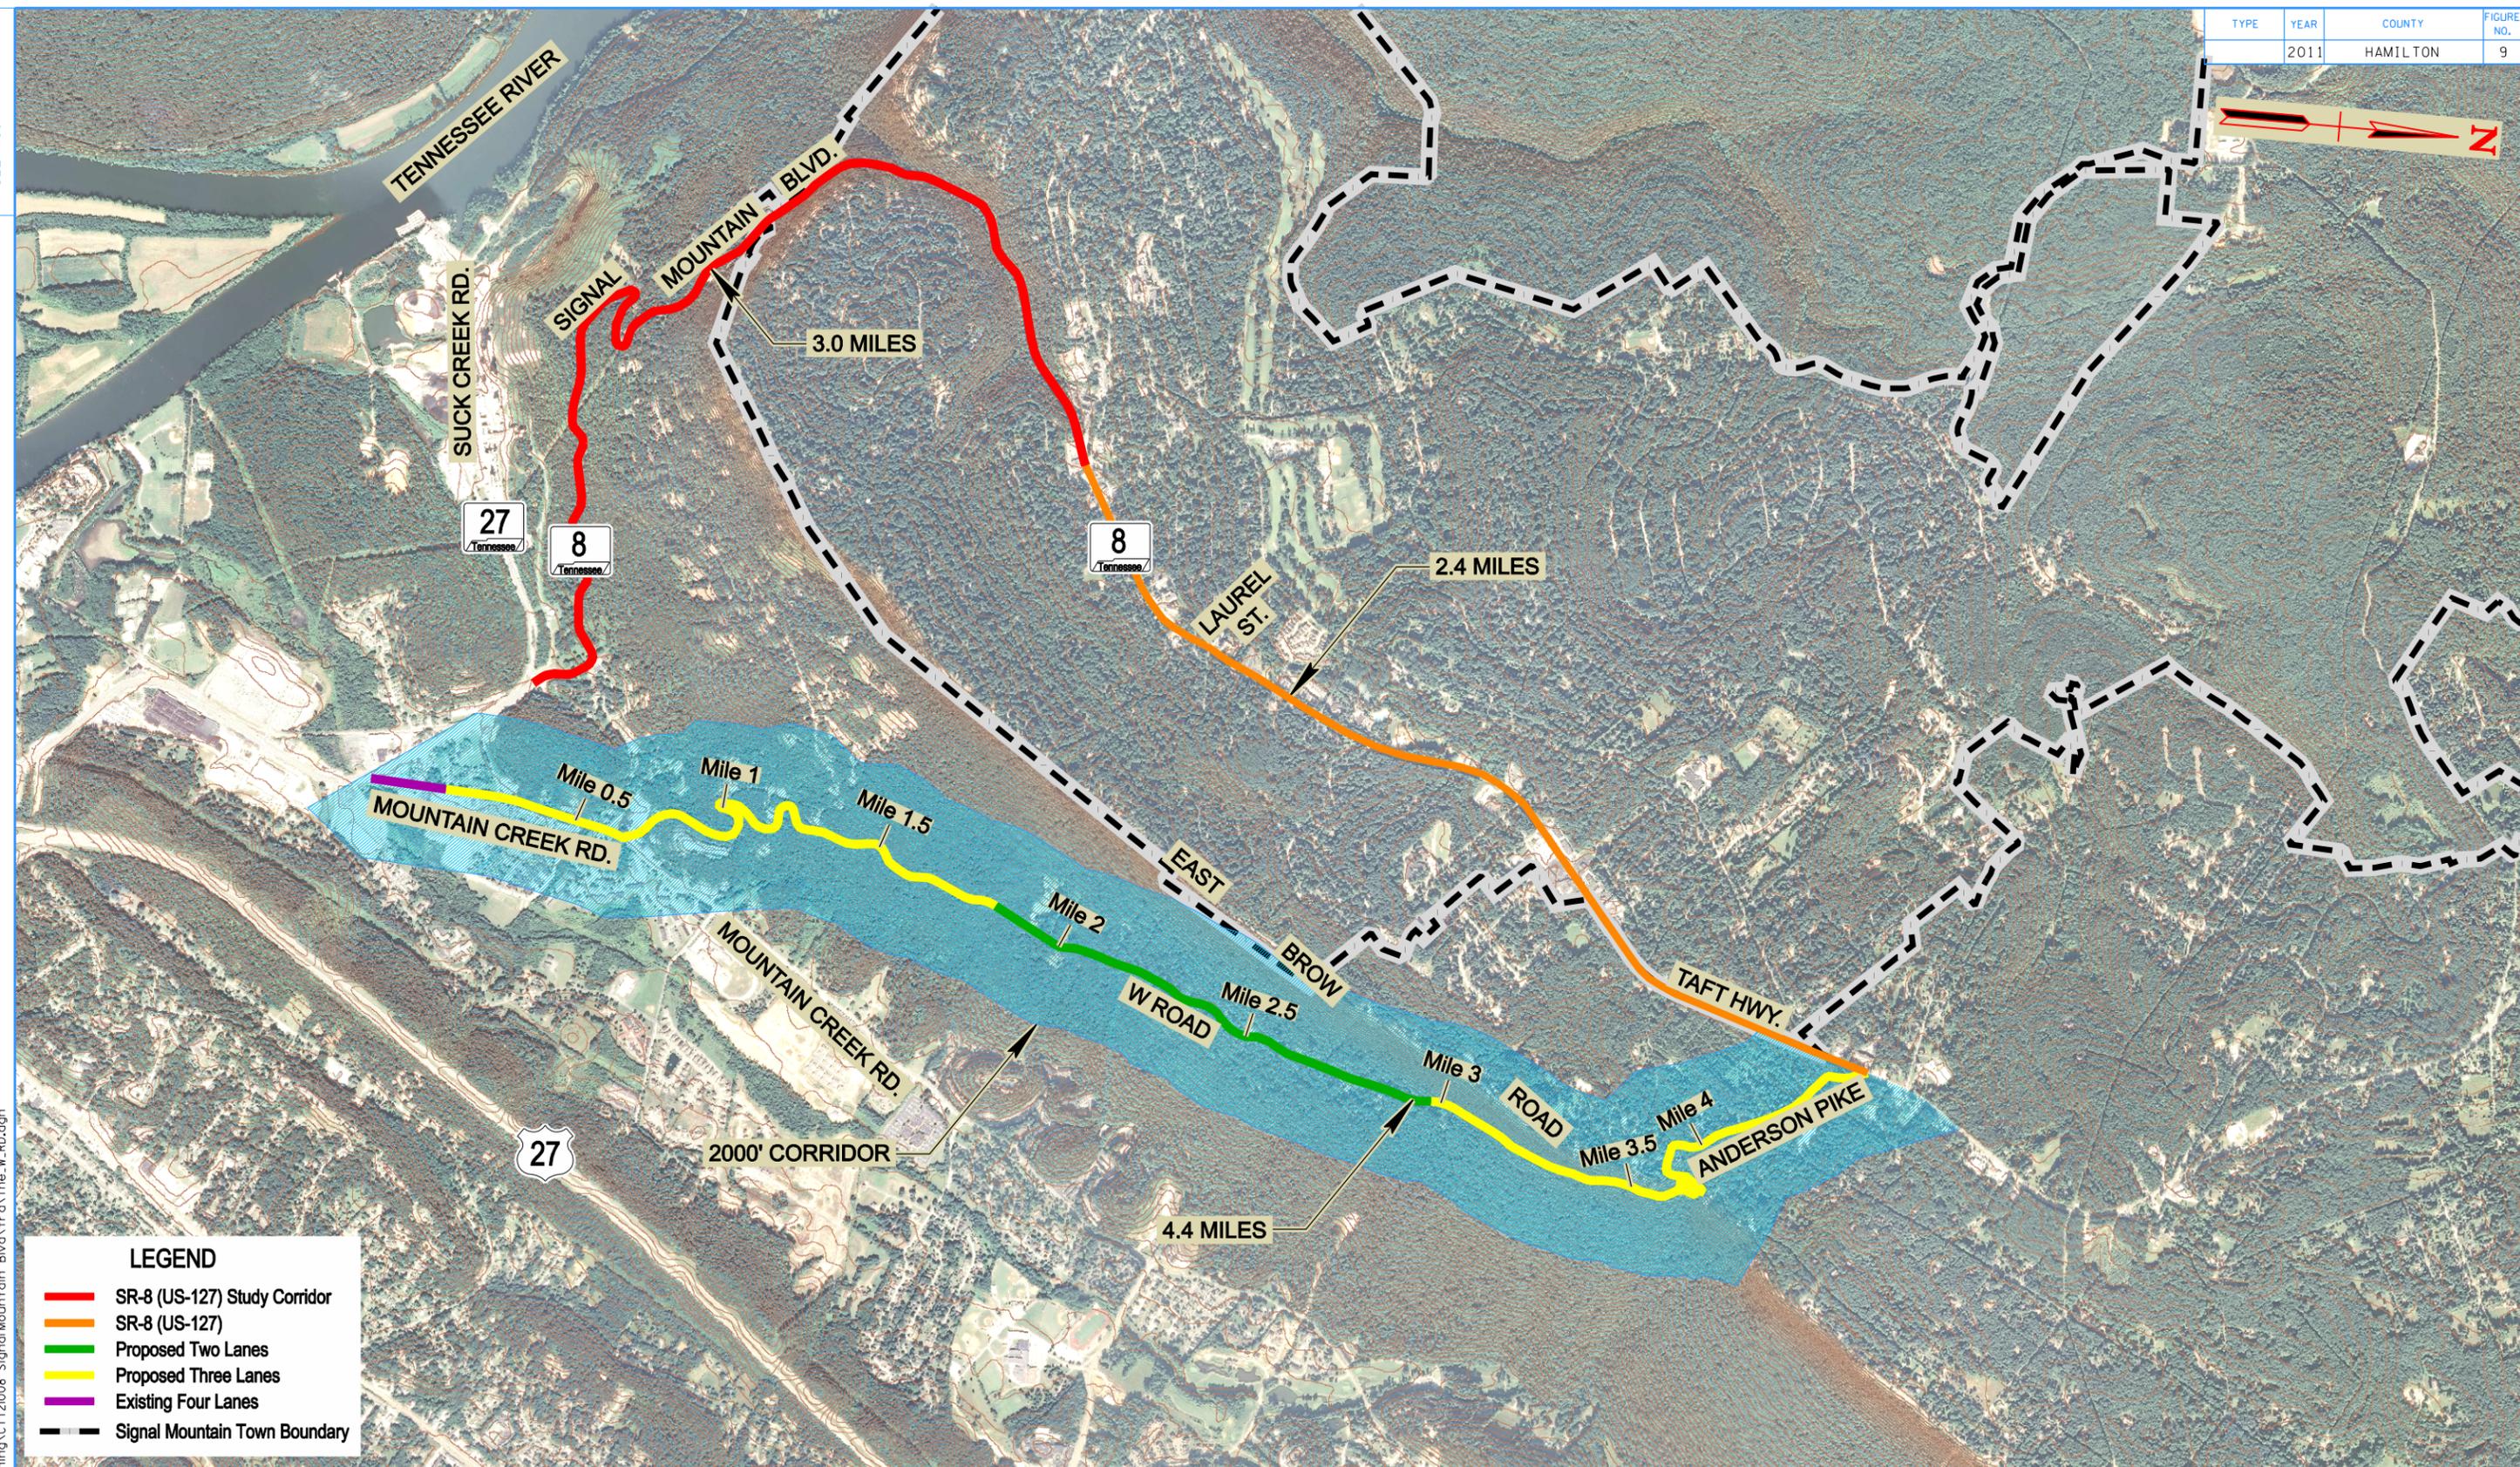
- SR-8 (US-127) Study Corridor
- SR-8 (US-127)
- Proposed Two Lanes
- Proposed Three Lanes
- Existing Four Lanes
- Signal Mountain Town Boundary

Option 3 consists of constructing an entirely new alignment that would follow the existing Mountain Creek Road, W Road and Anderson Pike routes, providing a 45 miles per hour minimum design speed, with two (2) lanes and an additional truck climbing lane along the W Road from Mile 0.6 to Mile 1.8 and from Mile 3 to Mile 4.4. The estimated cost of Option 3 is \$132 million. Large cut and fill slopes will cause considerable impacts to adjacent property owners and substantially alter the existing landscape. This Option would meet the majority of the stated purpose and need by creating a safer and more reliable route between Signal Mountain and Chattanooga. Option 3 increases the route length from Mountain Creek Road (LM 13.52) to Laurel Street (LM 17.55) by approximately two (2) miles. However, this option reduces the State Highway System by approximately one (1) mile.

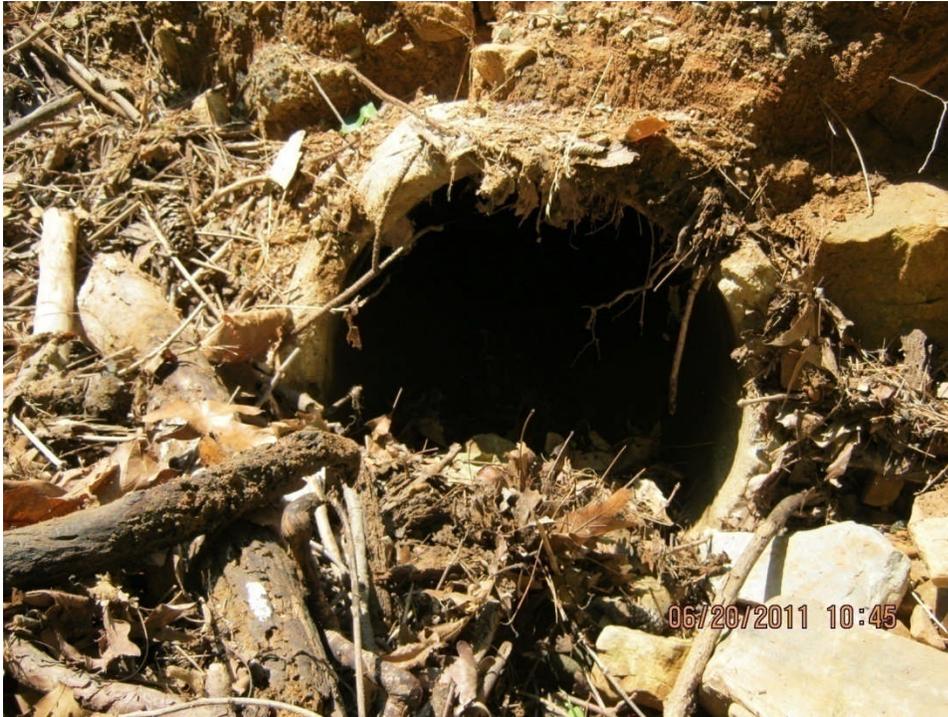
Drainage Photo 5 LM 14.54  
18" RCP  
Partially silted in

14.54	RCP	18	Crossing	75% obstructed by silt, woody debris, and roadside trash. Significant erosion present
14.69	CMP	24	Crossing	Inlet of culvert has been damaged and appears to obstruct 100% of flow. Significant erosion present.

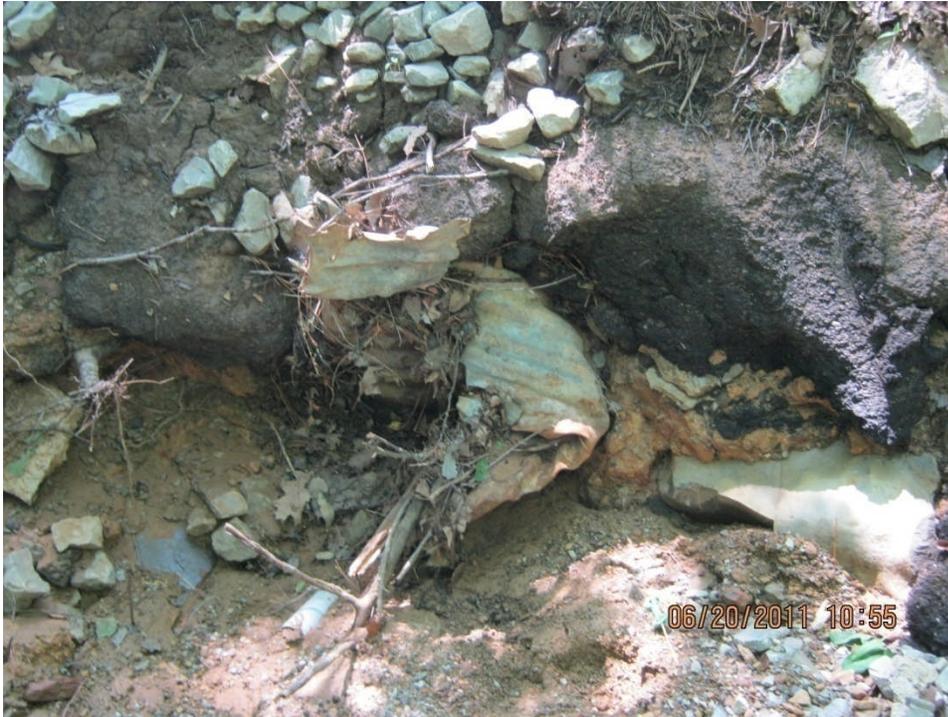
Drainage Photo 9 LM 14.69  
24" CMP, inlet damaged,  
completely obstructed

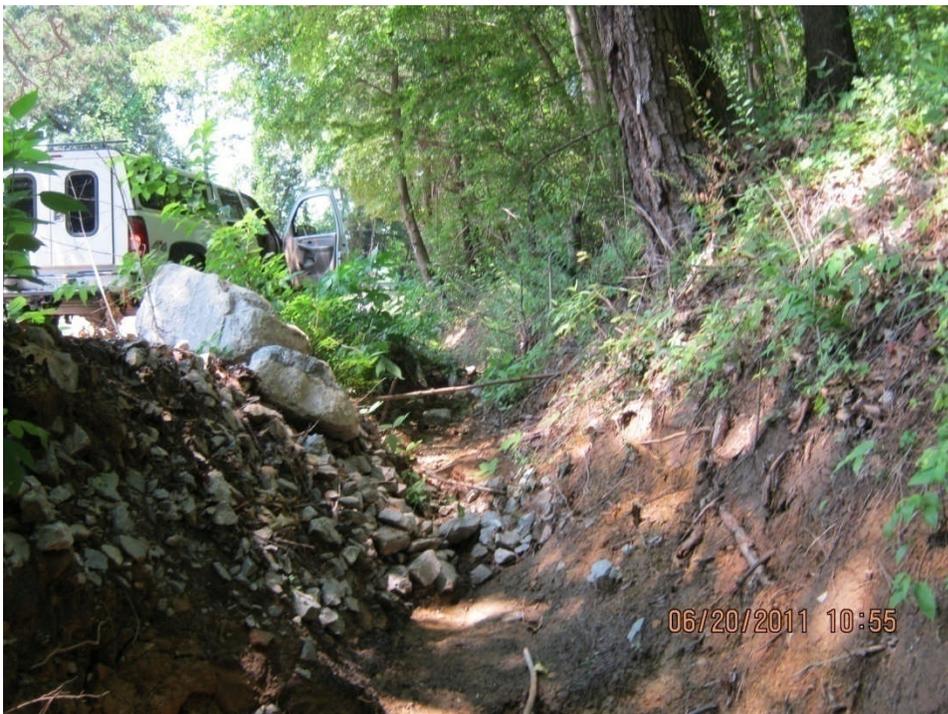
Drainage Photo 10 LM 14.69  
Unprotected drainage conveyance  
at 24" CMP, with significant erosion

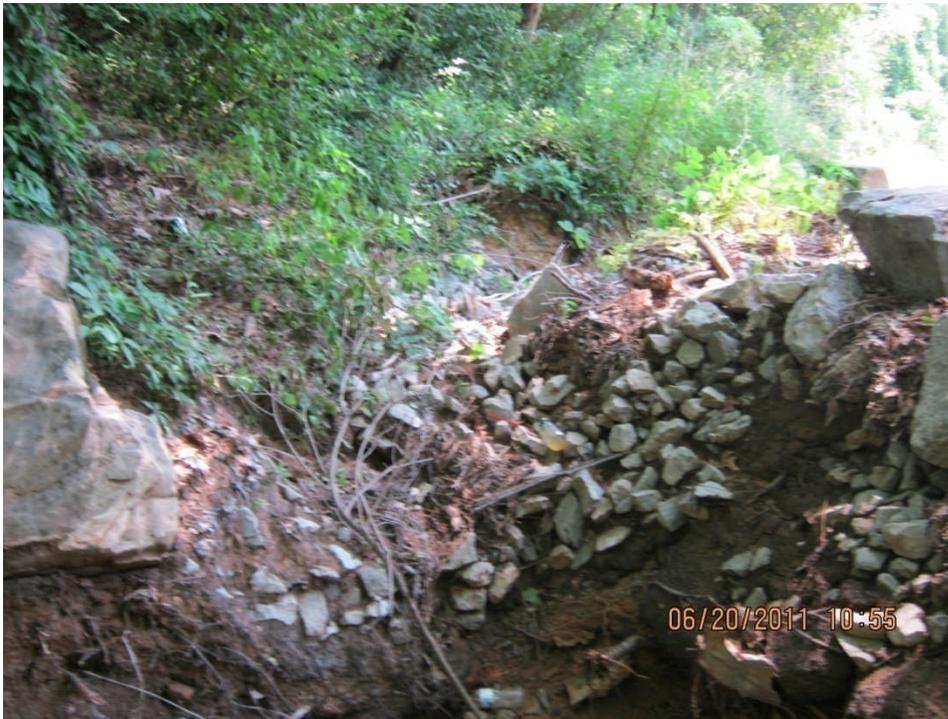
Drainage Photo 11 LM 14.69  
Significant erosion at 24" CMP inlet

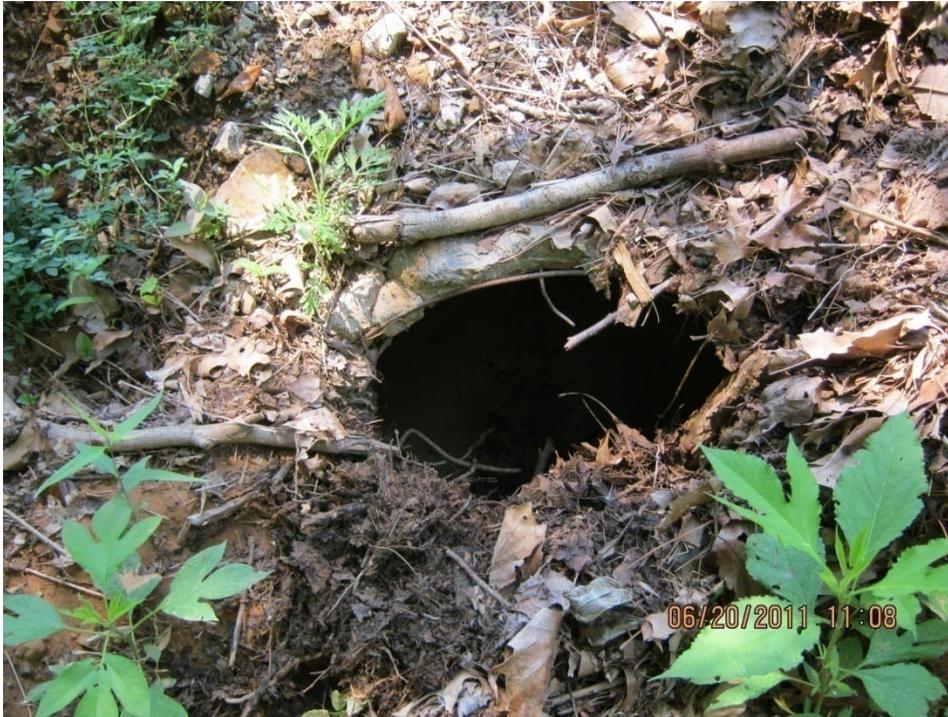
Drainage Photo 13 LM 14.75  
24" RCP, inlet side, partially  
obstructed with debris

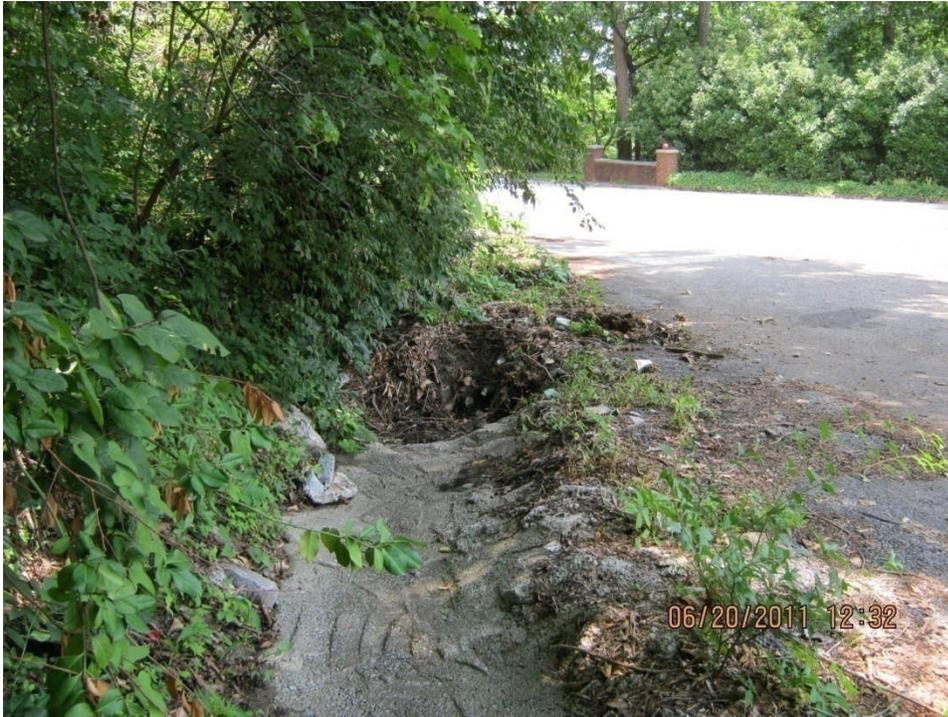
Drainage Photo 19 LM 15.29  
Location of 18"x12" CMP crossing  
Balmoral Dr., with concrete lined  
conveyance, inlet partially obstructed

15.25	RCP	18	Parallel	Siltation observed inside the catch basin and at the upstream inlet of the pipe
15.29	CMP-arch	18x12	Parallel	Inlet partially obstructed

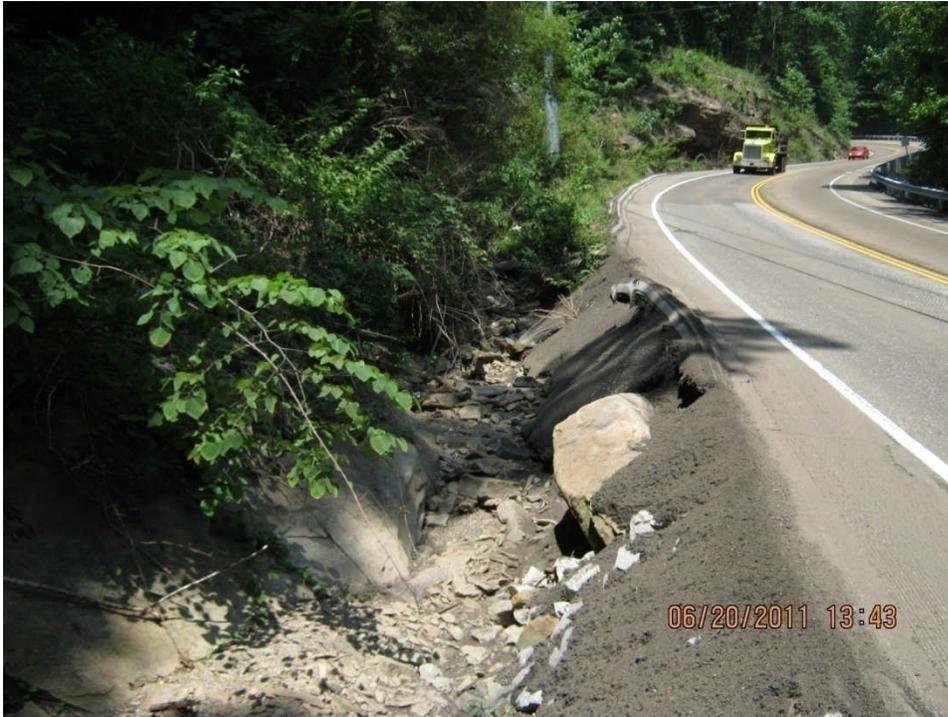
Drainage Photo 31 LM 16.46  
18" RCP inlet side

Drainage Photo 32 LM 16.46  
18" RCP inlet side,  
partially obstructed

16.46	RCP	18	Crossing	Inlet is bent, partially obstructed
16.56	RCP	24	Crossing	Inlet completely clogged
16.69	RCP	18	Crossing	Fair condition
16.79	RCP	30	Crossing	Headwall damage

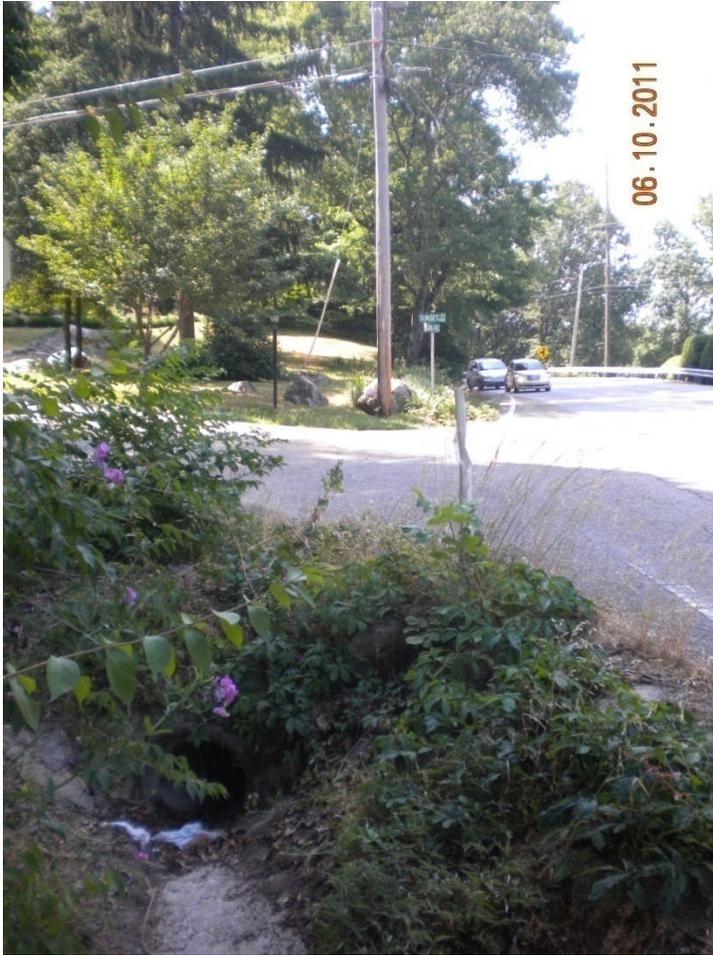
Drainage Photo 33 LM 15.42  
Piping Under Roadway
