## Knox County Health Department

Re: Fourth Quarter Air Monitoring Audit

On Oct. 21, 2020 – Oct 23, 2020 internal quality assurance performance audits were performed on Air Quality's monitoring network. All instruments were within acceptance criteria. Audit calculations, site evaluations, additional field notes and photos are included in the following audit report.

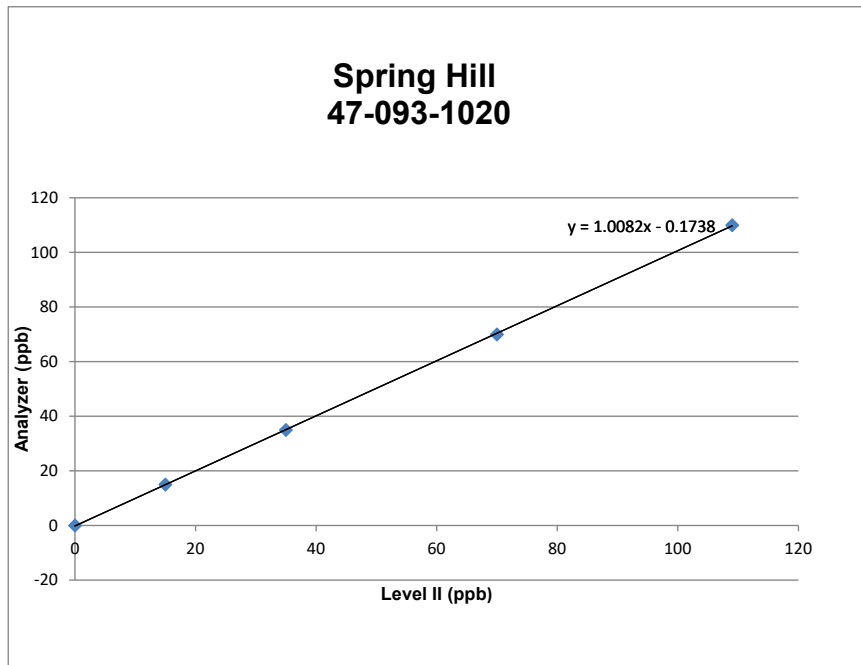
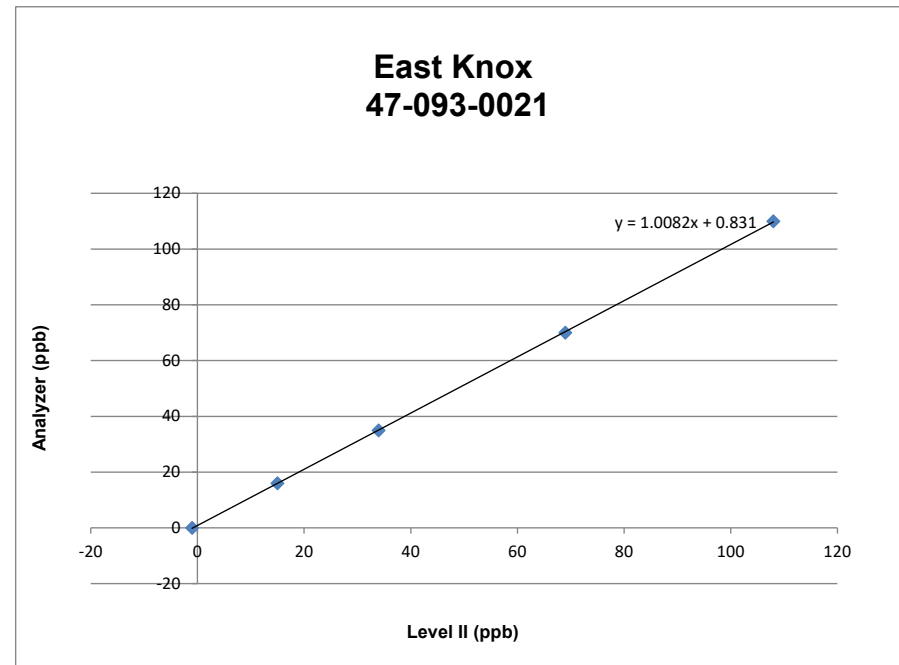
Slope 0.991868 correlation 0.999982  
 Intercept 0.17 R2 0.999964

Slope 0.991830 correlation 0.999982  
 Intercept -0.82 R2 0.999964

Notes: Pressure stable, no back pressure compensation performed

Notes: Pressure stable, no back pressure compensation performed. Brass cap on stainless port of calibrator. Replaced with stainless cap. Best to keep like with like to reduce damage. Logbook not fully filled out see photos.

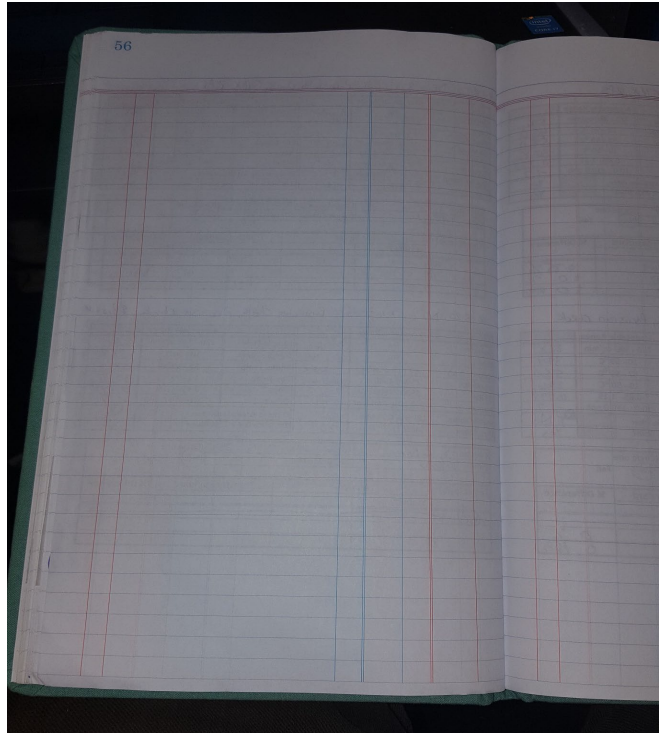
- SN4006 (East Knox Ozone)– sticky form left mostly blank from 10/8 and skipped pages. Forms and logbooks should be filled out immediately after the activity. Blank spaces must be X'ed out to prevent backfilling. Auditor X'ed out blank pages.
- SN218920606 (Springhill 2025) no documentation of semi-annual maintenance (7/20)

Maintenance Criteria				
Monthly Includes:	Clean Pm10 Inlet, First stage Inlet and VSCC. Perform Clock, Temp Pressure and Flow QC check and external leak check			Dates recorded on Verification Sticky
Quarterly:	Inspect V Seals, O-rings, and clean down tube			
	Date Performed	Date Due	Date Performed	Date Due
Q1	3-11-20	3/20	Q3	9-2-20
Q2	6-3-20	6/20	Q4	12/20
Bi-Annually	Exchange particulate trap filter, replace batteries.		Clean air filters	
	Date Performed	Date Due	Date Performed	Date Due
1	2-12-20	2/20	2	7/20
Annually:	Date Performed	Date Due	Other	
Calibration	7-15-20	7/20	Date Performed	
			Pump Rebuild

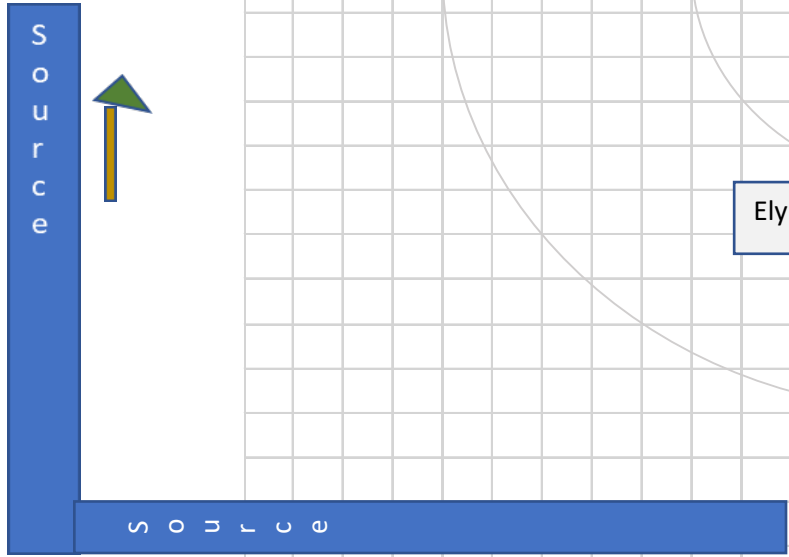
**Site Drawing**

Pollutant	Scale	Probe Height <sup>1</sup>	Flow (hi or Low)	Separation from samplers <sup>1</sup>	Pass/Fail	Distance to Road <sup>1</sup>	Pass/Fail
Lead	Microscale	4.8M	Hi	N/A		12.8M	Pass

Obstruction type <sup>2</sup>	Obst. Height <sup>1</sup>	Obst. Distance <sup>1,2</sup>	Pass/Fail	Tree	
				Dripline <sup>1</sup>	Pass/ Fail
Small trees NNE	4.9M	12.4M	Pass	11M	Pass
Large Tree SW	15.8M	34.4M	Pass	>20M	Pass

Estimated Degree of Unrestricted Air Flow: 360°

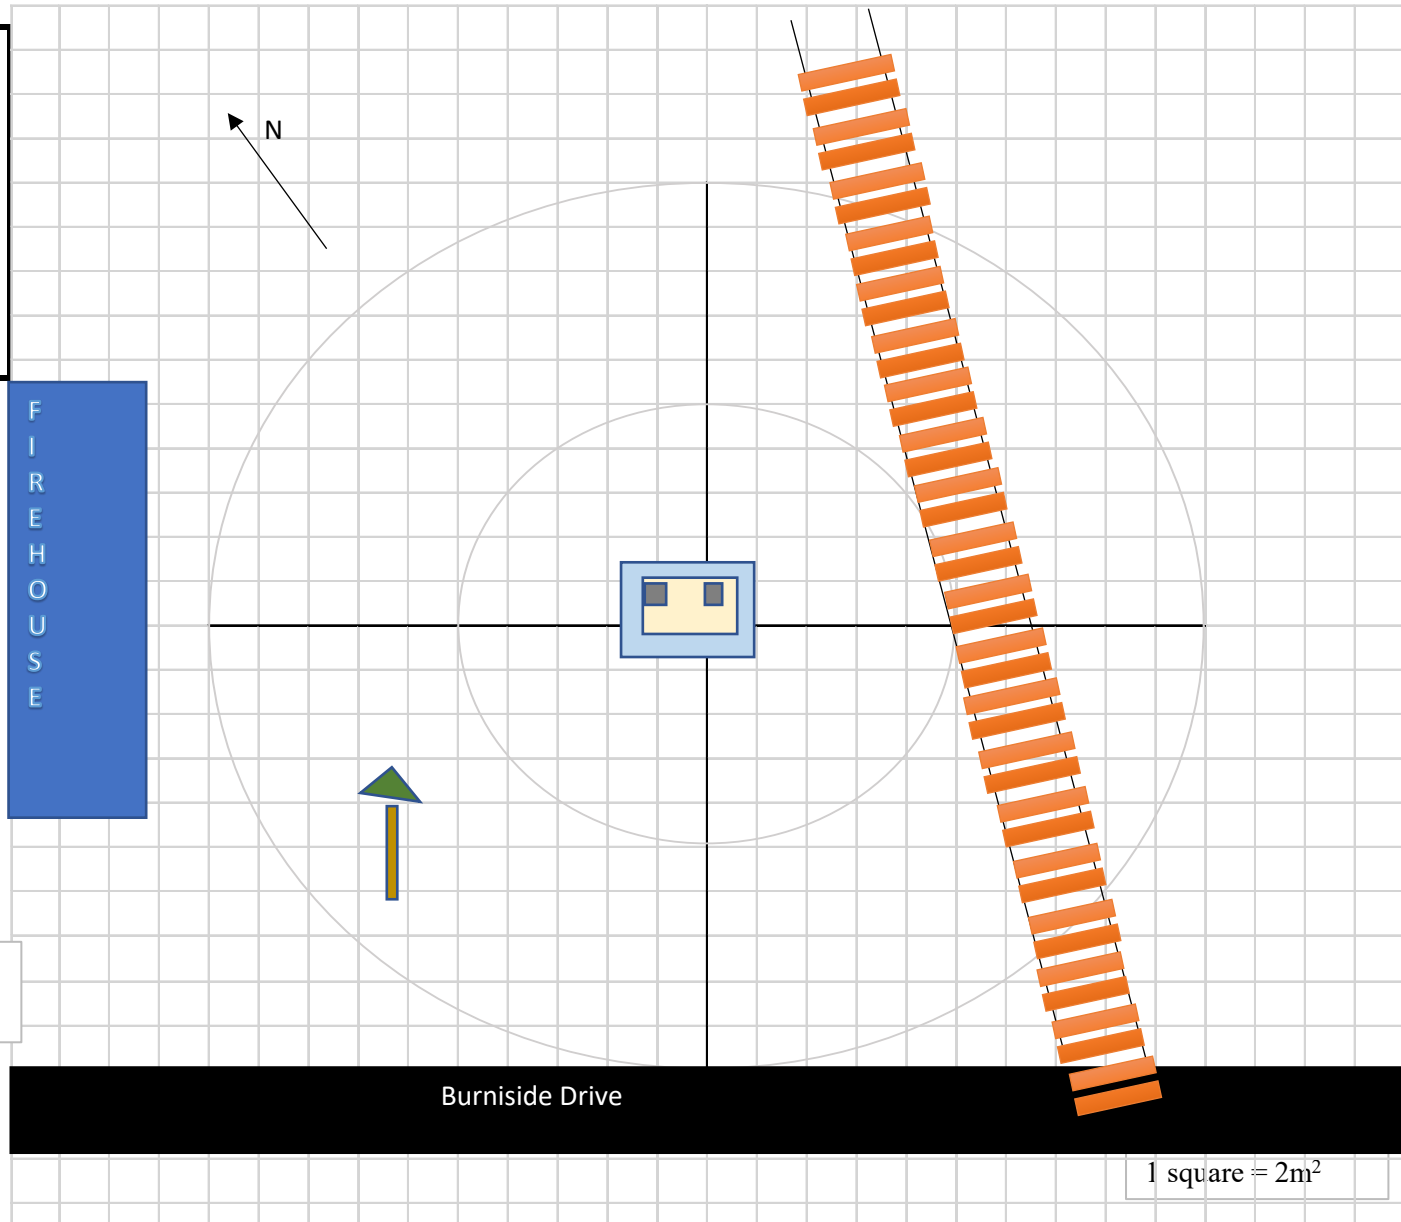
Site Drawing

Pollutant	Scale	Probe Height <sup>1</sup>	Flow (hi or Low)	Separation from samplers <sup>1</sup>	Pass/Fail	Distance to Road <sup>1</sup>	Pass/Fail
Lead - Official	Neighborhood	2M	Hi	2.56M	Pass	24.0M	Pass
Lead Collocated	Neighborhood	2M	Hi	2.56M	Pass	23.8M	Pass

Tree					
Obstruction type <sup>2</sup>	Obst. Height <sup>1</sup>	Obst. Distance <sup>1,2</sup>	Pass/Fail	Dripline <sup>1</sup>	Pass/ Fail
Tree SW quadrant	20	18		10.5	Pass
Firehouse	6.2	26.2	Pass

Estimated Degree of Unrestricted Air Flow: 270°

Burnside Drive

1 square = 2m<sup>2</sup>
