Bid Package
City of Rutledge
Nance Building Column and Soffit Restoration

Nance Building Columns and Soffit Restoration

Current Photographs

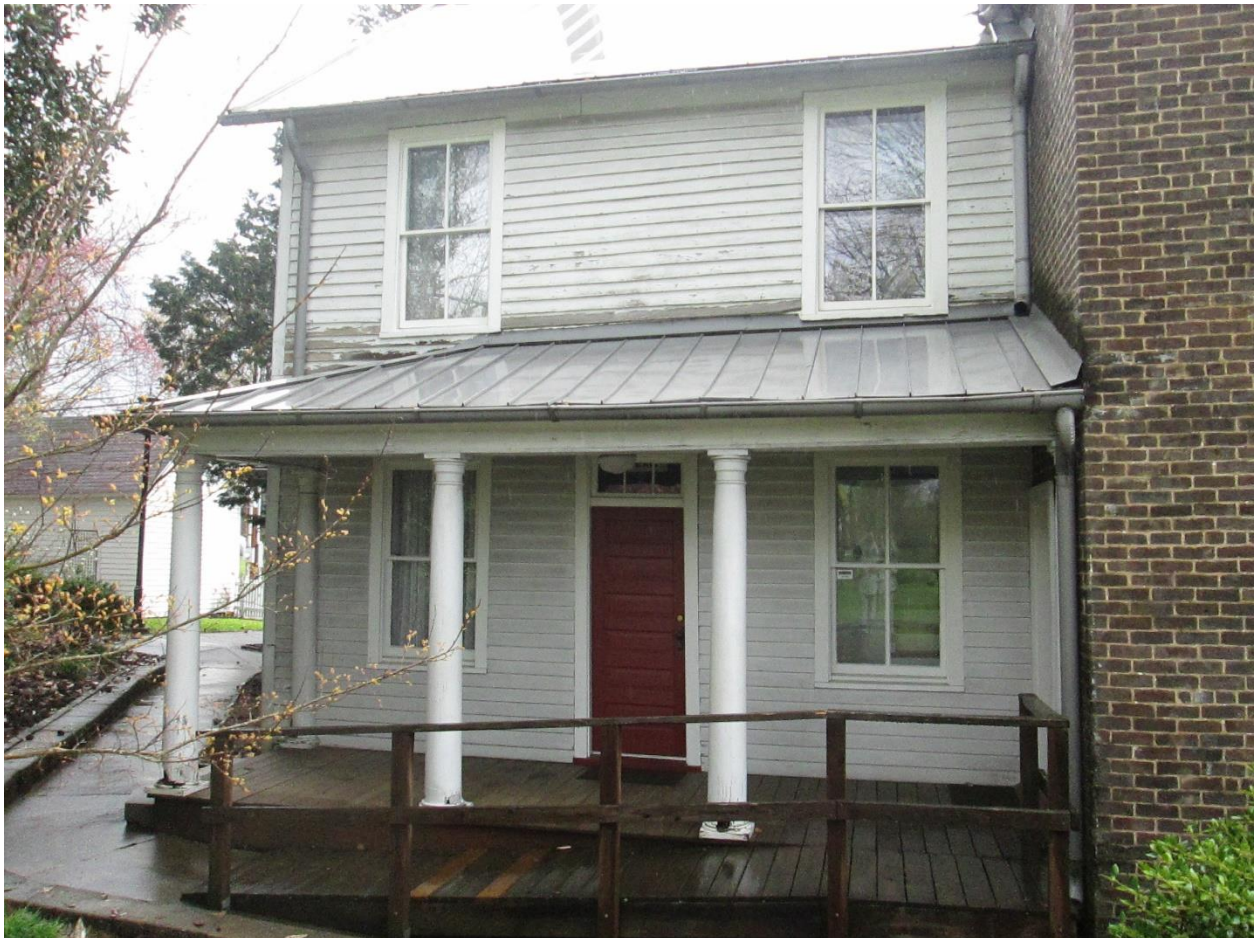
The west elevation includes three freestanding columns and two pilasters. The majority of these columns and pilasters present substantial deterioration (see Photographs 1-3).

Photograph 1. Partial view of the west elevation of the Nance Building, facing east, showing the entire porch including the three freestanding columns and two pilasters.
