# **Health Consultation**

781 Airways Boulevard

OWENS CORNING/EUTHER DAVIDSON  
(a/k/a OWENS-CORNING/EUTHER DAVIDSON SITES)

JACKSON, MADISON COUNTY, TENNESSEE

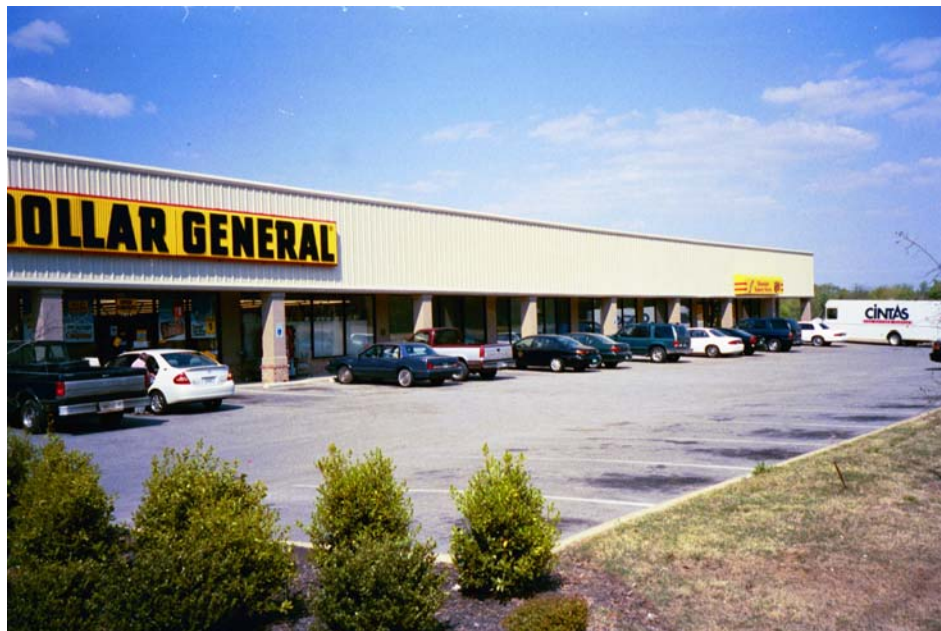
**Figure 1**  
781 Airways Boulevard (Highway 70) building  
Jackson, Madison County, Tennessee  
(Photo credit: David Borowski, TDH 4/15/03)

During an April 15, 2003 site visit, office manager Shirley Jones escorted Bonnie Bashor and David Borowski of EHSS through the 781 Airways Boulevard building in Jackson, TN, ZIP code 38301. Airways Boulevard is the local name for state Highway 70. 781 Airways Boulevard is a small strip mall with three tenants (Figure 1). The tenants, from west to east, or left to right as one faces the building, are Dollar General (781E), WTHCF (781B) (Figure 2), and a bakery store (781A). The WTHCF is a small administrative office with no patient care. In the state office and the neighboring businesses, approximately 30 people are routinely present. During the site visit, investigators learned that the 781 Airways Blvd building footprint might be over a former Superfund site.

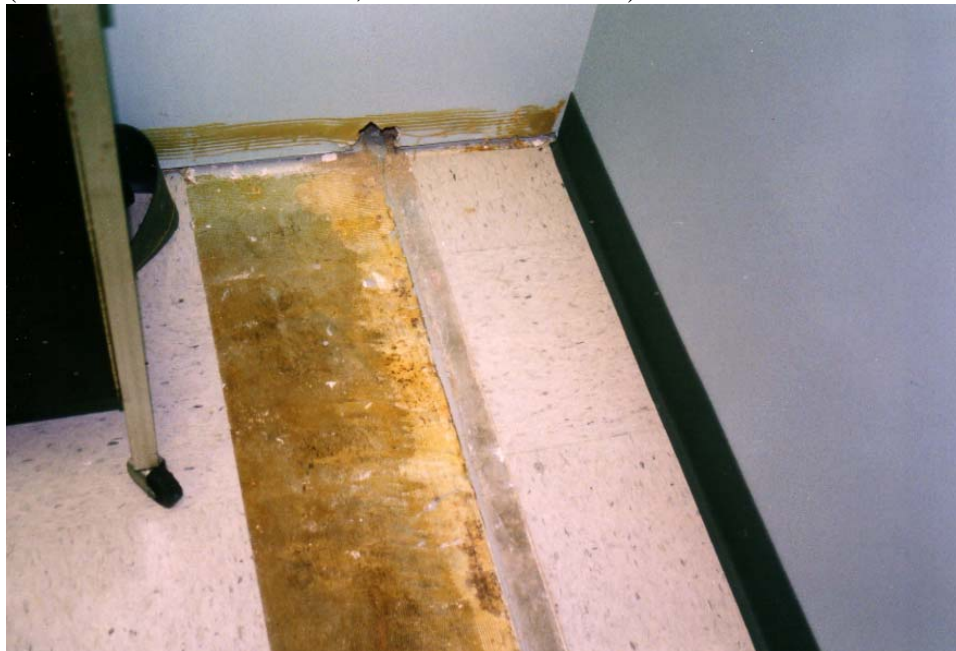
**Figure 5**

In the WTHCF, inspection of buckling floor tile and carpet led to the discovery of cracks in the concrete slab foundation. The building management filled the cracks with foam and caulk. Some of the foundation cracks were true irregular fault lines and others were seams where various concrete slabs joined. Figures 5 and 6 illustrate where the floor buckled and the tile and carpet have been repaired. During the repair process, investigators inspected sewer pipes via tracer and determined they were in good working order, with no leaks.

781B – West Tennessee Health Care Facility break room floor tile buckle  
Jackson, Madison County, Tennessee  
(Photo credit: Shanda Hunt, TDEC DSF 1/09/03)

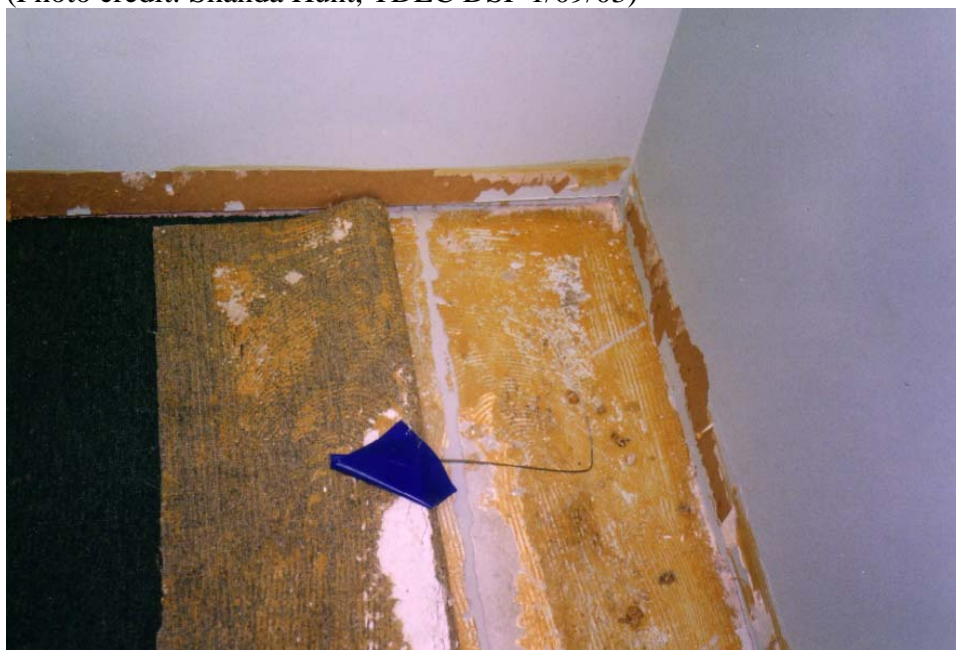
**Figure 6**

781B – West Tennessee Health Care Facility buckle in carpeted cubicles  
Jackson, Madison County, Tennessee  
(Photo credit: Shanda Hunt, TDEC DSF 1/09/03)

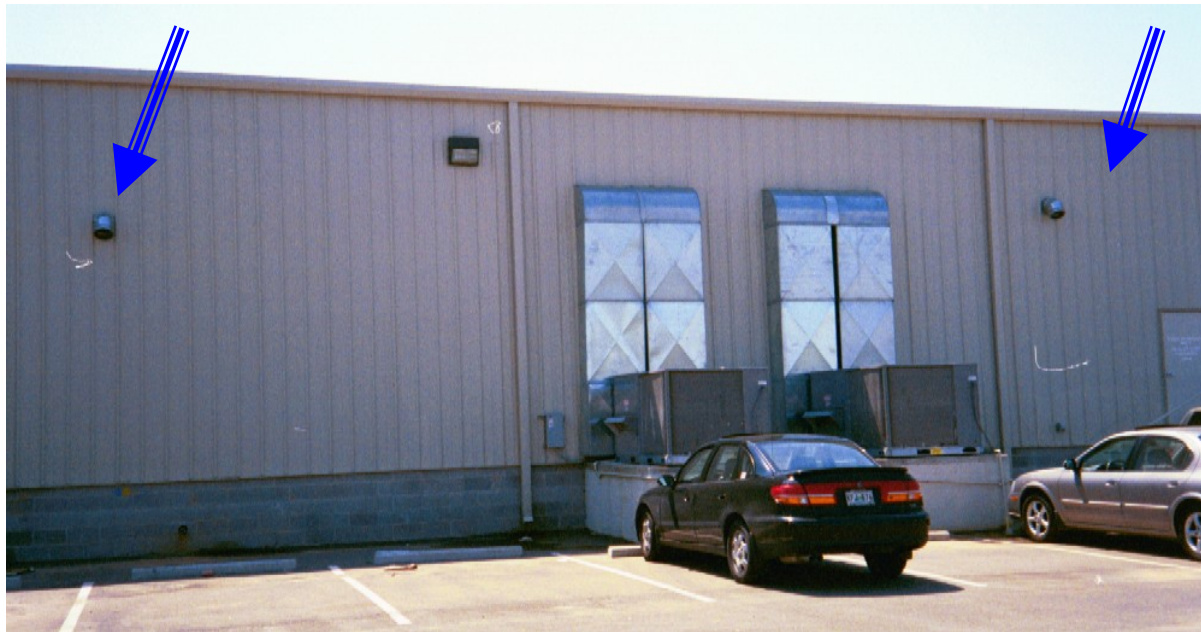
**Figure 7**

781B – Two recently installed vents to increase indoor/outdoor air exchange  
Jackson, Madison County, Tennessee  
(Photo credit: David Borowski, TDH 4/15/03)

To increase air exchange within 781B WTHCF the building management installed additional ductwork, including two vent ducts to exchange indoor and outdoor air (Figure 7). Two 30-foot PVC pipes ventilated with small holes were pushed into the building foundation. This forces the gases to migrate horizontally, out of the foundation rather than vertically into the building (Figure 8).

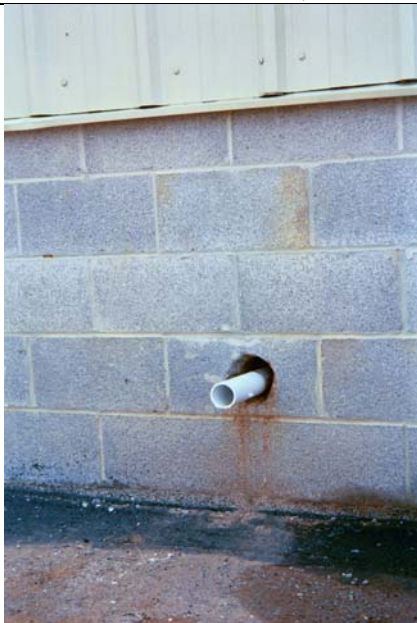
**Figure 8**

781B – One of two recently installed PVC vent pipes through solid foundation  
Jackson, Madison County, Tennessee  
(Photo credit: David Borowski, TDH 4/15/03)

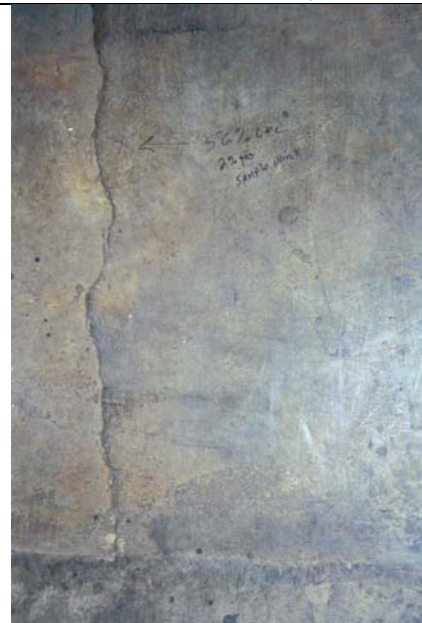
**Figure 9**

781A – Bakery store concrete floor  
“56% LEL 2% gas sample point”  
Jackson, Madison County, Tennessee  
(Photo credit: David Borowski, TDH 4/15/03)

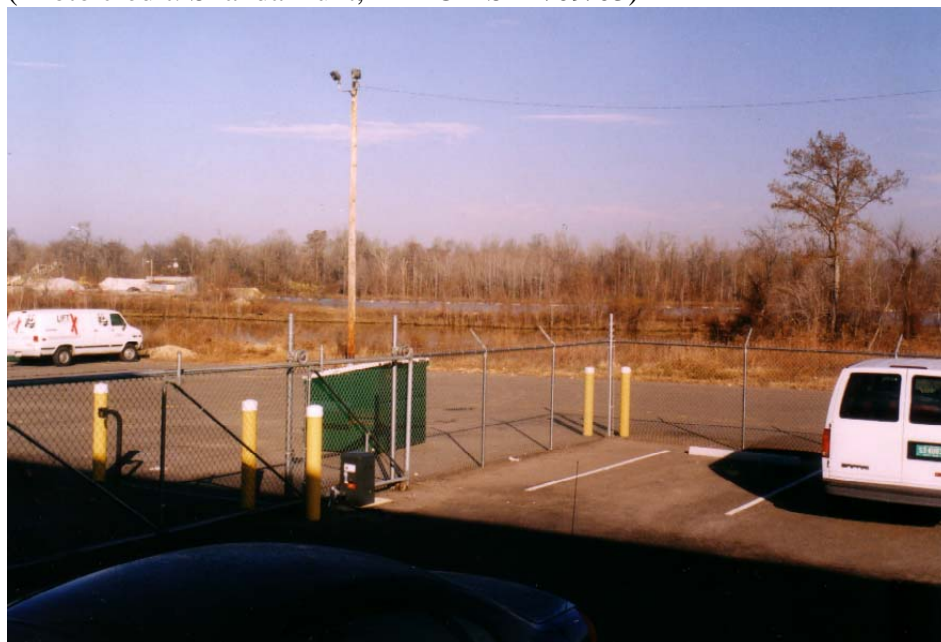
**Figure 10**

781B – Backside parking looking north toward gravel mining and wetlands  
Jackson, Madison County, Tennessee  
(Photo credit: Shanda Hunt, TDEC DSF 1/09/03)

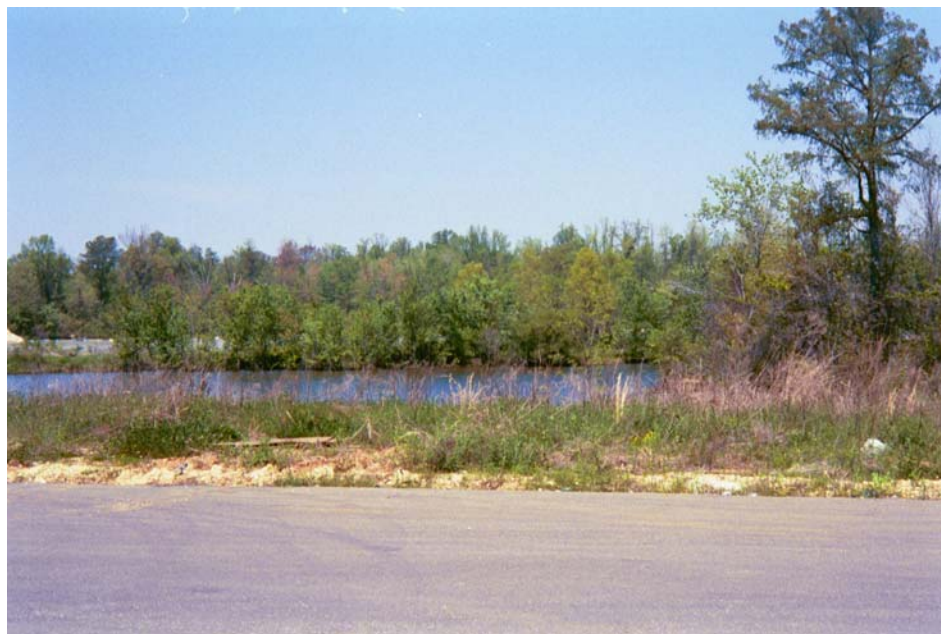
**Figure 11**

781B – Edge of backside parking lot looking north toward gravel mining and wetlands  
Jackson, Madison County, Tennessee  
(Photo credit: David Borowski, TDH 4/15/03)
