Health Consultation

Evaluation of Surface Soil Sampling Results

Swan Pond Recreation Areas

Kingston, Roane County, Tennessee

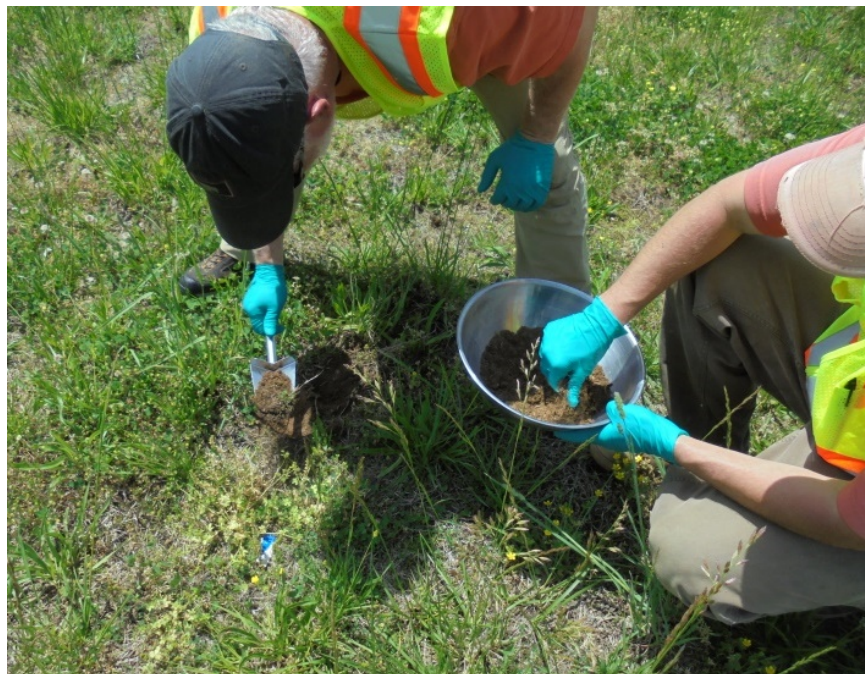
Tennessee Department of Environment and Conservation staff sample soil on the Swan Pond Recreation Areas soccer fields on May 7, 2019.

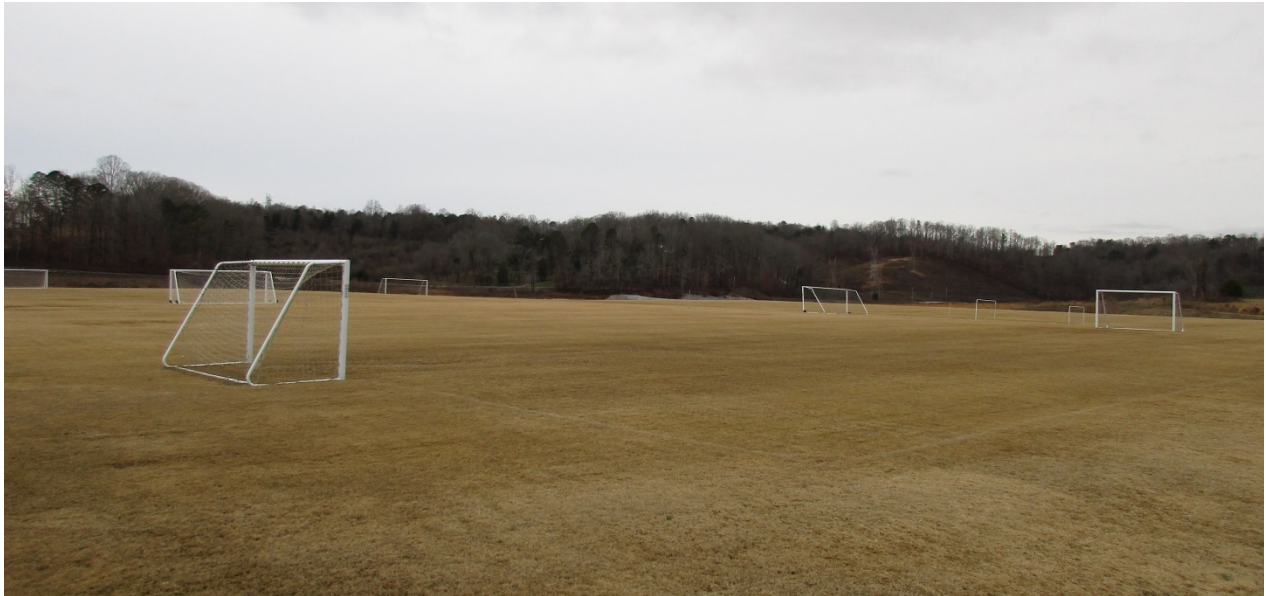
Photo 1. Soccer fields at the Swan Pond Sports Complex. Even in winter the soccer fields have widespread and thick grass cover (Source: TDH, January 3, 2019).

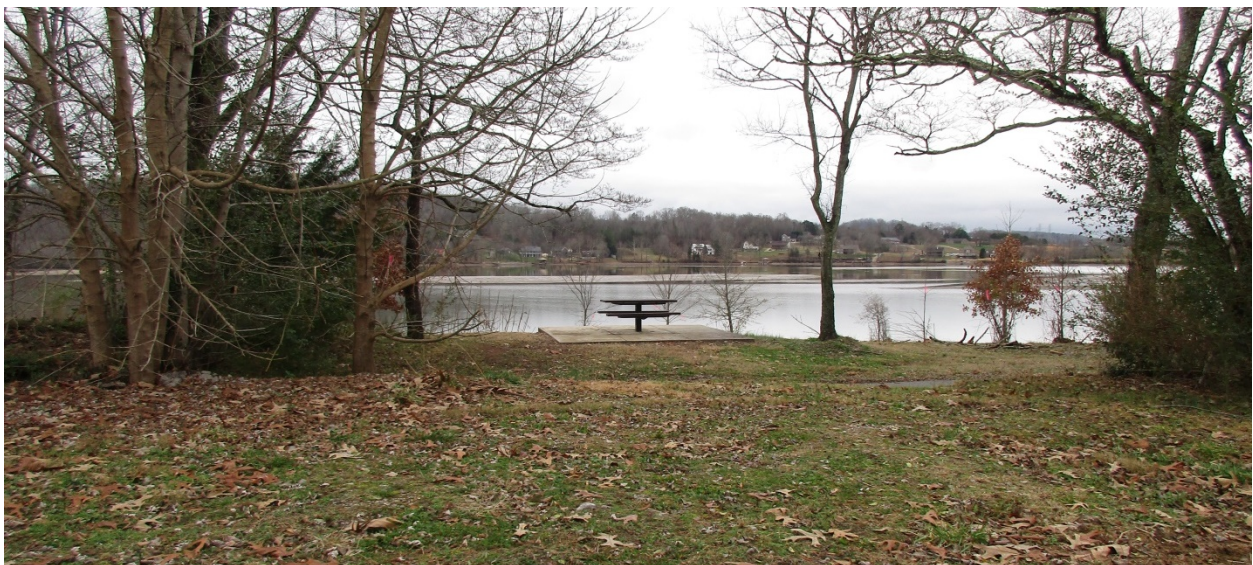
Photo 2. Picnic area in Lakeshore Park. An example of one of the areas where soil samples were collected in the park (Source: TDH, January 3, 2019).

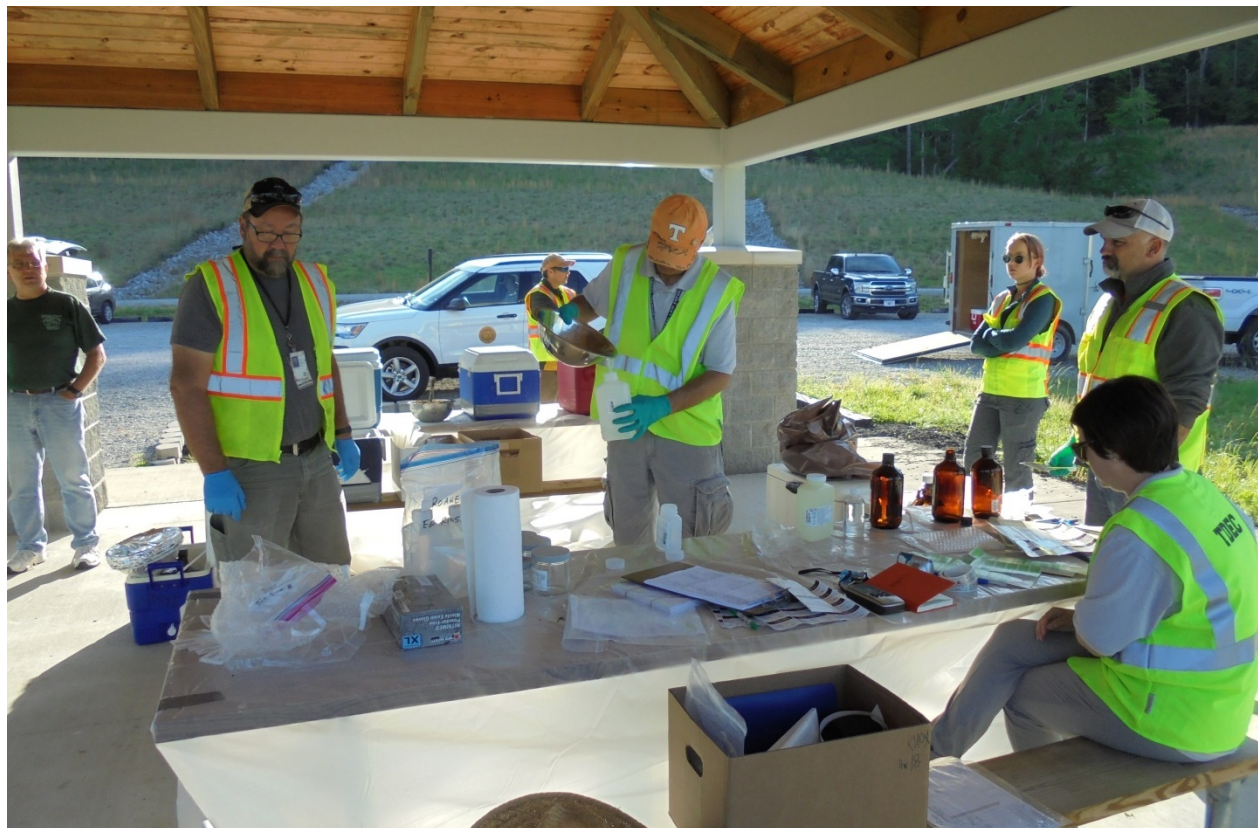
Photo 3. Tennessee Department of Environment and Conservation field sampling staff, TVA field sampling personnel, and a Roane County Environmental Review Board representative look on as an equipment field blank is collected from a sample collection and mixing bowl at the sample management station set up in the onsite pavilion (Source: TDH, May 7, 2019).

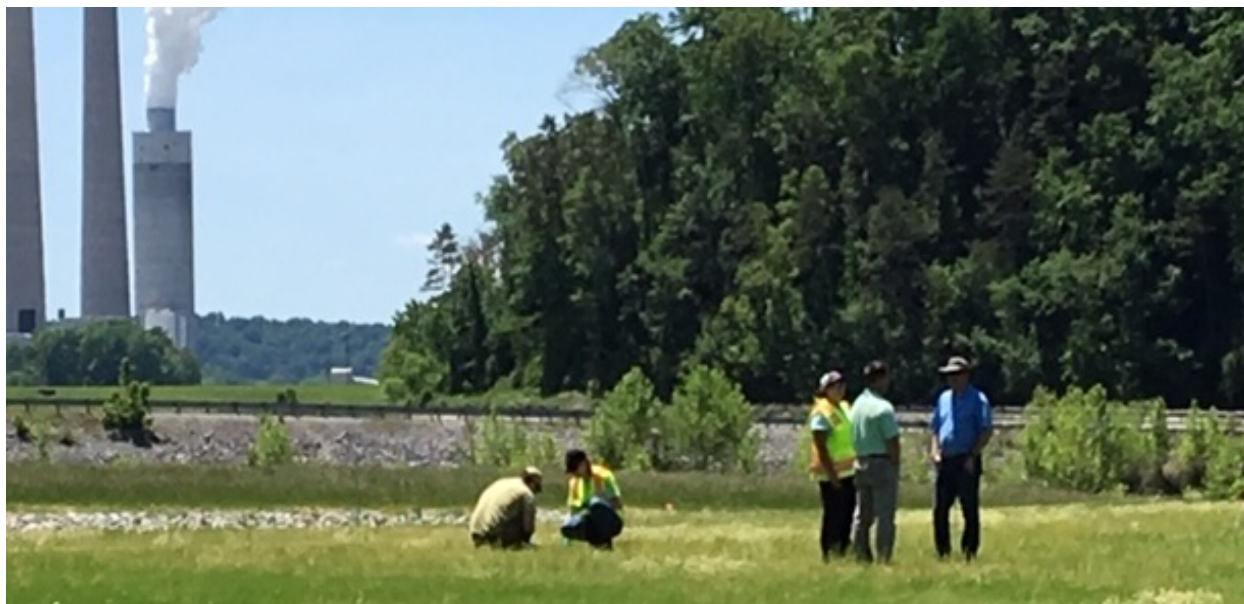
Photo 4. Tennessee Department of Environment and Conservation personnel collect soil samples from one of the soccer fields (Source: TDH, May 7, 2019).

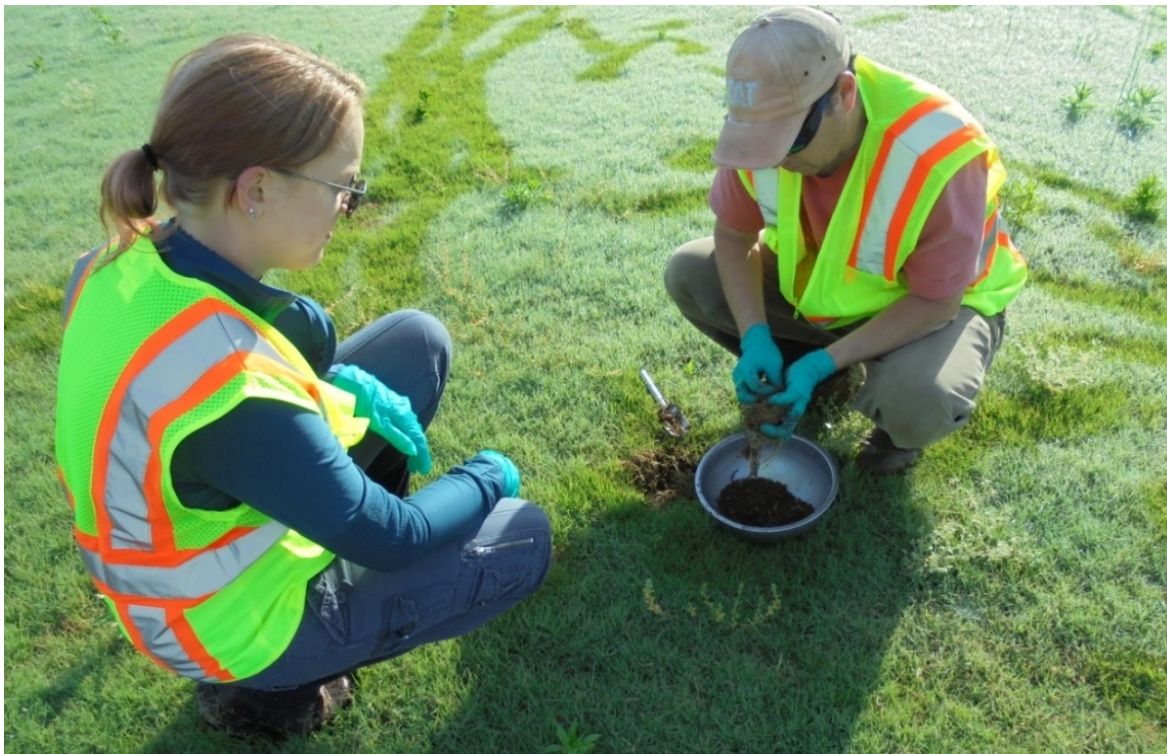
Photo 5. Tennessee Department of Environment and Conservation personnel collect a portion of one of the soil samples from the soccer fields (Source: TDH, May 7, 2019).

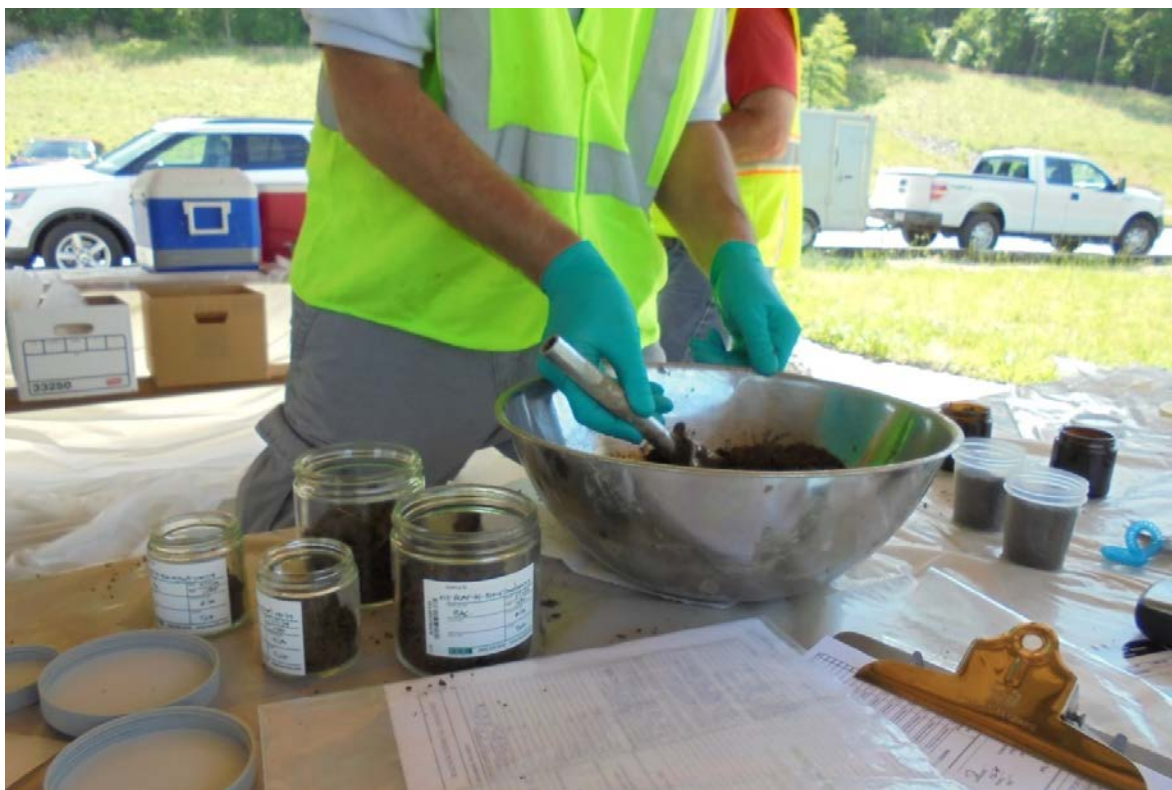
Photo 6. A Tennessee Department of Environment and Conservation geologist mixes the 9 sub-samples at the sample management station in the sports complex pavilion before placing the soil in laboratory-supplied sample containers (Source: TDH, May 7, 2019).

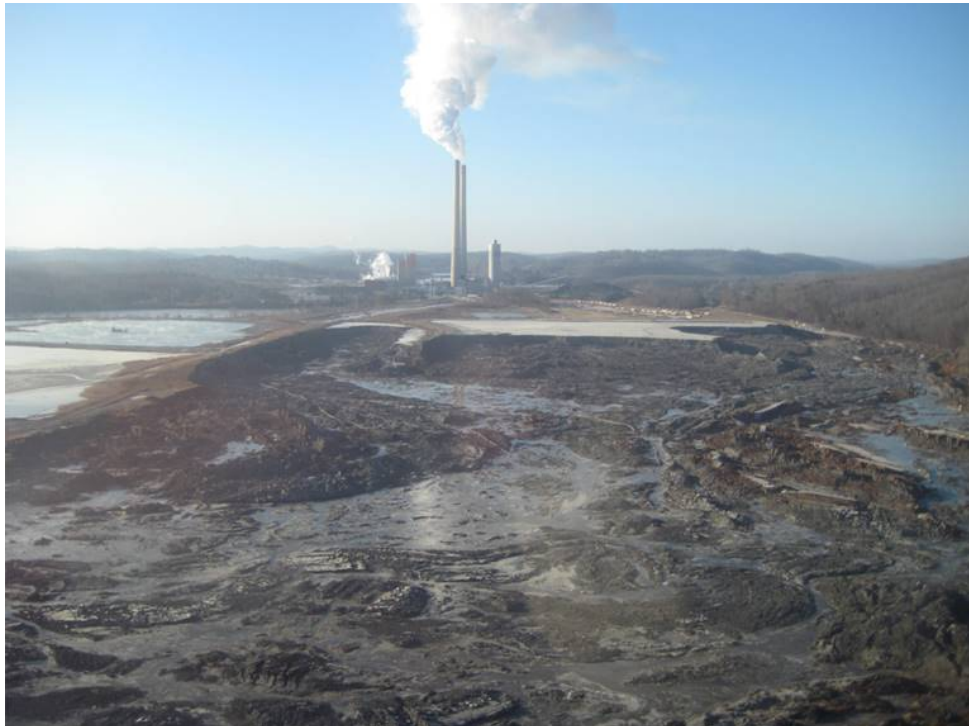
Figure 1. TVA's Kingston Coal Ash Release in December 2008. View is looking south at the breached containment dike area. Note the coal ash spilled into the Emory River toward where Roane County's Swan Pond Sports Complex is now located. Image source: TVA

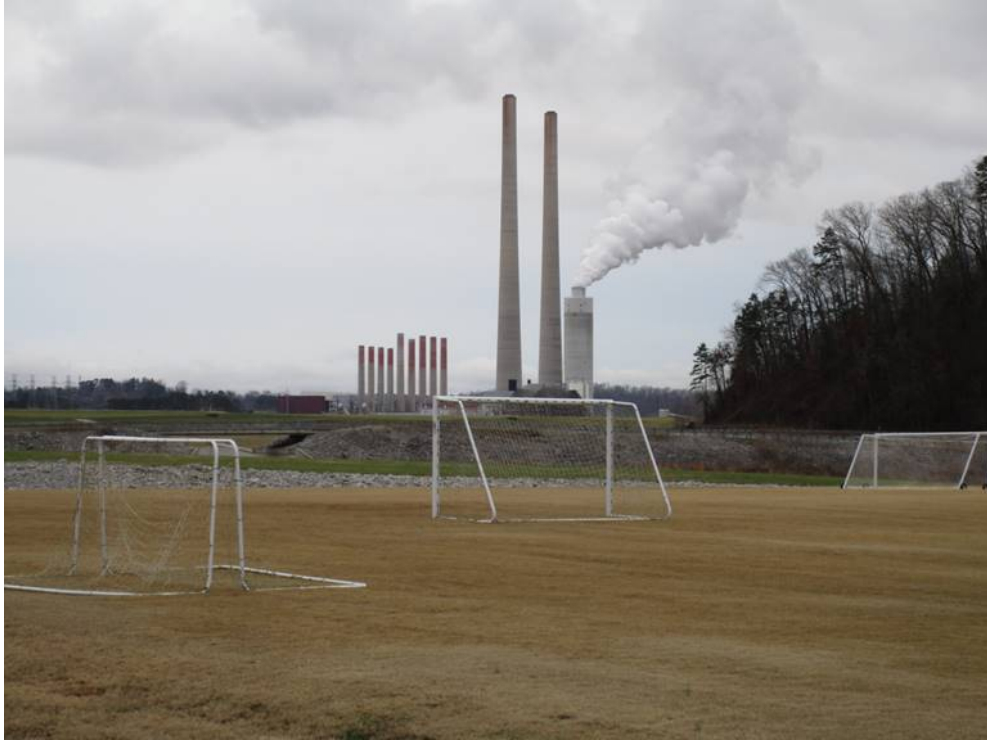
Figure 2. Athletic Field in January 2019. Note the proximity to TVA Kingston. Source: TDH

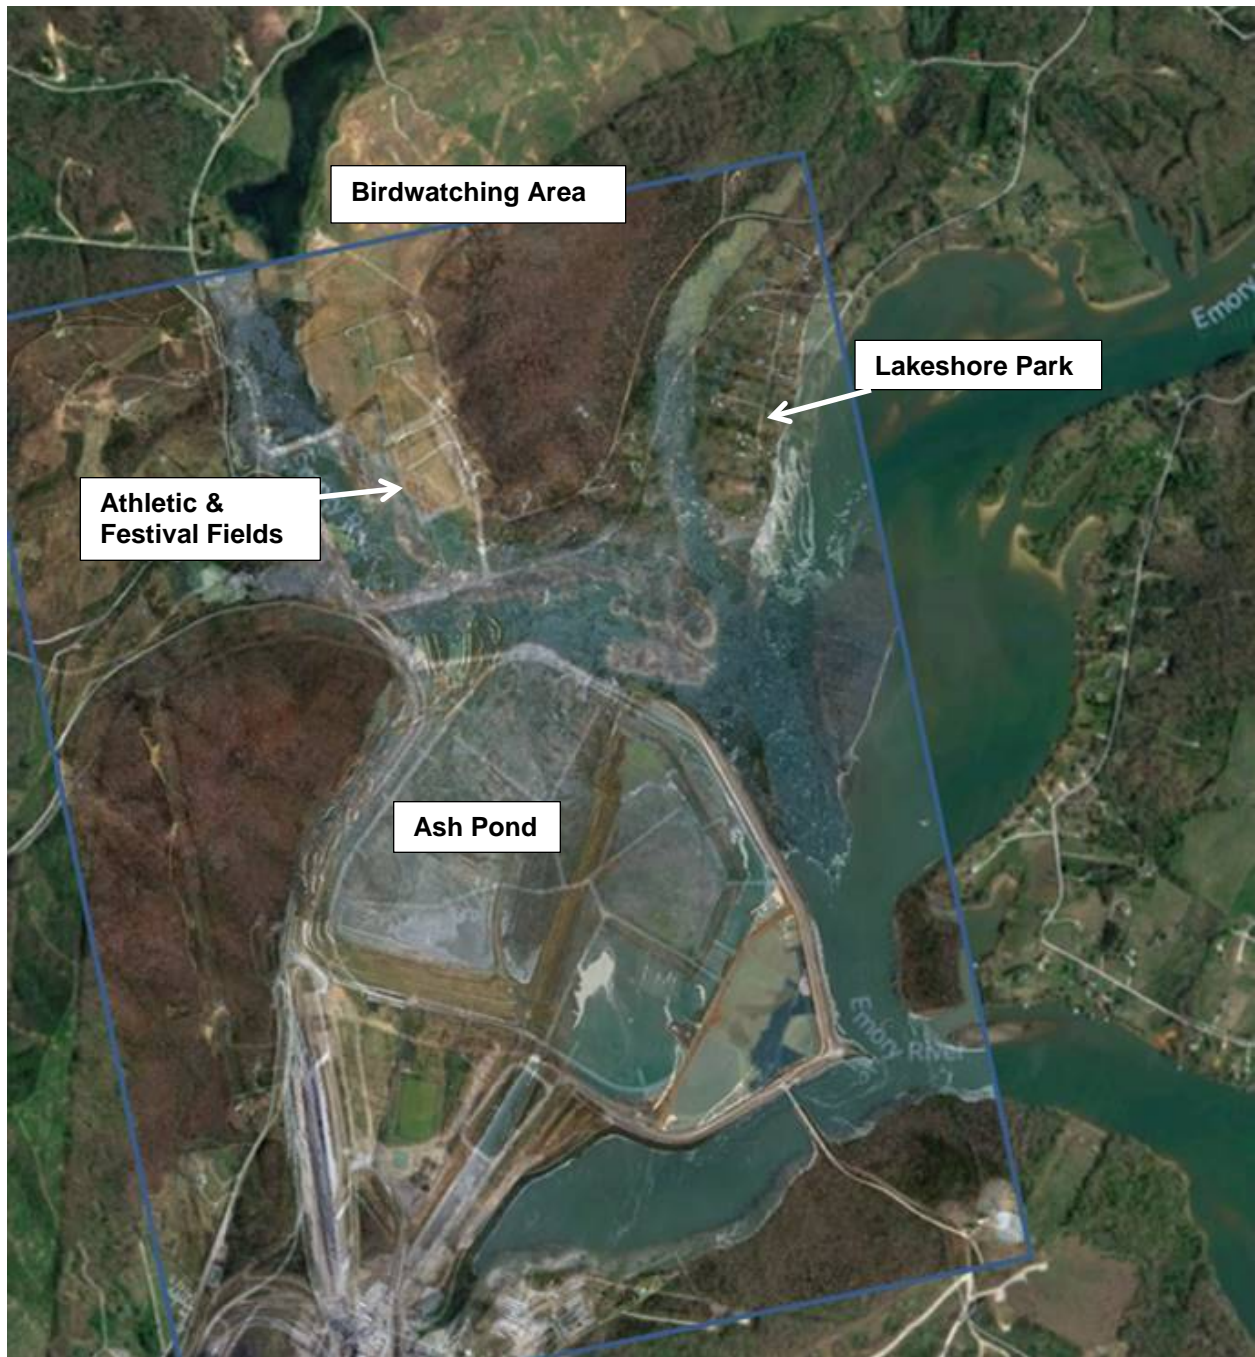
Figure 3. Overlay of the extent of TVA Coal Ash Release with the closed coal ash pond and Athletic & Festival Fields, Birdwatching Area, and Lakeshore Park areas noted.

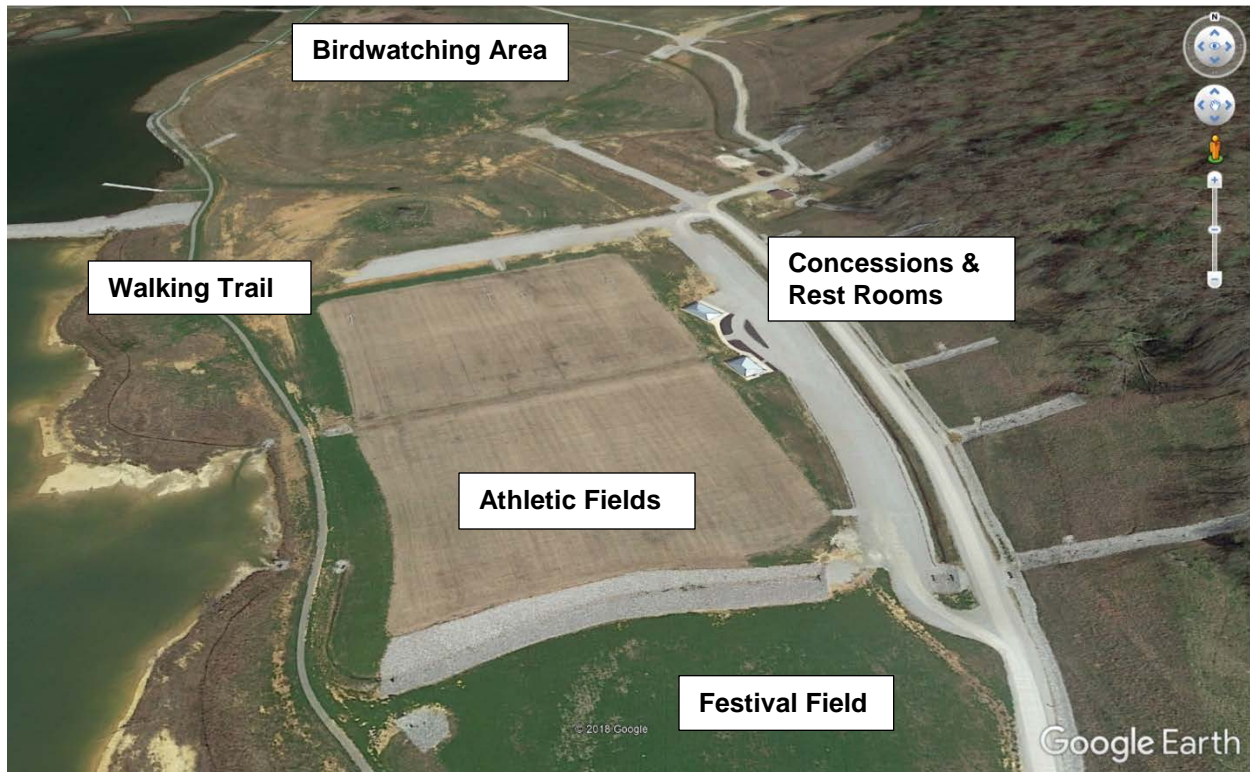
Figure 4. Aerial view of Festival Field (green area in lower center) and Athletic Fields (tan areas in center). Walking Trail is to the left and Birdwatching Area at top. Source: Google Earth 2019

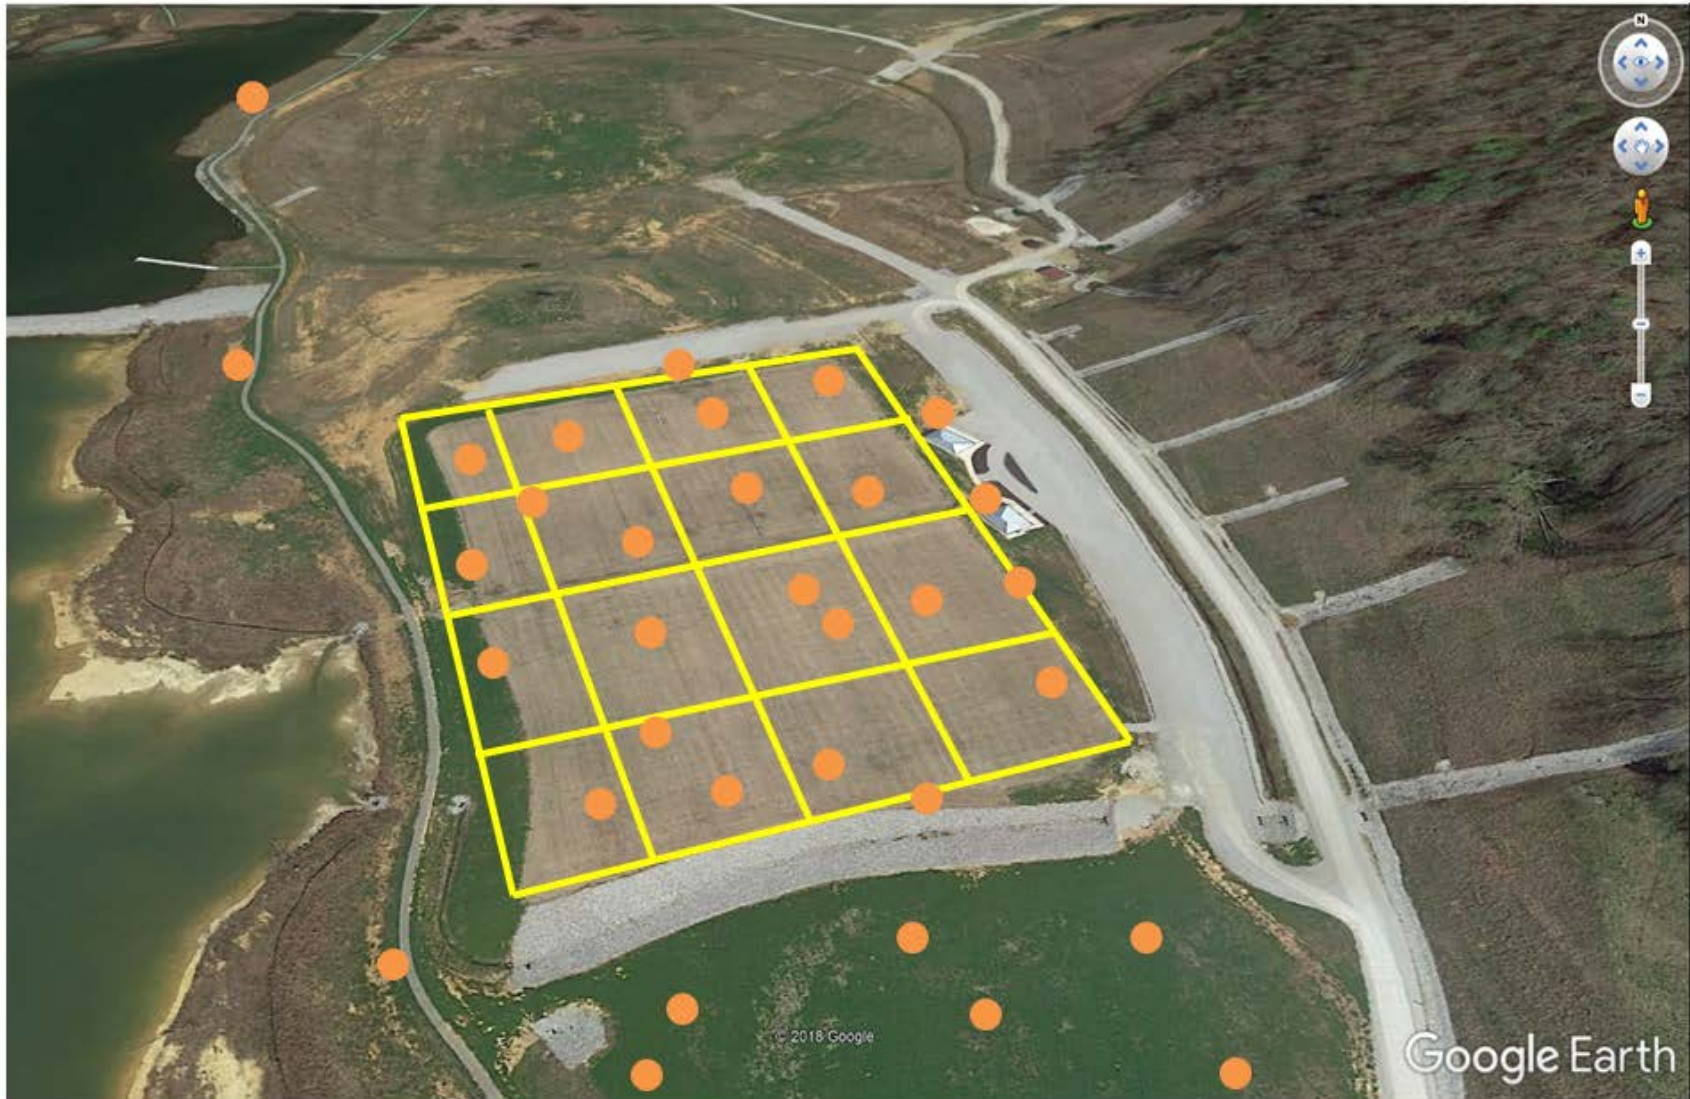
Figure 5. Orange dots represent approximate suggested surface soil sampling locations for Athletic Fields, Festival Field, and Walking Trail to ensure areas are safe for public recreational use. Image source: Google Earth 2019

The Athletic Fields will have the most surface soils tested. Both large athletic fields will be divided into eight approximately equal blocks to ensure soil sampling was performed in all parts of each field. This will ensure the smaller soccer fields will have been evaluated as the fields are configured for different age players. Samples will be collected from any worn areas such as centerfield or in front of the goal areas. Off-field samples will be focused in areas where children may play or sit. Note that TDEC will not rehabilitate the athletic fields after soil samples have been collected.

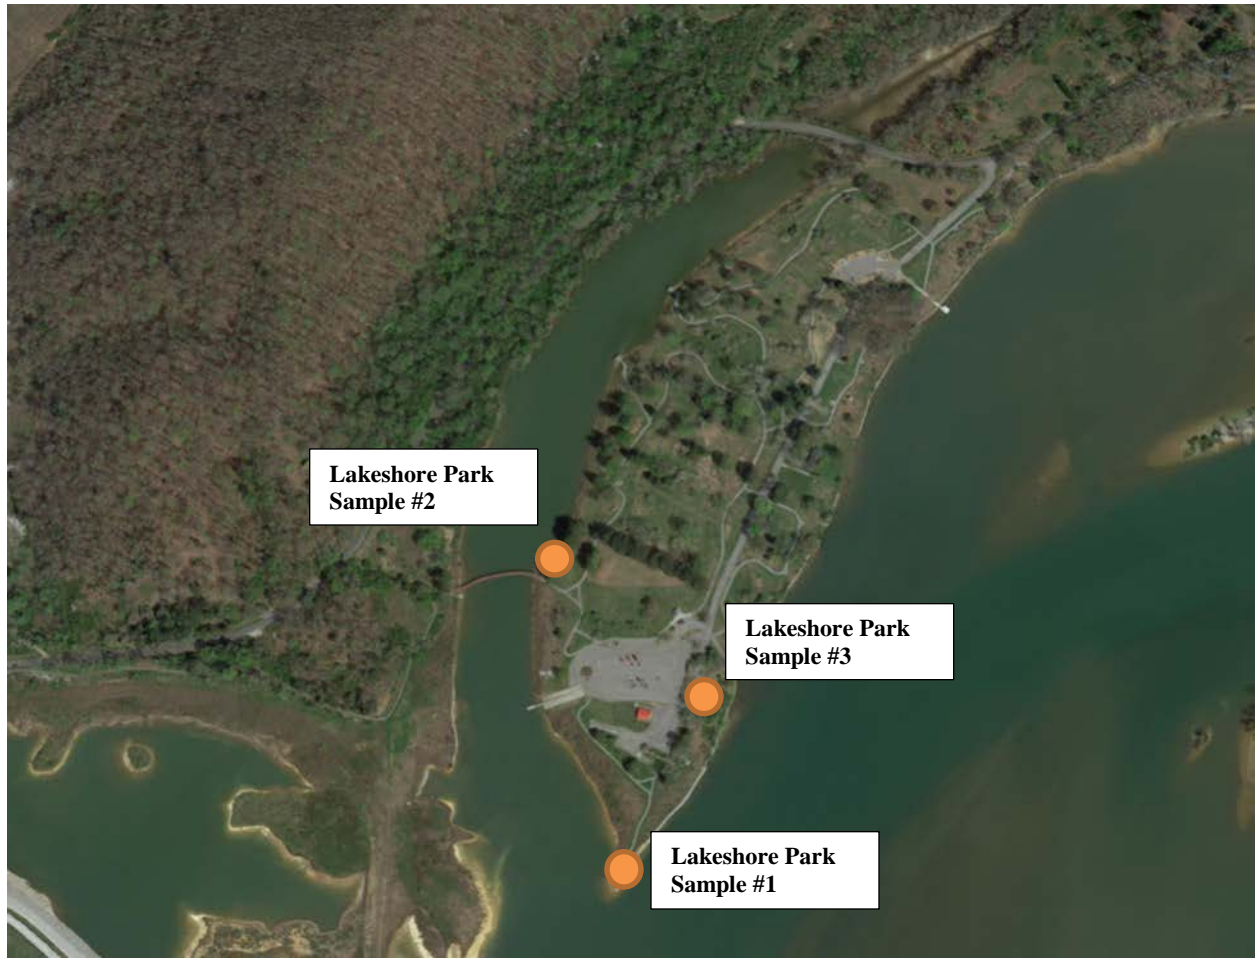
Figure 6. Orange dots represent approximate suggested surface soil sampling locations for Lakeshore Park. Image Source: Google Earth 2019

Both the GPS coordinates and the rationale for the locations for the three samples in Lakeshore Park are provided below in Table 2.

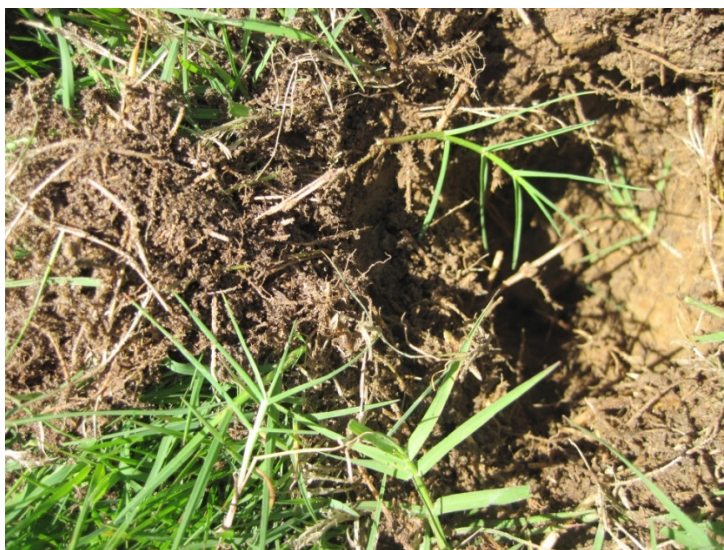
Photo 1. Picture of soil following collection of a single aliquot for Sample # 1 on the Swan Pond Complex Athletic Fields on Monday, May 6, 2019.

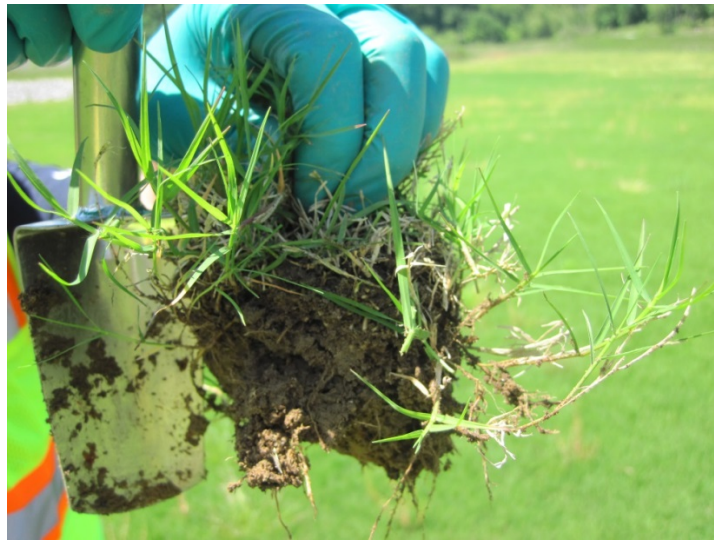
Photo 2. Photo of soil attached to grass following the removal of the surface layer at the Swan Pond Complex Athletic Field on Monday, May 6, 2019.

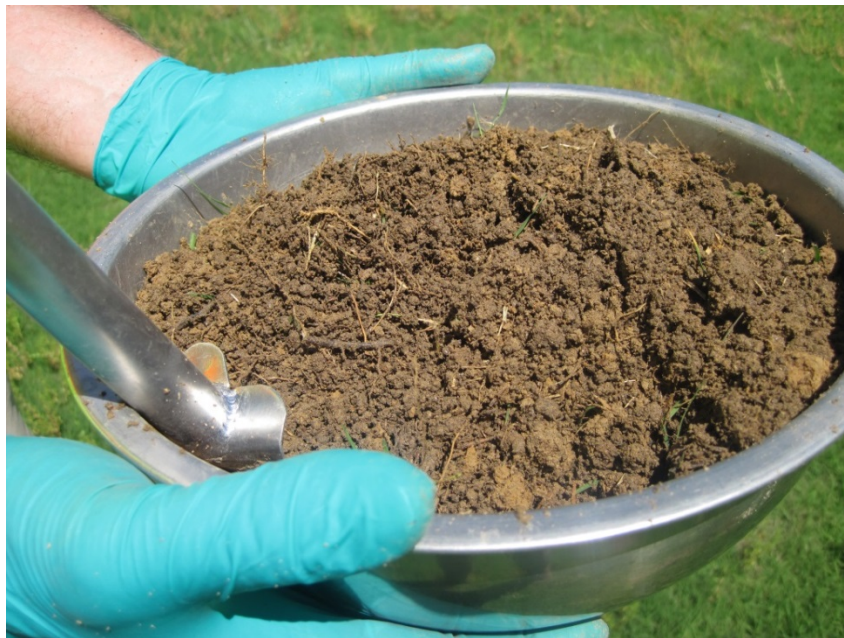
Photo 3. Bowl following collection and homogenization of 9-point composite sample # 1. Photo taken on Monday, May 6, 2019.

All samples collected were composed of 9-point composite aliquots, each aliquot being collected from within the sample grid. As each aliquot was collected using a stainless steel trowel and added to the stainless steel bowl, the sample was continuously mixed to homogenize the aliquots.

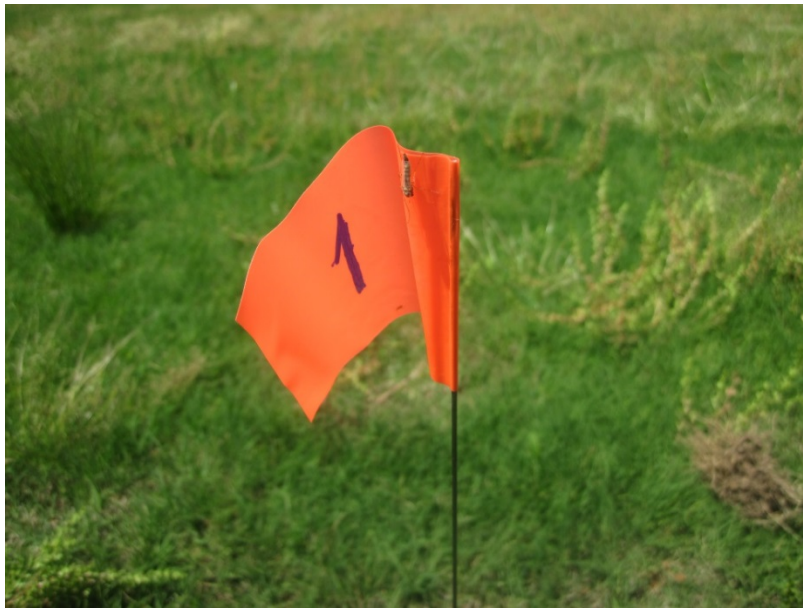
Photo 4. Pin flag marked for sample #1. Photo taken on Monday, May 6, 2019.

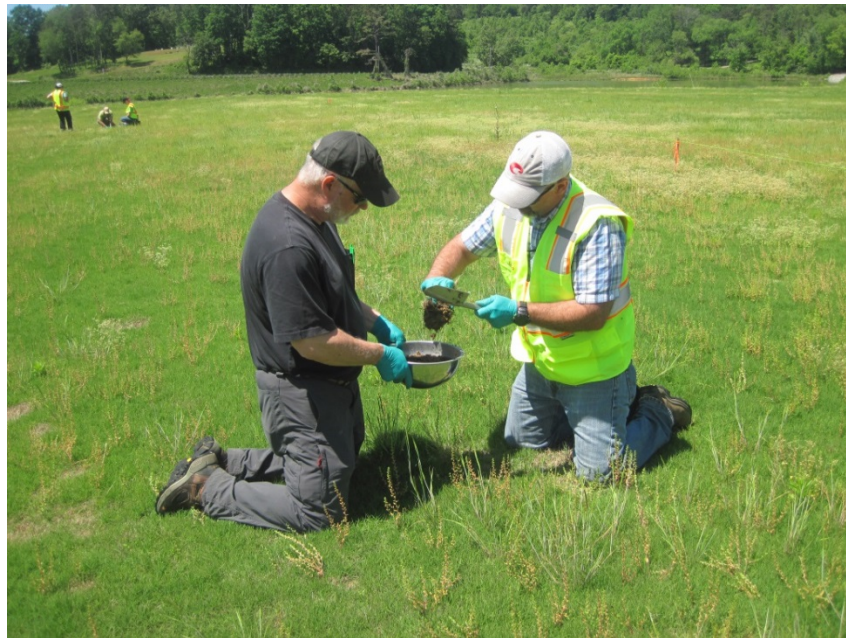
Photo 5. Collection of sample #2 on the Swan Pond Complex Athletic Field on May 6, 2019. A second sampling team collects another sample in the background.

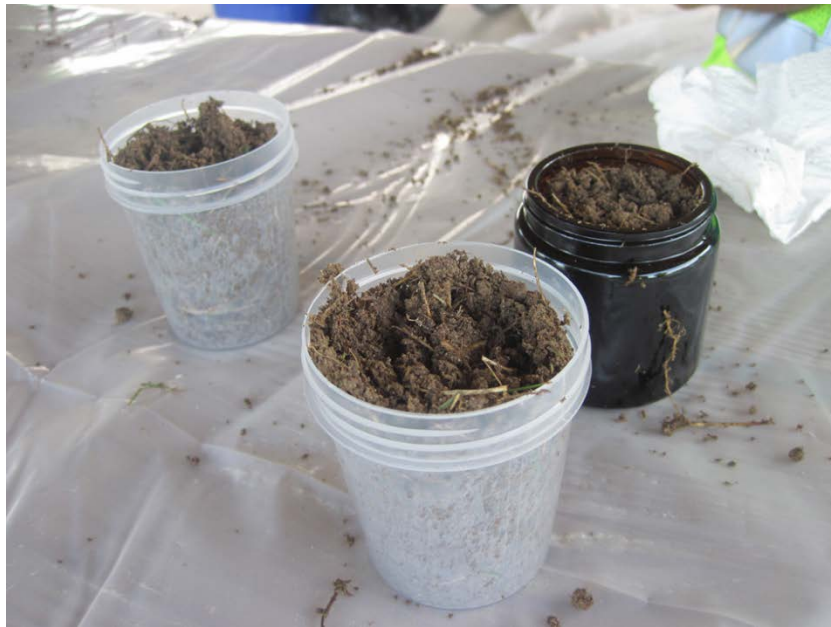
Photo 6. *Samples in lab analysis jars during sample splitting with TVA. Each sample was sent for analysis of the following contaminants- metals, Radium 226 and 228, fluoride, sulfide and chloride and Polarized Light Microscopy (PLM). Photo taken Monday, May 6, 2019.*

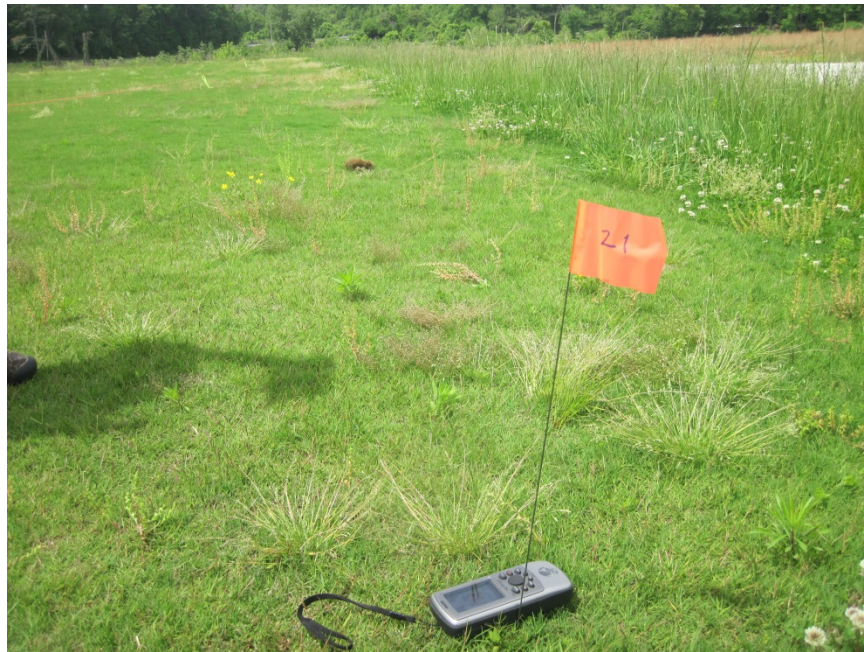
Photo 7. Determination of GPS coordinates for Sample #21. Photo taken Tuesday, May 7, 2019.

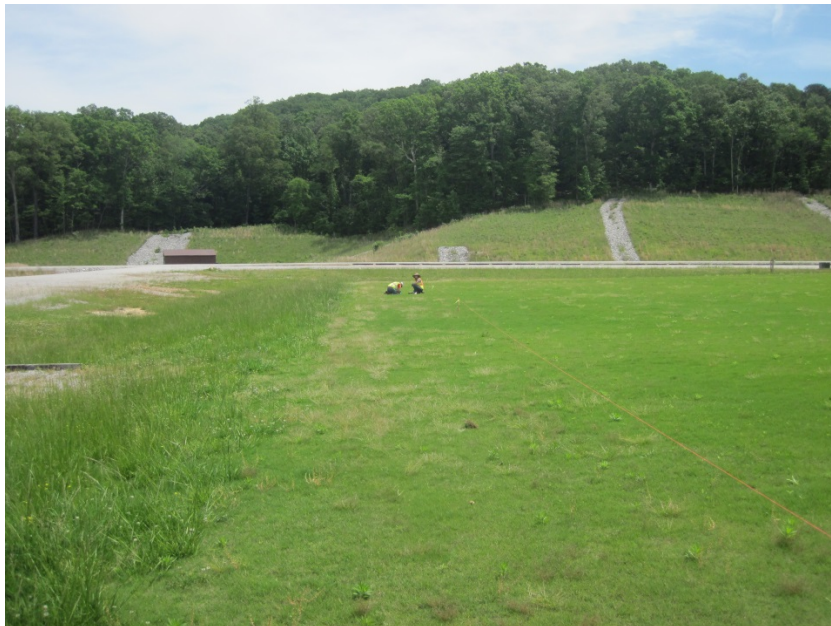
Photo 8. Sampling team collecting composite sample # 22, in the drainage swale on the western most boundary of the athletic field. Photo taken Tuesday, May 7, 2019.

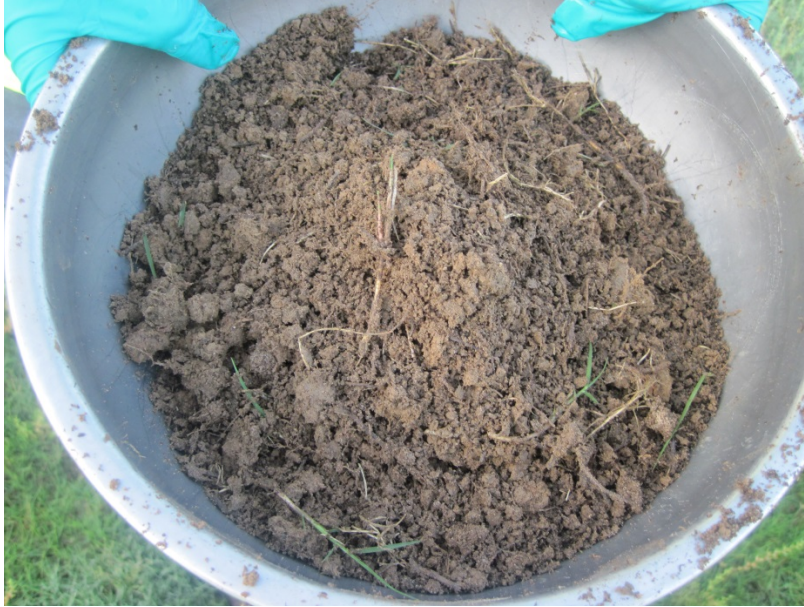
Photo 9. Bowl following 9-point composite sample collected for Sample #25. Photo taken Tuesday, May 7, 2019.

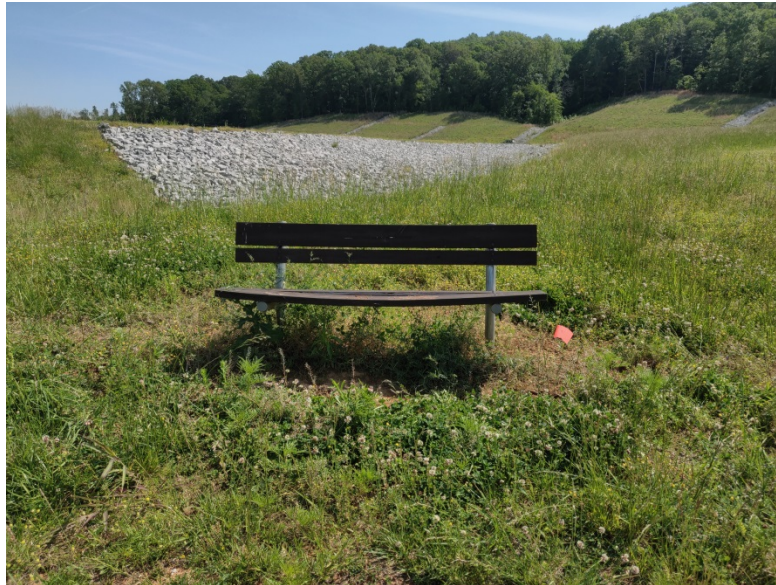
Photo 10. Location for collection of Sample #31. This is the eastern most park bench on the walking trail, closest to the entrance to the Swan Pond Athletic Complex. Directly behind the park bench is the Festival Field that was also sampled during this event. Photo taken Wednesday, May 8, 2019.

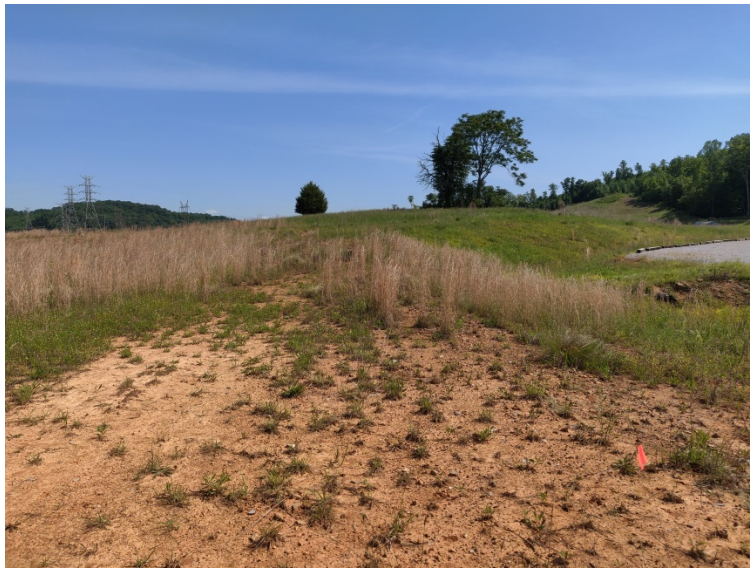
Photo 12. Location for collection of Sample # 32. This is an area approximately at the midpoint of the walking trail (between the entrance to the Swan Pond Athletic Complex and the bird watching area). This area included bare spots and is easily accessible to people coming from the athletic fields following games. Photo taken Wednesday, May 8, 2019.

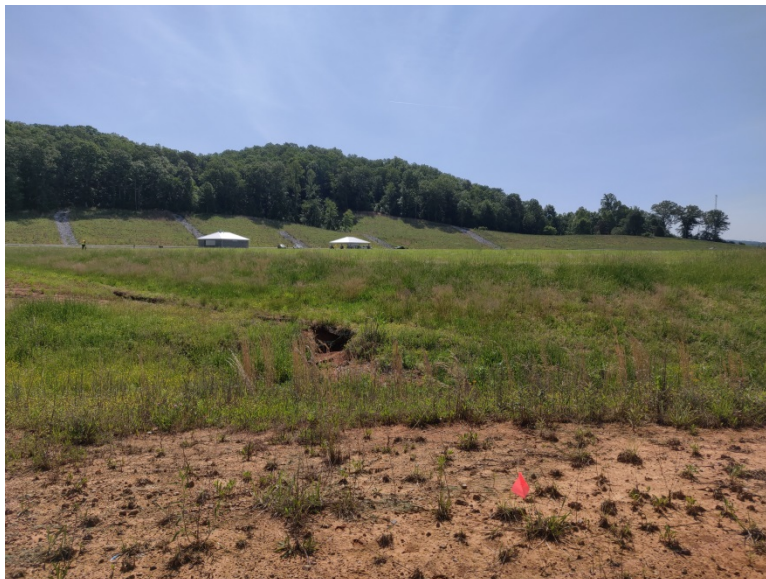
Photo 13. Flag indicating the area for collecting Sample #32. In the background, both the concession stand/restrooms (left) and the pavilion (right) on the other side of the Athletic Fields are observed. Photo taken Wednesday, May 8, 2019.

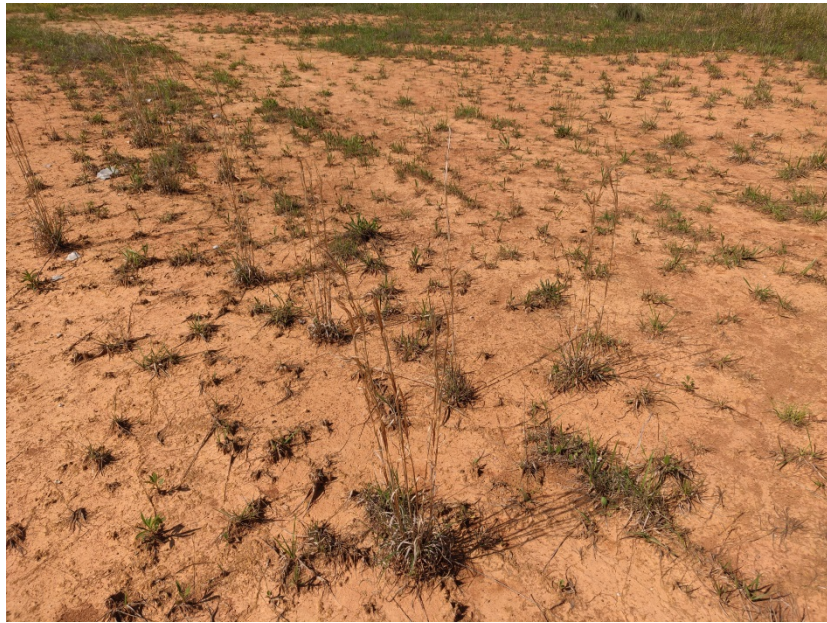
Photo 14. Close up of the bare dirt surrounding Sample #32. Bicycle tracks and dog paw prints were observed in the dirt, providing evidence that this area is frequented by people using the athletic fields. Photo taken Wednesday, May 8, 2019.

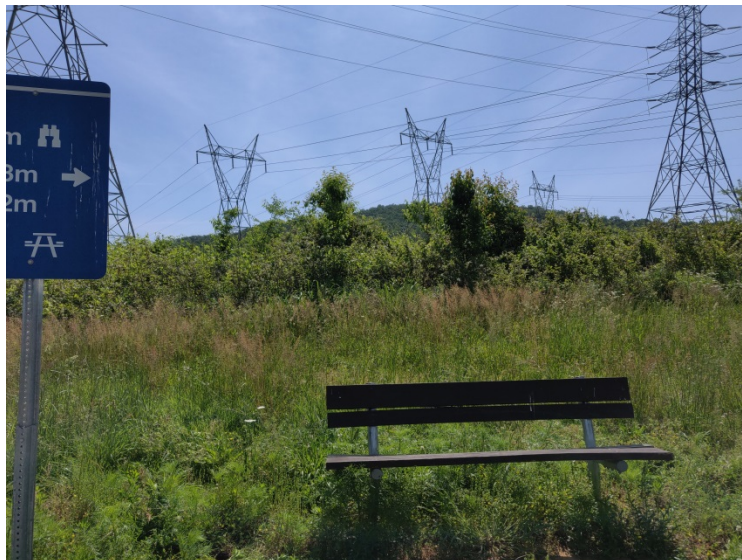
Photo 15. Location for the collection of Sample #33. This is the most west park bench along the walking trail; it is also the closest to the Bird Watching Trail area. Photo taken Wednesday, May 8, 2019.

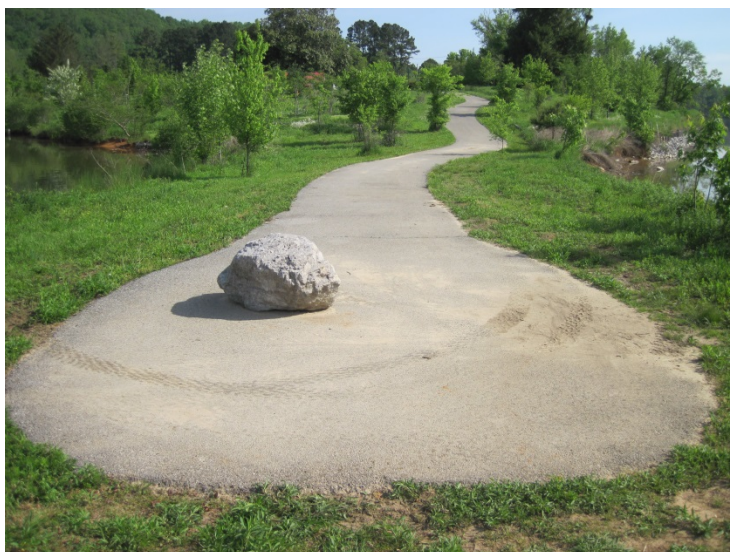
***Photo 17.** Lakeshore Park trail leading to the shore fishing where Sample #34 was collected. Photo taken Wednesday, May 8, 2019.*

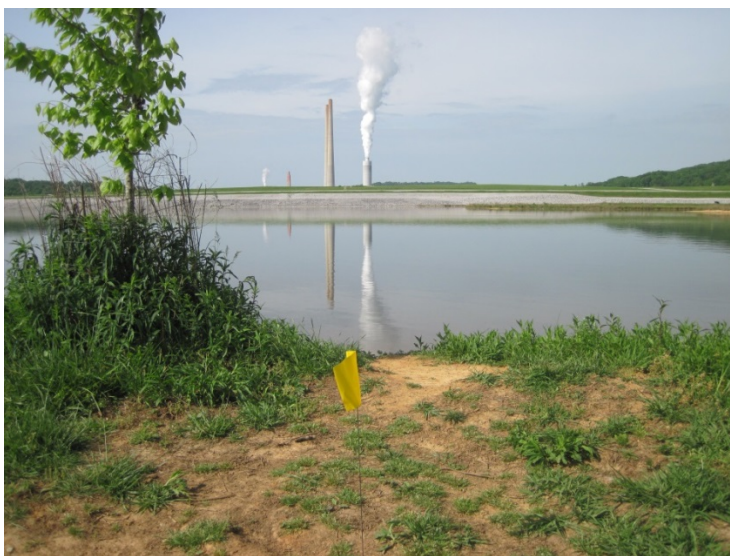
***Photo 18.** Sampling location for Sample # 34 in Lakeshore Park (targeted following evidence of shore fishing). The TVA Kingston Fossil Plant can be observed in the background. Photo taken on Monday, April 29, 2019.*

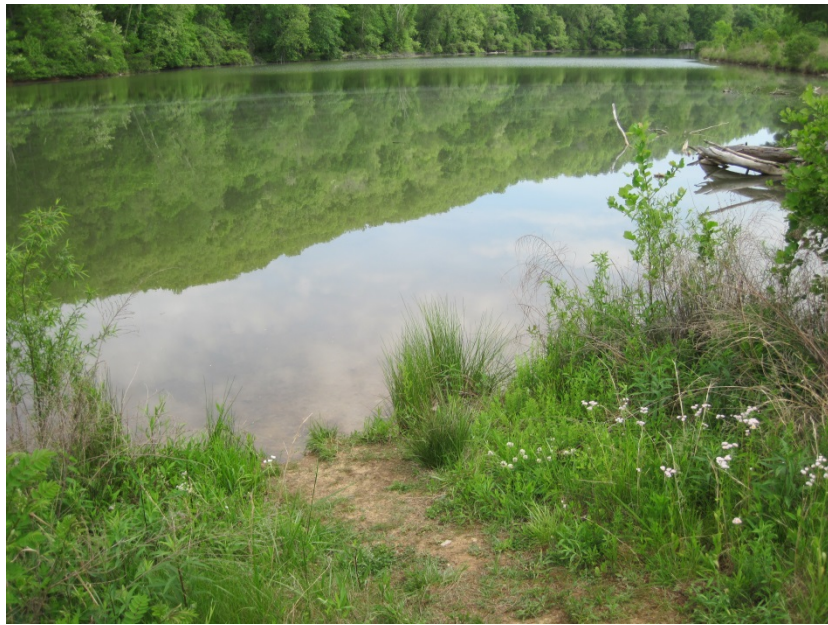
Photo 19. *Reconnaissance for sampling locations in Lakeshore Park. This area, adjacent to the bridge on the walking trail, was selected for Sample #35. There was also access to the water for shore fishing and evidence that the area had been utilized recently (discarded refuse found along shoreline). Photo taken on Monday, April 29, 2019.*

A second area to the right of the bridge over the water was identified as another area where shore fishing is popular (Sample # 35). This area consisted of a flat, barren area of ground adjacent to the water. Evidence of recent fishing activities was also observed here. Finally, the last area identified for sample collection was the picnic area right off the main walking trail near the parking lot. This area (Sample # 36) could be used for picnics and grilling, as it is in close proximity to the water as well as the trail. A grill is nearby and the area looked like it had been used for this purpose recently.
