Health Consultation

Evaluation of Surface Soil Sampling Results

Swan Pond Recreation Areas

Kingston, Roane County, Tennessee

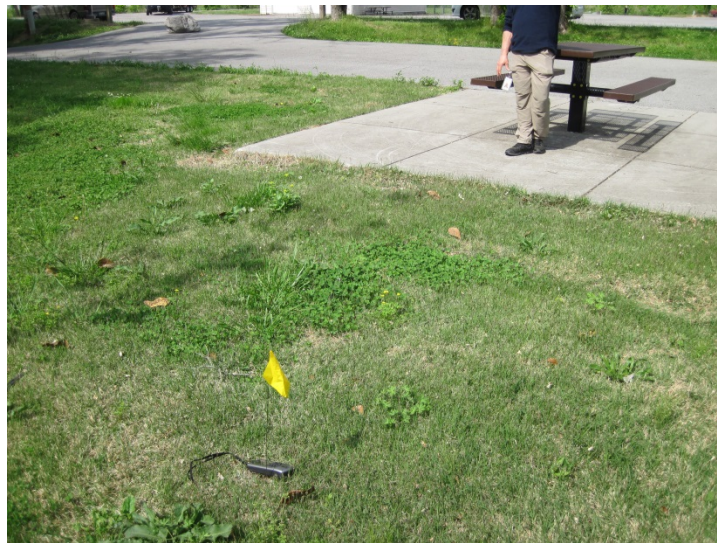
Photo 20. *GPS Coordinates to identify sampling location #36, around picnic table and area directly off of walking trail in Lakeshore Park. Photo taken on Monday, April 29, 2019.*

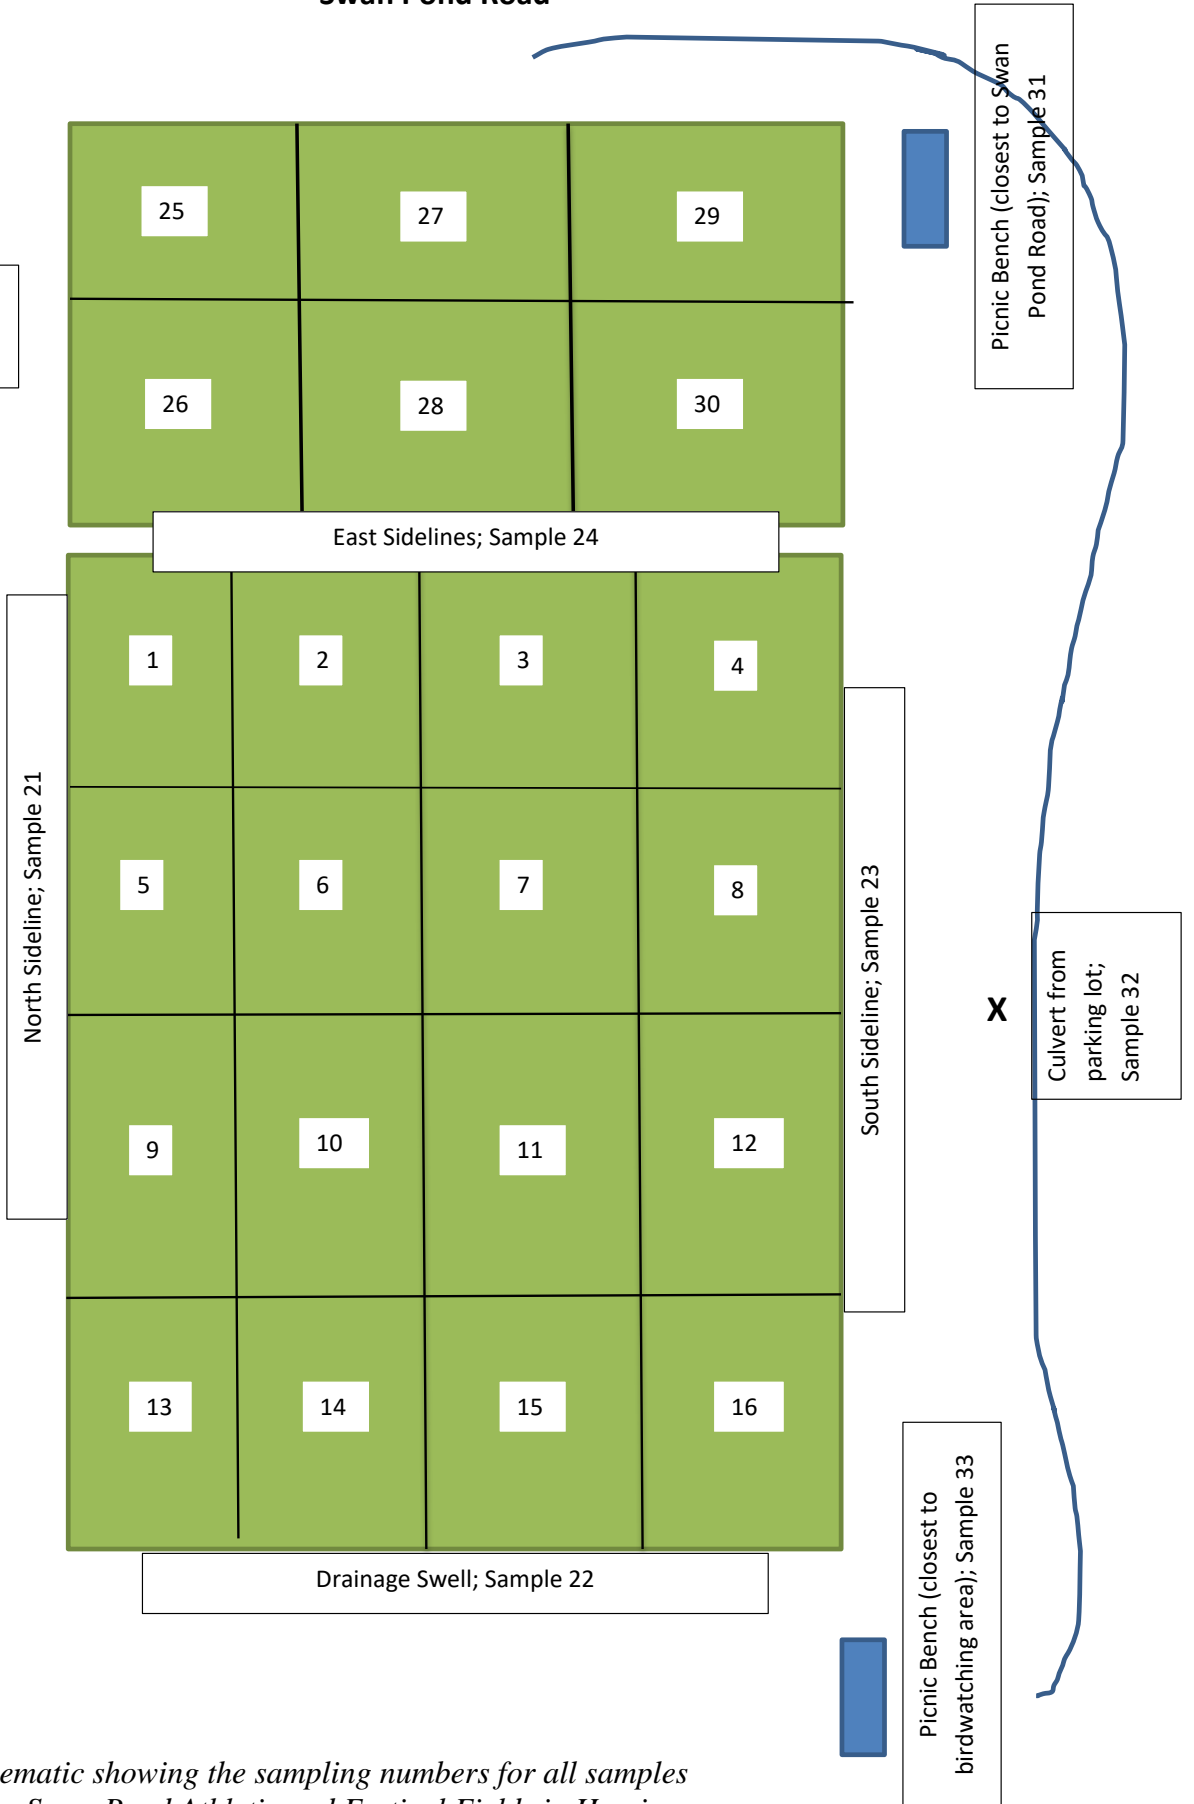
Figure 1. Schematic showing the sampling numbers for all samples collected at the Swan Pond Athletic and Festival Fields in Harriman, TN.
