TDOT SHORT LINE RAILROAD ASSESSMENT

Produced for the Tennessee Department of Transportation | 10307-09 | September 2020

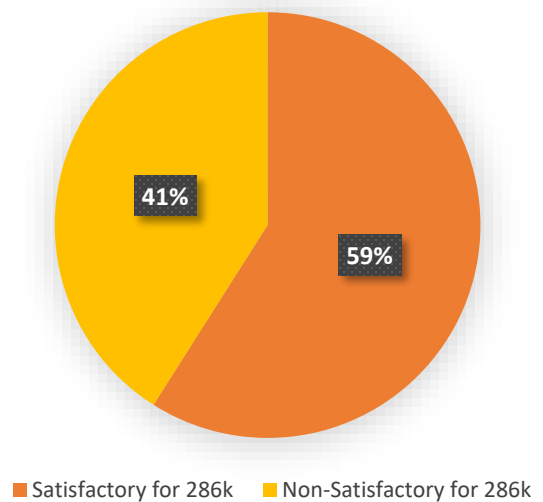
Overall 286k GVW Rail Operation

By Rail Size, the breakdown is as follows:

- 59% of rail sizes are Satisfactory for 286k GVW Operation (100# rail and above)
- 41% of rail sizes are Non-Satisfactory for 286k GVW Operation (less than 100# rail)
