## **14. Caught in auger**

A **54-year-old** employee died after falling into an auger at his workplace. The victim operated a wheel-blast machine that sends large quantities of steel abrasive shot at high velocity into a blast chamber. The purpose of this is to remove rust and scale from the large construction equipment attachments built by the company. A large skidder arm attachment weighting 1500 pounds was run through the machine and exited into the blow-off area. Soon after the part arrived in the blow-off area, the victim walked out onto the metal-bar-grating floor of the blow-off area to attach a lifting strap to the skidder arm. The bar-grating covers three hoppers each equipped with a nine-inch screw auger. This hopper system reclaims the shot media that accumulates on the part as it passes through the blast machine. As the victim walked onto the bar-grating floor, the bar grating that he was walking on fell from its support bracket and dropped into the reclaim hopper. The victim fell into the 42-inch deep hopper and his legs became caught in the auger as it turned approximately 25 rotations per minute. Sometime later two co-workers began looking for the victim and someon

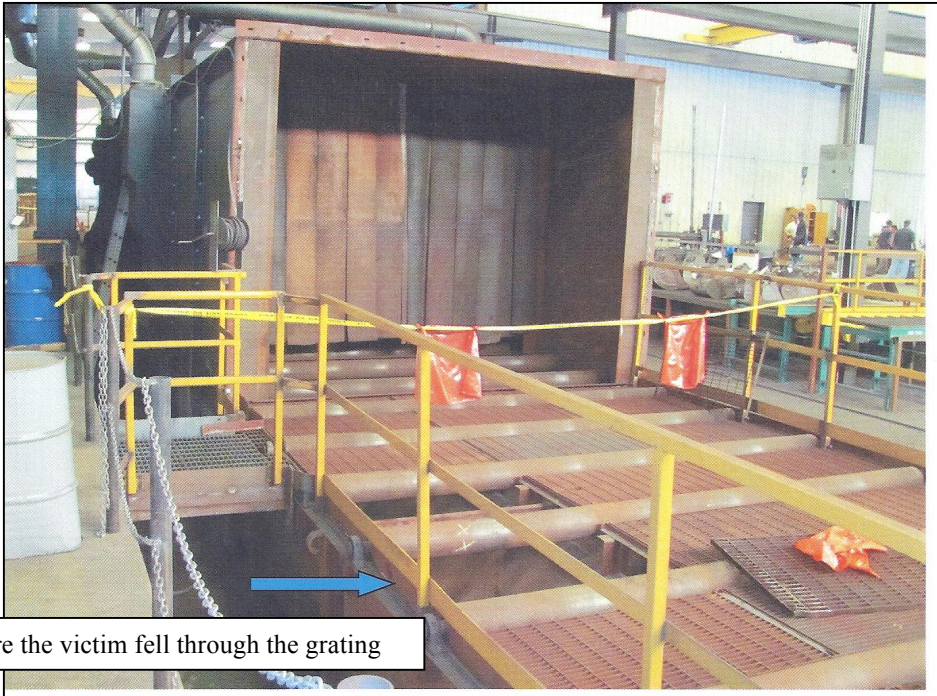
Where the victim fell through the grating

Item 1 T.C.A. 50-3-105(1)	The employer did not furnish employment and a place of employment which were free from recognized hazards that were causing or likely to cause death or serious physical harm to employees in that the metal-bar-grating floor panels were not secured by anchoring them to their supports by positive mean or were not of adequate size to prevent them from being accidentally dislodged into the reclaim hopper.

Item 2 1910.23(c)(3)	Regardless of height, open-sided floors, walkways, platforms, or runways above or adjacent to dangerous equipment were not guarded with a standard railing or toe board.

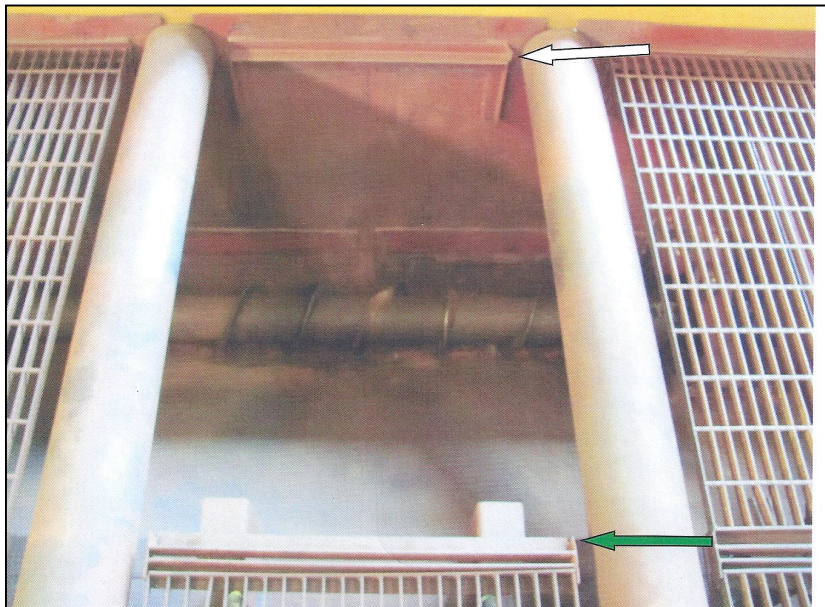
Opening that the victim fell through and auger he fell onto
