7. Excavation collapse

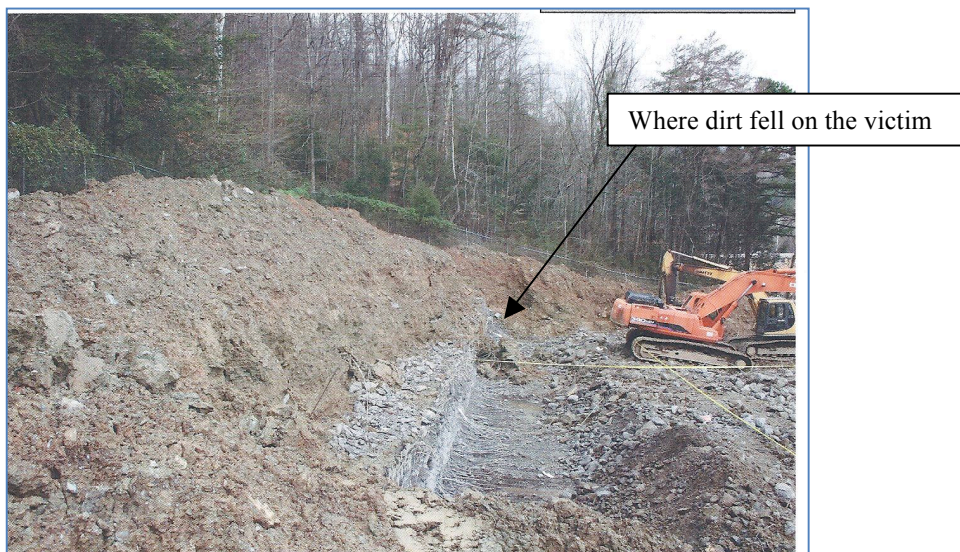
A **57-year-old** construction worker died when he was covered by soil when a bank collapsed. The victim's employer was subcontracted to demolish standing walls of an equalization basin at a water treatment facility. Several months previously the east wall of the basin had separated from the north, south, and baffle walls, leaving extensive damage to the structure. When the concrete walls were demolished, only the earthen walls were left standing. The earthen walls were not sloped, shored, braced or protected; the upper earthen wall had a bench installed but it was not to proper standards. The victim was cutting the rebar that had tied into the foundation of the equalization basin and into the back concrete wall so that the removal of the foundation could be started. As he was doing so a large section of the earthen wall sheared off above him and covered him with soil. He died from the injuries he sustained.

Item 1a 1926.651(j)(1)	Adequate protection was not provided to protect employees from loose rock or soil that could pose a hazard by falling or rolling from an excavation face in that such protection did not consist of scaling to remove loose material; installation of protective barricades at intervals as necessary on the face to stop and contain falling material; or other means that provide equivalent protection

Item 1b 1926.652(a)(1)	Each employee in an excavation was not protected from cave-ins by an adequate protective system designed in accordance with TOSHA standards in 29 CFR 1926.652.

Item 2 1926.651(k)(1)	Daily inspections of excavations, the adjacent areas, and protective systems were not made by a competent person for evidence of a situation that could result in possible cave-ins, indications of failure of protective systems, hazardous atmospheres, or other hazardous conditions.
