**#9: Crushed By – Inspection #317752582**

A **46 year old male** employee was pinned between two semi trailers. A newly hired employee was operating the truck on the day of the incident while the victim, the trainer, was riding as a passenger. The employees traveled to Counce, TN to pick up their load for delivery. Upon entering the lot, the desired trailer was identified and the victim requested that the trainee back the semi tractor under the trailer. The trainee stated that he backed the semi tractor under the trailer and pulled the tractor forward to ensure the trailer king pin was inside the semi tractor’s hitch, locked in place and secured. Once secured, the victim exited the semi tractor, walked around the front of the truck, down the driver’s side of the truck and began hooking the trailer up to the semi tractor. The trainee stated that he looked into his driver’s side mirror and observed the victim hook both air lines going from the semi tractor to the trailer in the glad hands by standing on the back portion of the truck. The victim climbed off the truck and began to raise the landing gear for the trailer. The trainee stated, at this point he left the drivers’ seat and

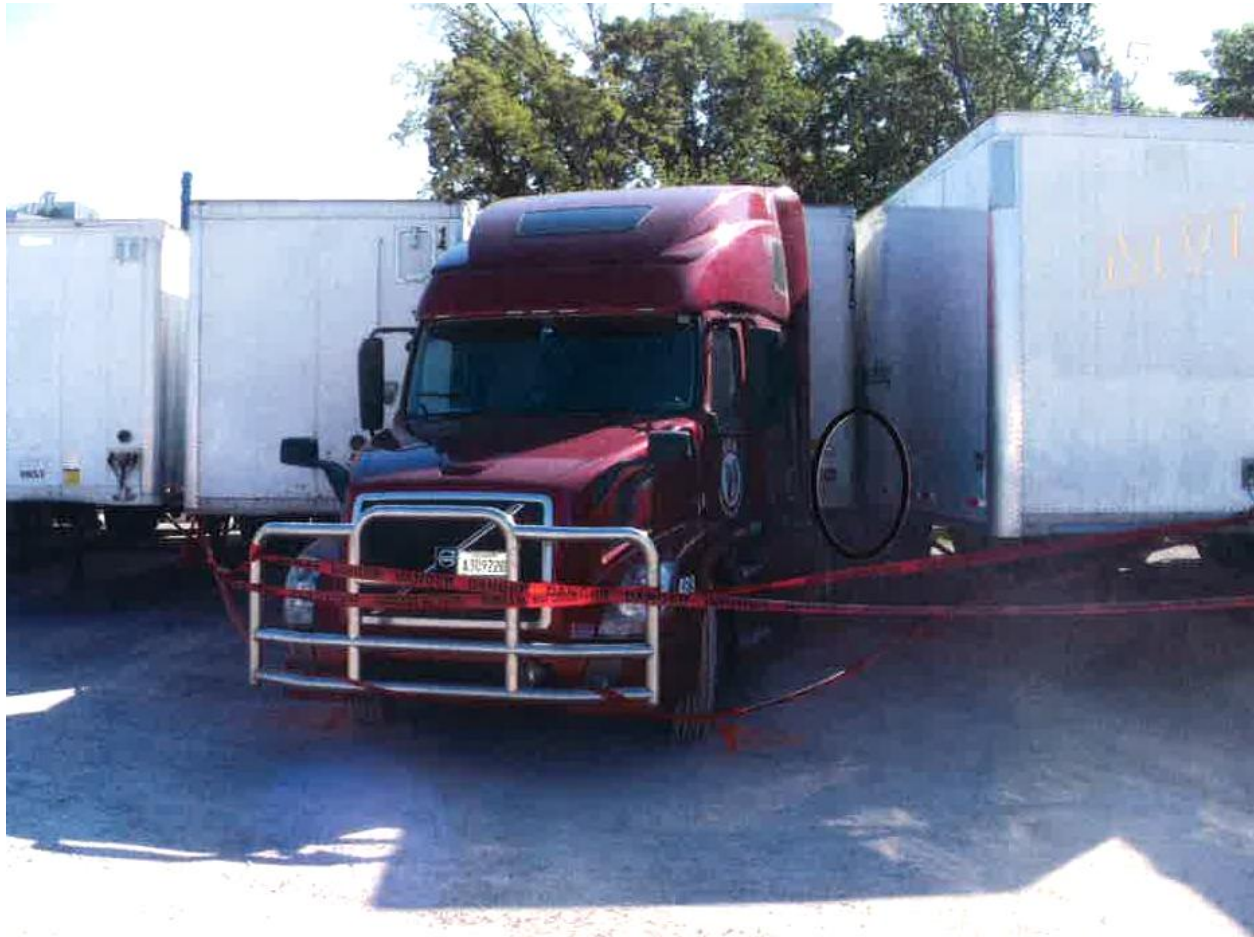
Photo 1 of 3 – The semi tractor was backed under the trailer at an angle therefore, when the trailer began to roll it moved closer to the trailer next to it. The circle denotes where the victim was crushed between the two trailers.

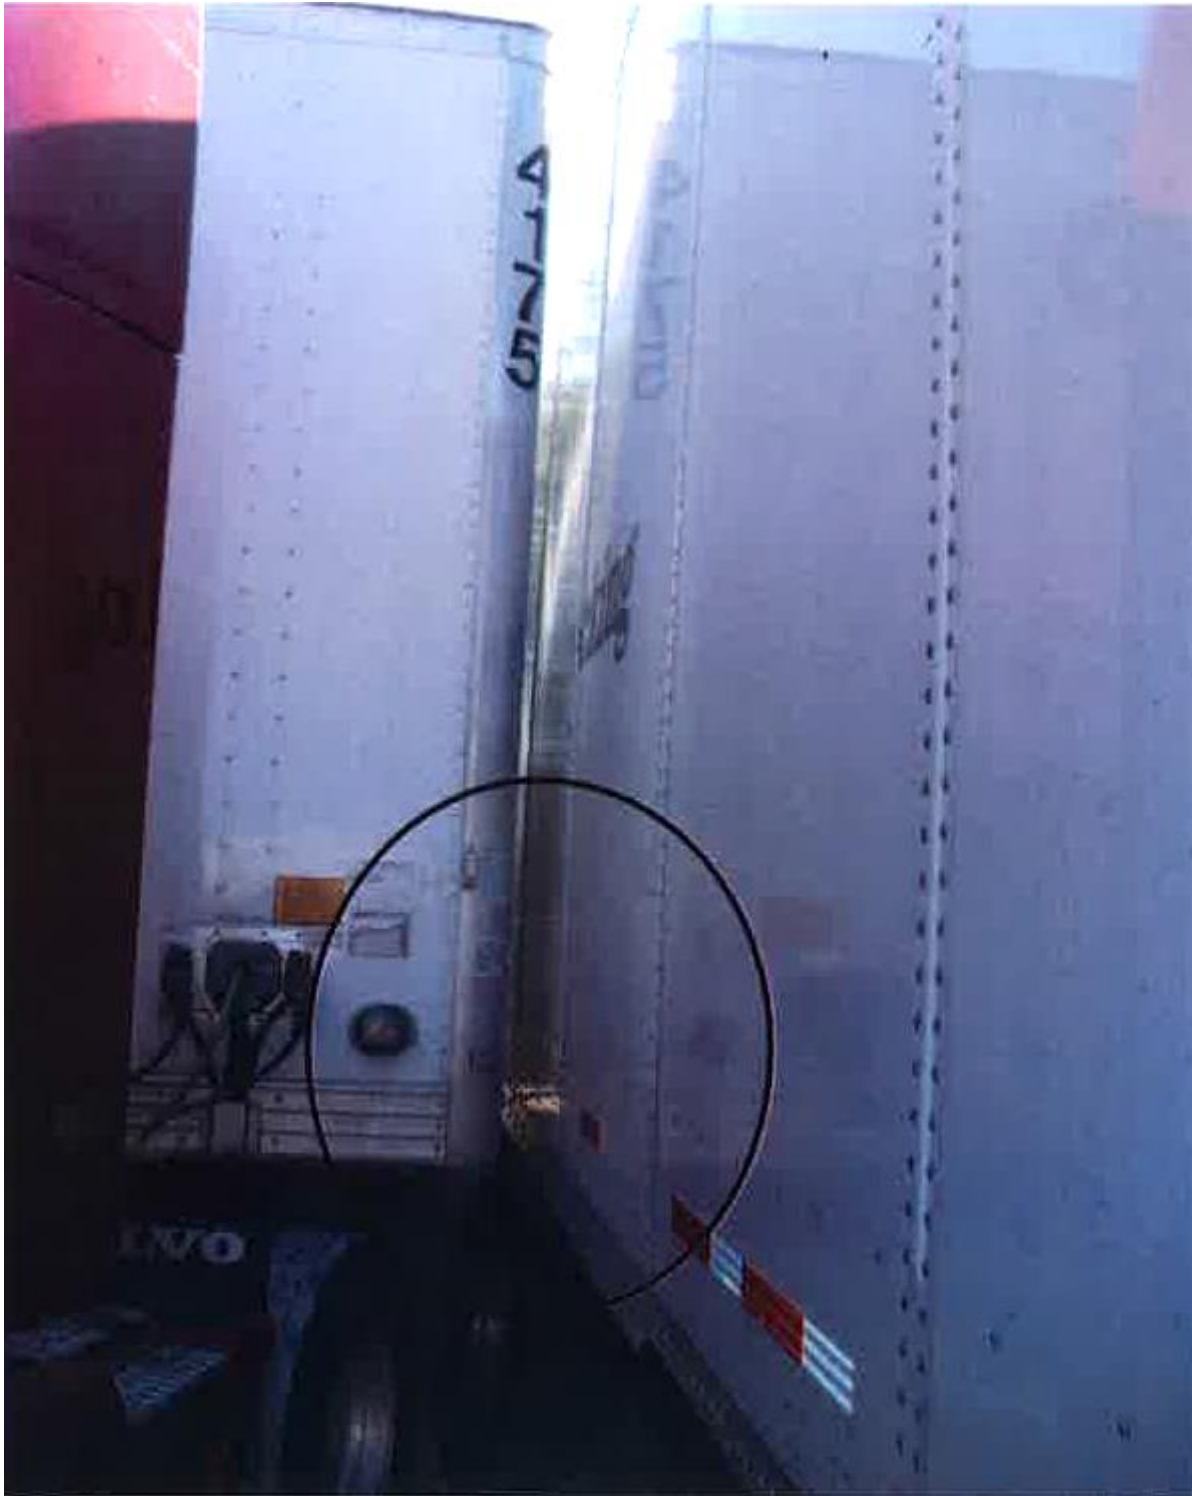
Photo 2 of 3 – The circle denotes the area where the victim was crushed and measured approximately 4/12 to 5 inches between the two trailers.

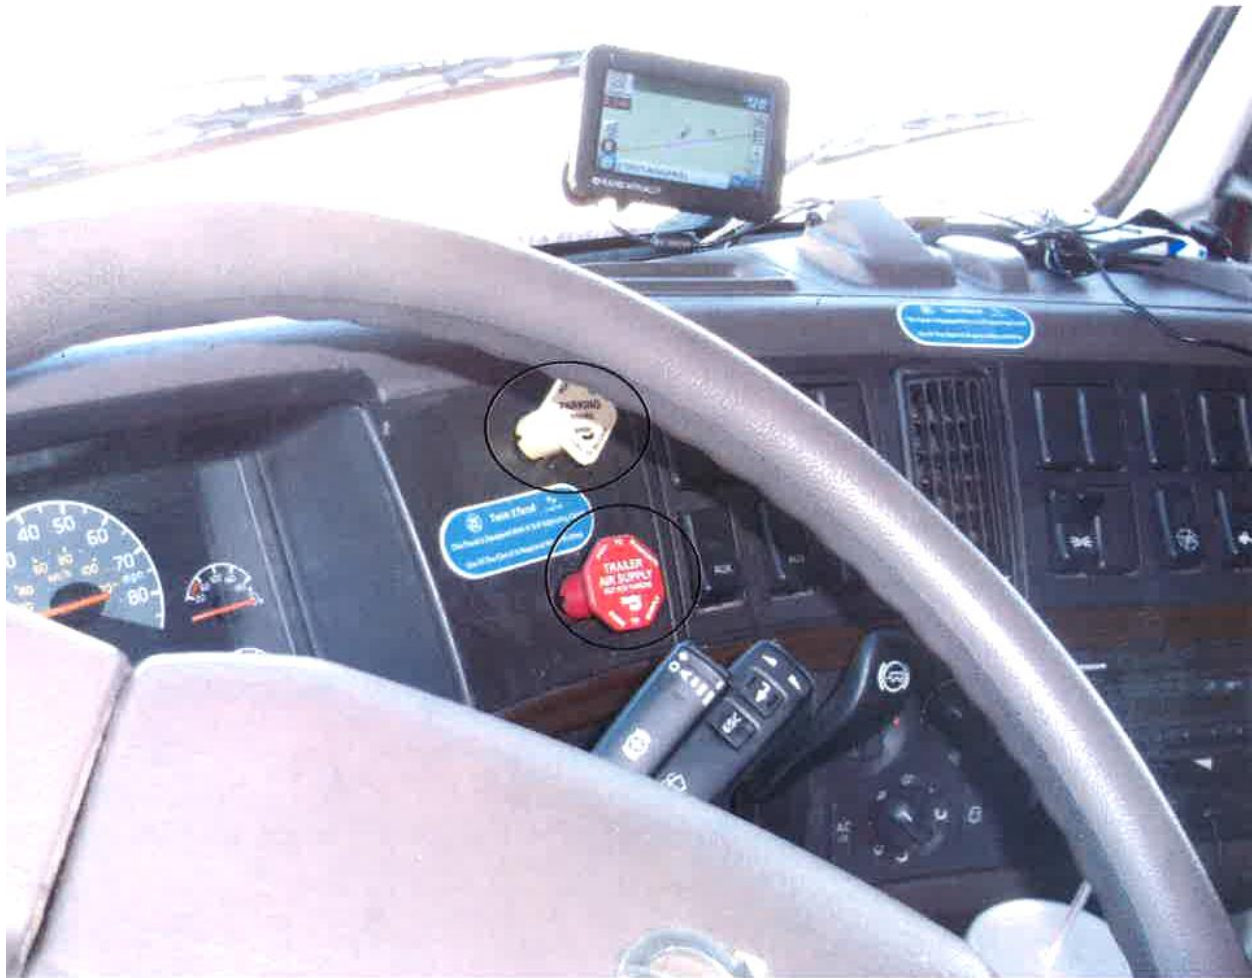
Photo 3 of 3 – The circles denotes the yellow and red knobs inside the cab which engage & release the air brake system for the trailer and semi tractor. The yellow knob which controls the parking brake for the semi tractor was not set while the trailer was being connected.
