## **#18: Crushed By – Inspection #317819118**

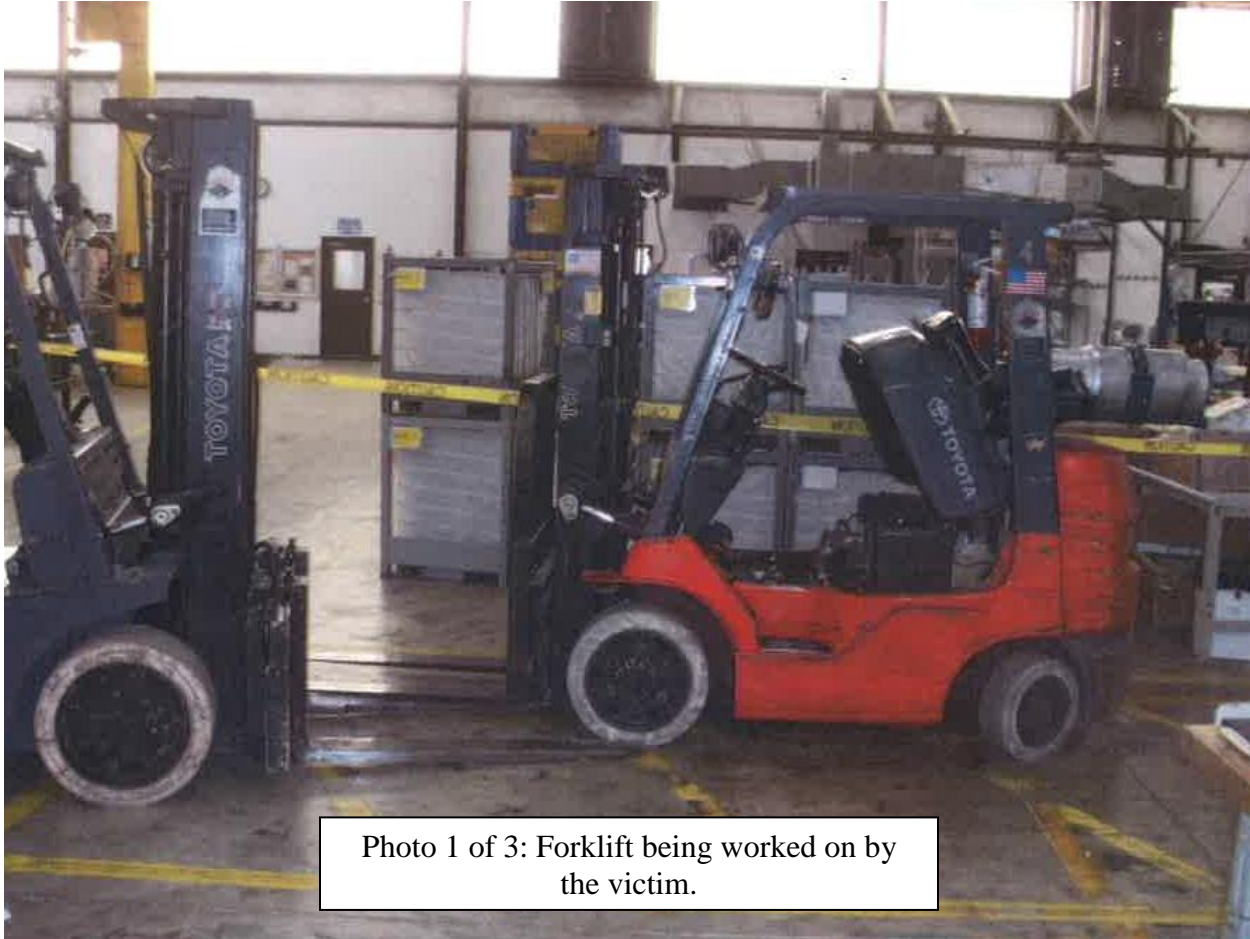
A **59 year old male** employee was pinned under a forklift while repairing the starter switch. The victim worked as a maintenance employee at the site and was responsible for forklift repairs. A forklift that would not start was moved to the assembly area, where troubleshooting and possible repair could take place. A maintenance supervisor removed the floor board from the forklift and left the area to retrieve a flashlight. The maintenance supervisor asked the victim for his help in repairing the broken lift. The victim diagnosed the problem and returned to the maintenance area to retrieve a forklift jack and a multi-meter to test for a bad electrical connection. The victim thought there was a wiring issue with the starter and he was going to test the wire with a multi-meter from underneath. The victim placed the jack behind the left front tire of the forklift and raised the forklift off the ground. No secondary support system was used. The victim then asked the supervisor to go to the other side of the forklift and when the indication was given turn the switch to the “on” position. The victim crawled underneath the forklift as the supervisor walked to the other side of the forklift. The supervisor heard the victim say something and noticed the forklift starting to move in a downward motion. At this point employees working in the area heard a loud noise and noticed the forklift had fallen from the jack. An employee working near the accident informed management that an accident occurred and that 911 had been called. Management rushed out to the floor to find another employee, who had been working in the area, had retrieved a nearby forklift, placed its forks under the forklift the victim had been working on and lifted the forklift off the victim so that the supervisor could pull him out from under the forklift. The victim had been hit in the head and was breathing and bleeding when he was removed from underneath the forklift. First aid and CPR were started until emergency Services arrived. The victim was taken by ambulance to the local hospital. The victim later died as a result of his injuries. During the TOSHA investigation no manufacturer marking, serial number, or weight rating were observed on the jack. The jack was labeled with the following warnings:

| Item 2 1910.244(a)(2)(iii) | Loads that had been raised were not cribbed, blocked or otherwise secured, in that the Toyota Forklifts, model 7FGCU25, was not cribbed, blocked or otherwise secured after it was raised. |

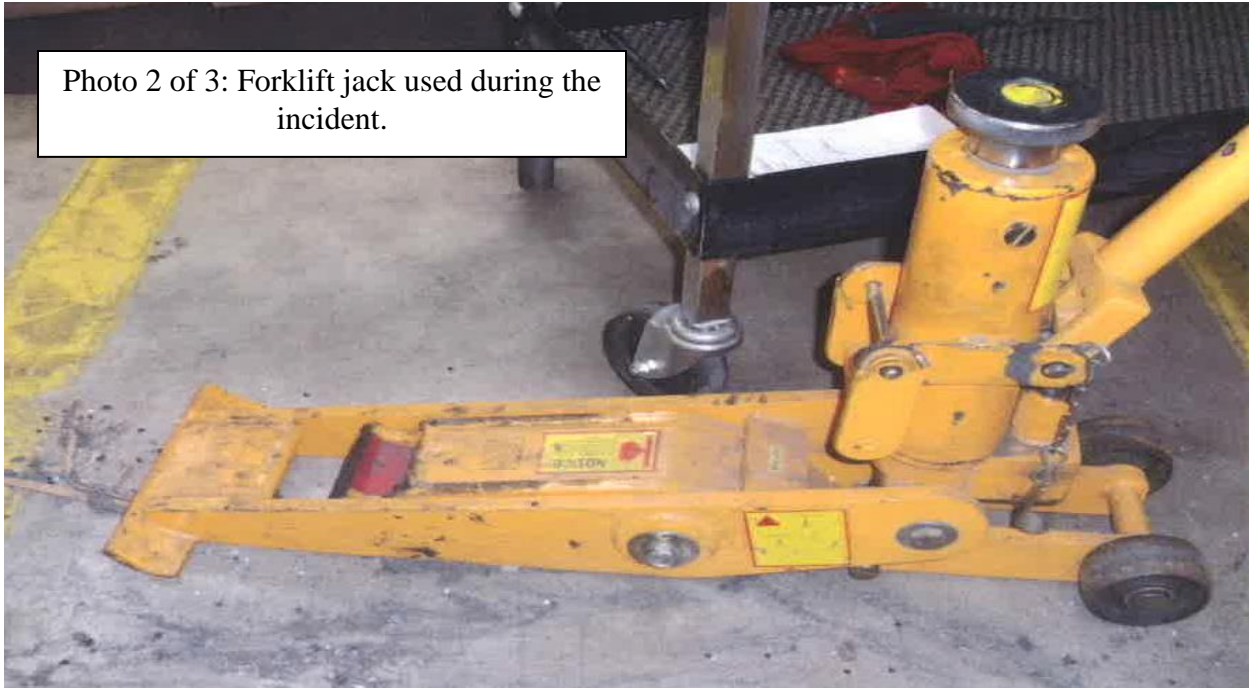
Photo 2 of 3: Forklift jack used during the incident.

| Item 1 1910.244(a)(1)(ii) | Rated load(s) of portable jack(s) were not legibly and permanently marked in a prominent location on the jack(s) by casting, stamping, or other suitable means, in that the forklift jack being used to raise the Toyota forklift, model 7FGCU25, did not have any legible permanent markings on it as to its rated load capacity at the time of the accident. |

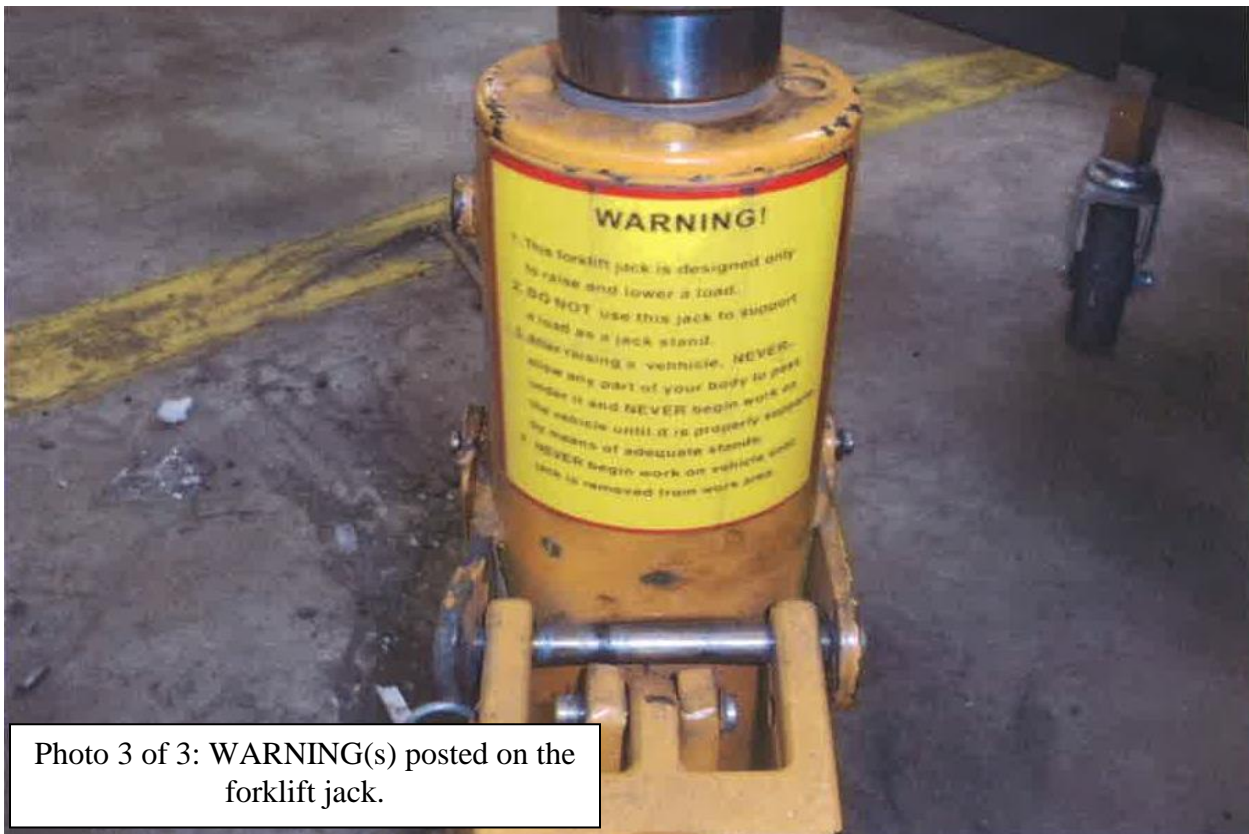
1. This forklift jack is designed only to raise and lower a load,
2. DO NOT use this jack to support a load as a jack stand,
3. After raising a vehicle NEVER allow any part of your body to pass under it and NEVER begin work on the vehicle until it is properly supported by means of adequate stands,
4. NEVER begin work on vehicle until jack is removed from work area.

Photo 3 of 3: WARNING(s) posted on the forklift jack.
