A 57 year old male employee was struck by a hook on an air powered bumper jack. The inspection was initiated due to an employer-reported referral of an employee being hospitalized after being found in the mechanic shop with severe facial and head injuries; the source of these injuries was not immediately apparent to co-workers nor county safety personnel. The victim sustained a 7mm left to right midline brain shift, bilateral orbital fractures (eyes), occipital bone fracture (rear of the skull), sphenoid bone (skull bone near the temple), and sphenoid sinus fractures.

Struck By bumper jack hook—Insp # 1672738 Knox County-Schools Maintenance

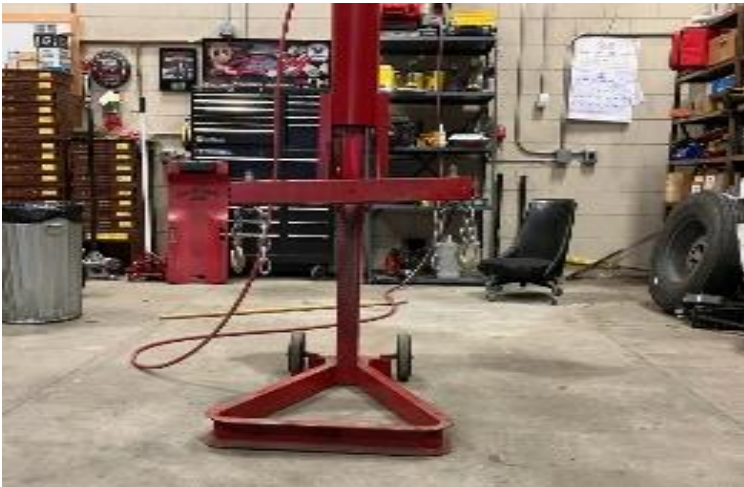
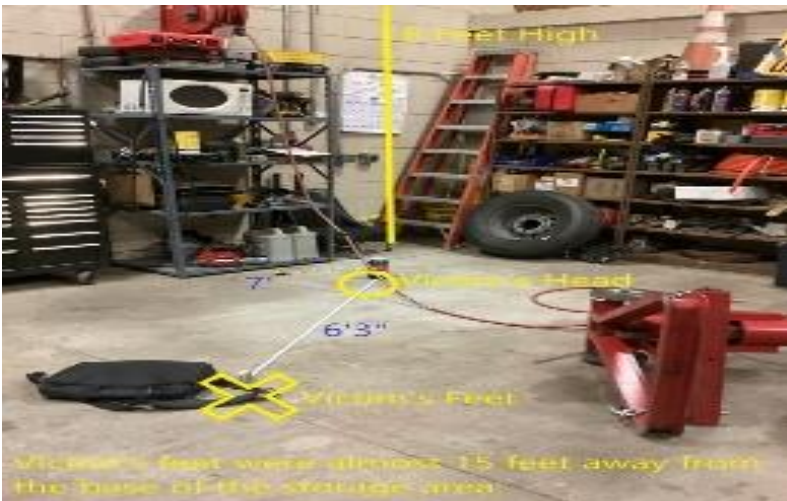
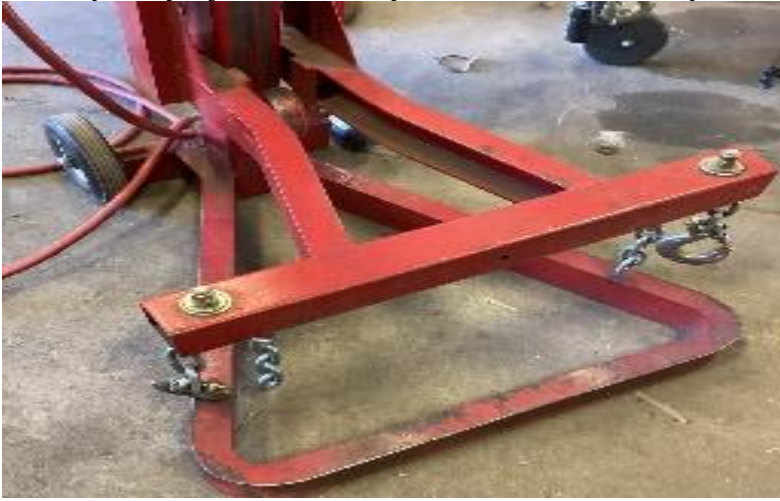
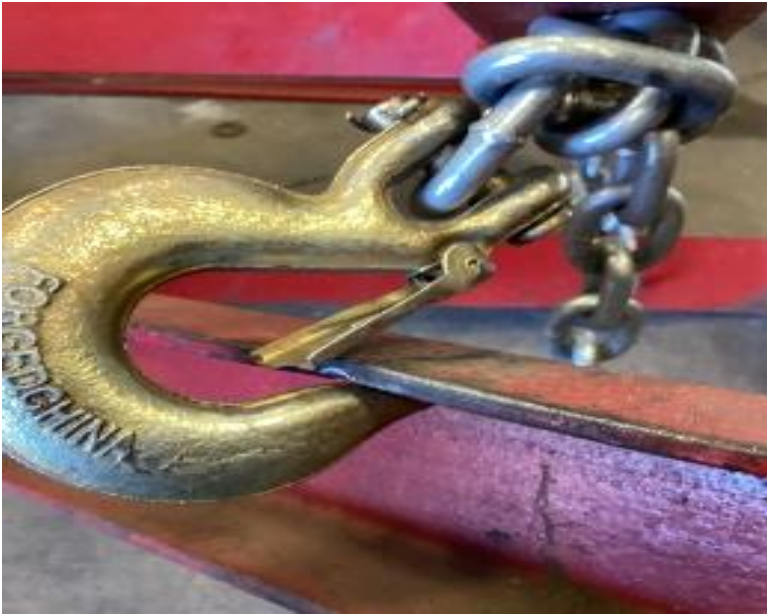
A Strongway air bumper jack was found in close proximity to the body, almost fully extended based on photos from the scene, and toppled over with the air hose draped over the top of the victim's body. It was discovered through interviews and research that the jack had been modified from its factory configuration, with chains and hooks supplemented to the lifting bar. The modification created a hazard where the added hooks would get caught on the base frame of the jack, but normally an employee would realize what had happened and would release the pressure. However, this created a dangerous condition where the jack was under pressure to lift but was stuck on its own frame. Based on the evidence at the scene, medical documentation of the sustained injuries, and the timeline, it is plausible to think that the victim was sweeping the shop and either wanted to sit and rest on the jack (co-workers said he did this from time to time), or he was attempting to move the jack. In any case, it is possible that the victim attempted to raise the jack, but a hook was caught on the frame. According to interviews, a hook being caught on the frame was not uncommon. When the victim moved his head to look or possibly pressed the button to raise the jack again, the jack suddenly let go from the edge of the frame, creating the upward deformation found on the jack's frame that fell in line with the corresponding hook on the left side when facing the jack. This force would have been sufficient to strike the victim with the top metal cylinder of the jack, striking him in the face, and causing him to fall straight back where he hit the back of his skull on the concrete floor. This explains the laceration to the lip, broken eye sockets, and massive facial trauma, along with the fractures to the back of the victim's skull. It also is likely that the jack would have turned away from him and the air hose would come to rest on top of his body, which is the position he was discovered in.

A proof-of-concept test was conducted by the Knox County Schools Safety Director. All personnel were removed from the shop and the jack was activated remotely via a breaker that operated the compressor. A wooden dowel was used to hold the hooks under the frame, simulating a condition where the hook would be caught on the frame. After an amount of time where the pressure was sufficient to break the wooden dowel, the jack broke the object and shot upwards with enough force to come off the ground several inches, despite weighing 195 pounds. This indicates that it is plausible to assume that the hooks on the jack could become hung on the frame and could potentially release enough stored energy to cause the injuries sustained by the victim. This, along with the deformation in the frame directly in line with the hook, makes it the most likely scenario for what occurred to cause the damage to the victim.

In that employees were exposed to a struck-by hazard while using one of three modified Strong-way air-powered bumper jacks found in the mechanic shop that utilized chains and hooks hanging from the support structure to lift a load instead of the stock rubber pads that pushed a load upwards. This modification exposed employees to a struck-by hazard when a hook catches on the frame, allowing for a sudden release of stored energy.
