## 9. Explosion

A **36-year-old** Hispanic boiler maker suffered fatal burns after an explosion occurred at a refinery where he was working. The victim and two injured co-workers were employed by a contractor at the facility. The three employees were hospitalized as a result of the explosion. The victim died four days later from burns over approximately 90% of his body. The events occurred in the area of the South Flare and Knock-Out Drum (KO Drum). A 36-inch pipe delivers hydrocarbons from the refinery production area and collects them in the KO Drum. Another 36-inch pipe exits the top of the KO Drum and delivers vapors to be burned at the South Flare to relieve pressure from the production area. The process leading up to the fatality began when, during a turnaround (shut down for maintenance), an environmental project was begun to capture flare gas and re-use it as fuel or feedstock rather than burn the gas in the flare. The 36-inch pipe between the KO Drum and the South Flare would be altered by installing a by-pass which would allow the South Flare to remain in service while work was performed at the KO Drum and the Flare Gas Recovery System. To begin the recovery project, the

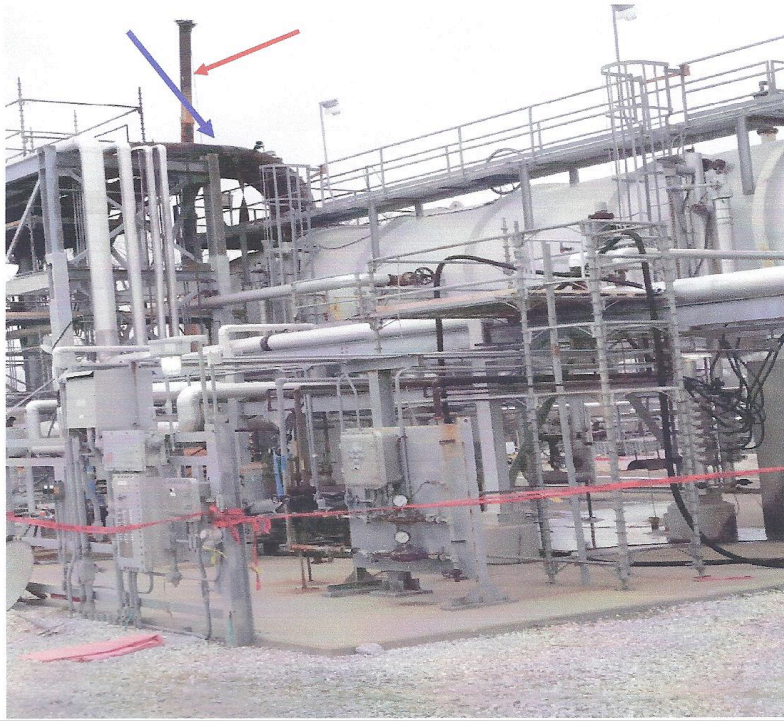
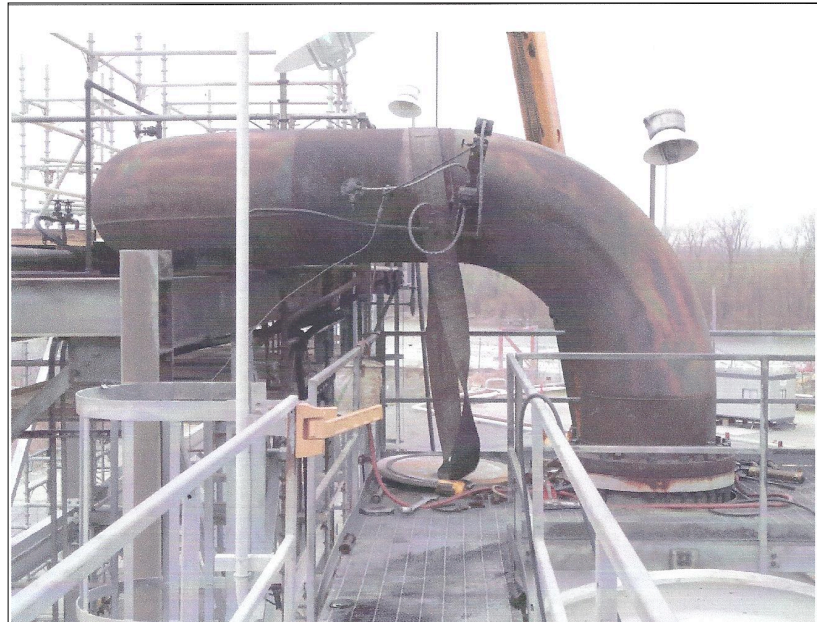
This photo shows the location of the South Flare KO Drum 36" pipe exiting the top of the drum as indicated by the blue arrow. The photo also shows the crane used to lift the blind to the platform & to help lift the 36" pipe so that the blind can be inserted into the flange as indicated by the red arrow.
