#1: Crushed by – Inspection #317585545

A **40 year old male** employee was working to demolish the old Hwy 22 Bridge over I-40 and construct a new bridge in its place. The victim and a co-worker were in the basket of a JLG 660 SJ aerial lift. According to the co-worker, the victim had inspected the aerial lift before they started working from the basket. He said there were no problems with the aerial lift and there were no problems with the aerial lift's controls. According to the co-worker, they were both wearing the personal fall arrest system (PFAS) full body harnesses and lanyards and they were both tied to the anchor points in the aerial lift's basket. They were removing bolts from the top of the easternmost concrete bulb tee beam. The bolts were used to support a catwalk along the easternmost edge of the Hwy 22 Bridge. According to the co-worker, they had removed a number of bolts and had to reposition the aerial lifts' basket to gain access to more of the bolts. The victim was operating the controls of the aerial lift and started to extend the aerial lift's boom. They were both facing away from the bridge and facing towards the aerial lift's control panel. The co-worker sai

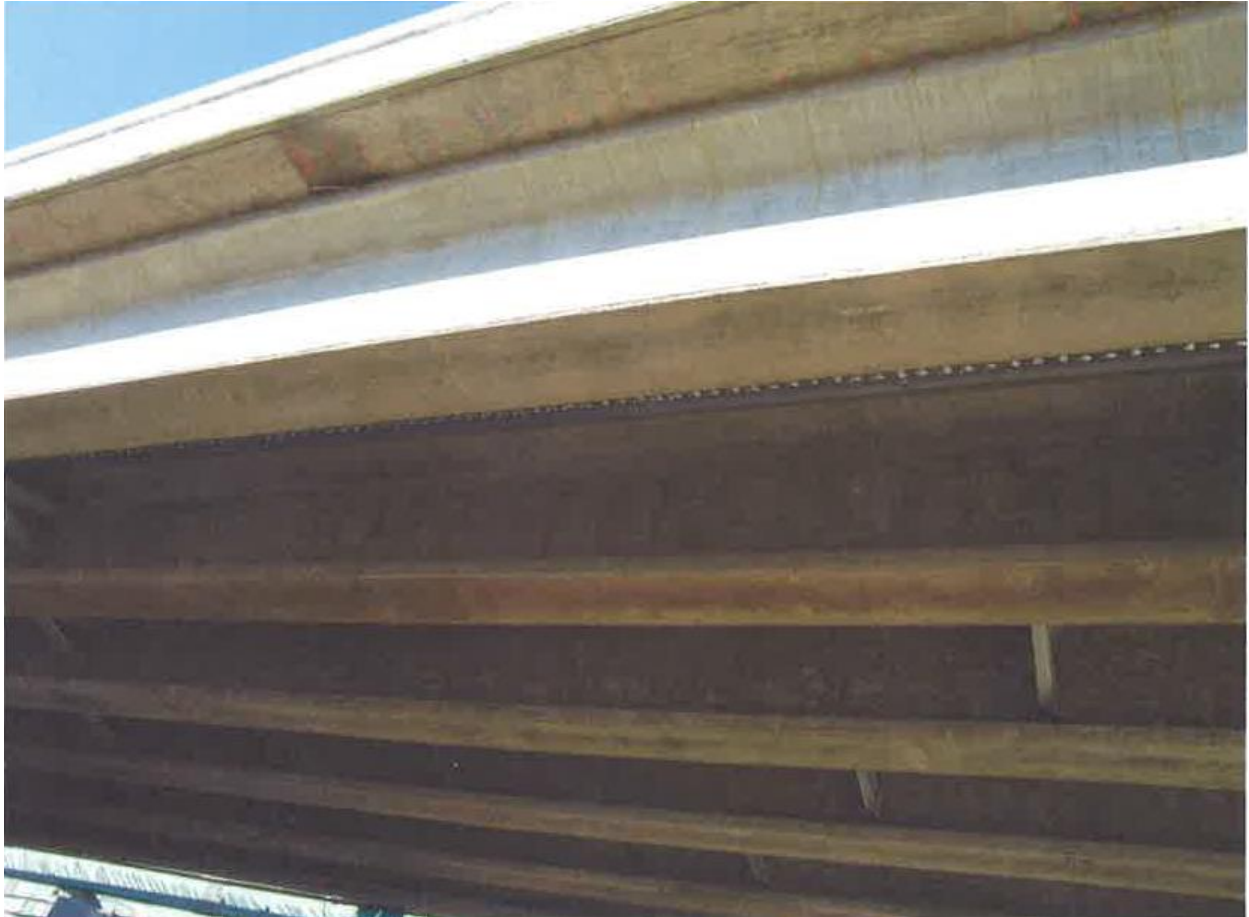
Photo 2 of 2 - Victim and co-worker were removing bolts from the top of the easternmost concrete bulb tee beam. The bolts were used to support a catwalk along the easternmost edge of the Hwy 22 Bridge
